Seismology and Ground Motion Features of 1995 South Hyogo Great Earthquake.....	220
Liquefaction and Damages to Harbour Facilities.....	228
Mountain Slope Failures Caused by the Great Hanshin Earthquake.....	233
Damages to Bridges on Highways and Railroads Caused by the Great Hanshin Earthquake of January 17, 1995.....	237
Damage to Large-Scale Underground Lifelines during the 1995 South Hyogo Prefecture Earthquake.....	272
Lifelines Performance and Damage during Jan. 17, 1995 South Hyogo Great Earthquake.....	283
Outline of the Geographical Information System (GIS) and Internet Information.....	296

## **Liquefaction and Damages to Harbour Facilities**

# Mountain Slope Failures Caused by the Great Hanshin Earthquake

# DAMAGE TO BRIDGES ON HIGHWAYS AND RAILROADS CAUSED BY THE GREAT HANSHIN EARTHQUAKE OF JANUARY 17, 1995

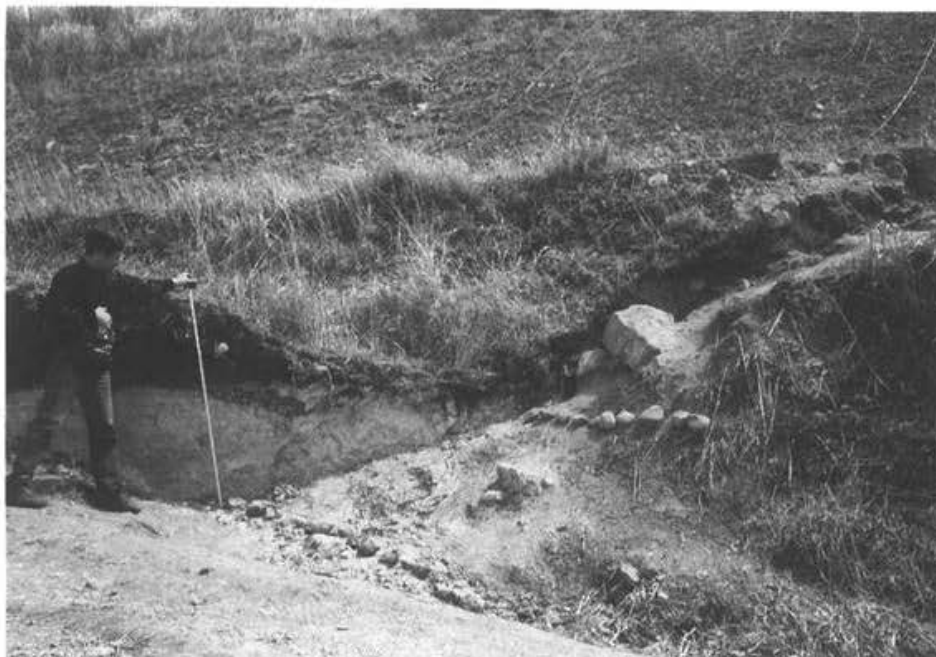
The movement mechanism of fault that it has strike-slip type with right-lateral movement. The direction of movement is from the south-west to the north-east. The maximum horizontal and vertical displacements which were observed in the ground surface are about 1.8 m and 1.3 m, respectively. The Photo 1 shows the Nojima Fault movement.

Photo 1 - Movement of Nojima Fault (source of quake)

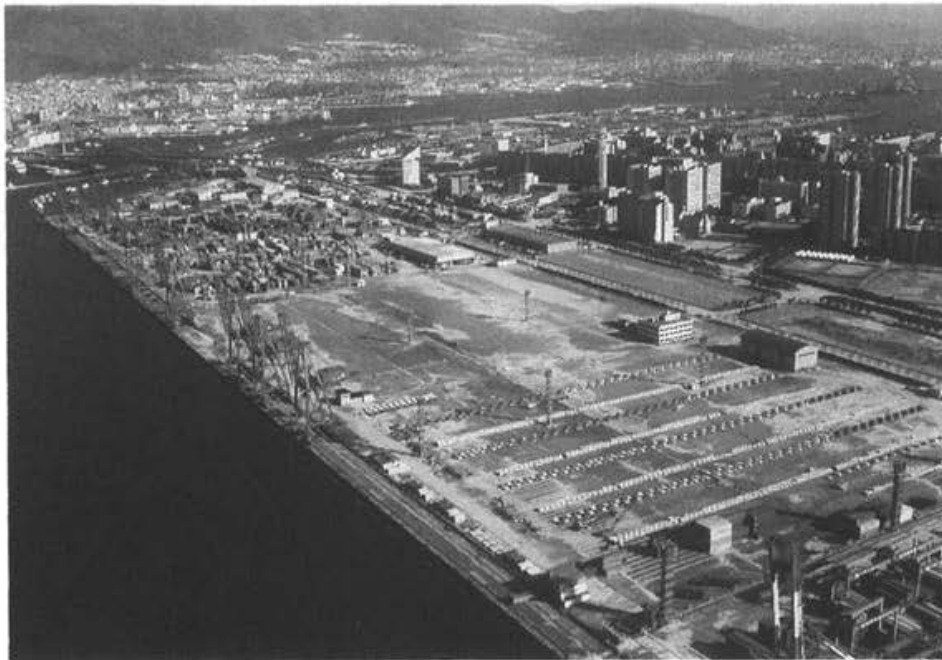
Figs. 3 and 4 show typical example of the earthquake damages to the islands, and these are the failure of south end shore-line of Rokko Island and the liquefaction at container yard at west shore of Port Island, respectively. As to the failure of shore-line, tilting and a large horizontal movement of concrete caisson was a typical of failure mode and the granular fill behind caisson settled and moved horizontally over a wide area. The movements of these shore-line are surveyed by using a satellite and the measurements at Port Island are shown in Fig. 5. The figure shows that the shore-line moved 2 to 3 m horizontally and settled over 1m in average. The possible cause of sea-wall failure seems to be

**Figure 4 Liquefaction of Container Yard at West of Port Island**

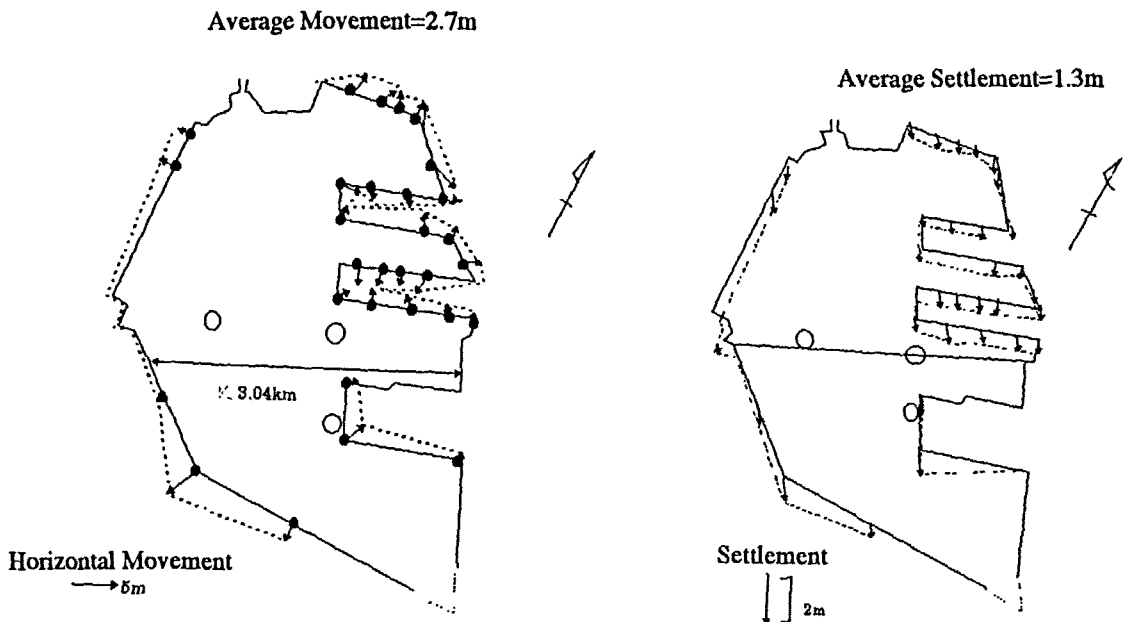
**Figure 5** Settlement and Horizontal Movements of Shore-line of Port Island

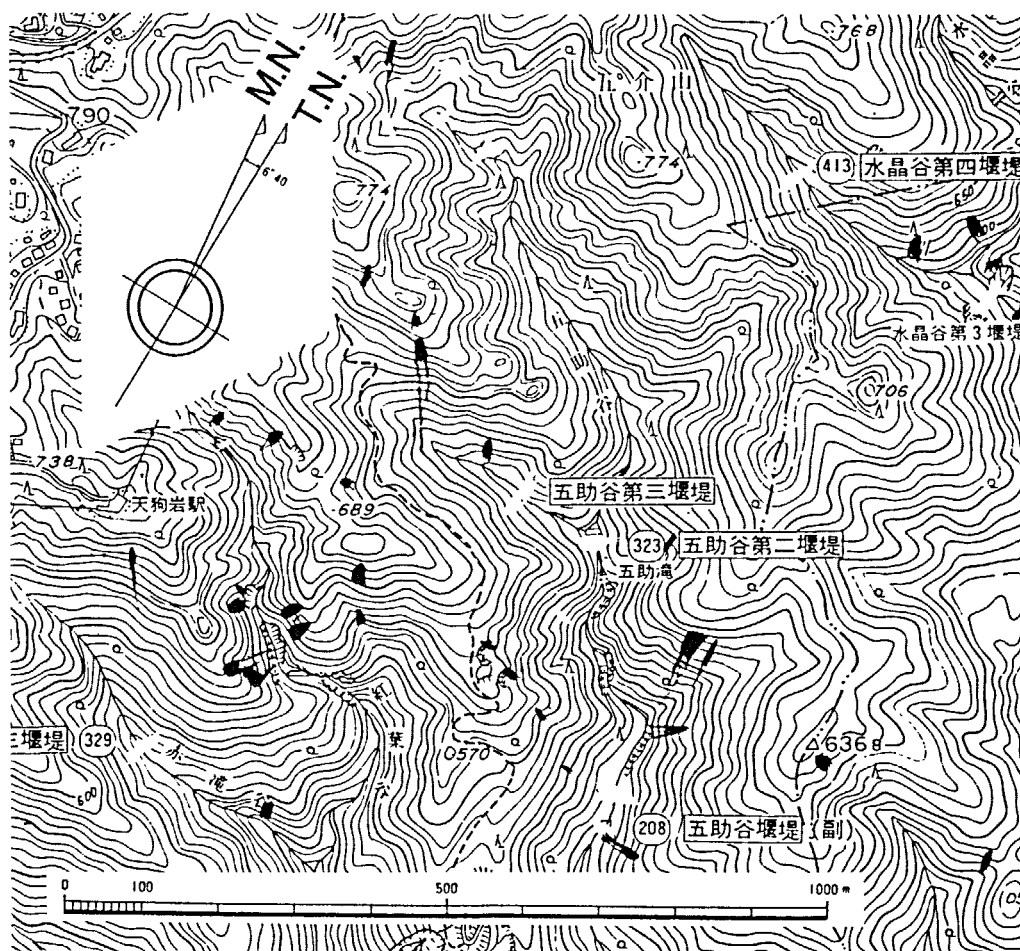
Figure 1 Part of the failure distribution

Figure 1 shows a part of the failure distribution figure which was reduced to a scale of 1 to 10,000. The area of this map is Gosuke and Momiji valley situated at the upper region of the Sumiyoshi river. It can be seen from this figure that the characteristics of mountain slope failures

obtained from the distribution map are: 1) as a whole, there are many cases of small area failures, 2) the failures are mainly on very steep slopes, 3) flowed and eroded areas are very small, 4) the failures appeared on planar and/or crest slopes, 5) failures often appear at knick points downwards from gentle to steep gradient, 6) some failures appeared at outcrop, 7) unstable rock mass failed and rolled along the slopes. (Refer to Photographs 13.1 and 13.2 on the Japanese language report) and 8) big cracks developed along the mountain slopes which have not yet failed. (Refer to Photograph 13.3 on the Japanese language report).

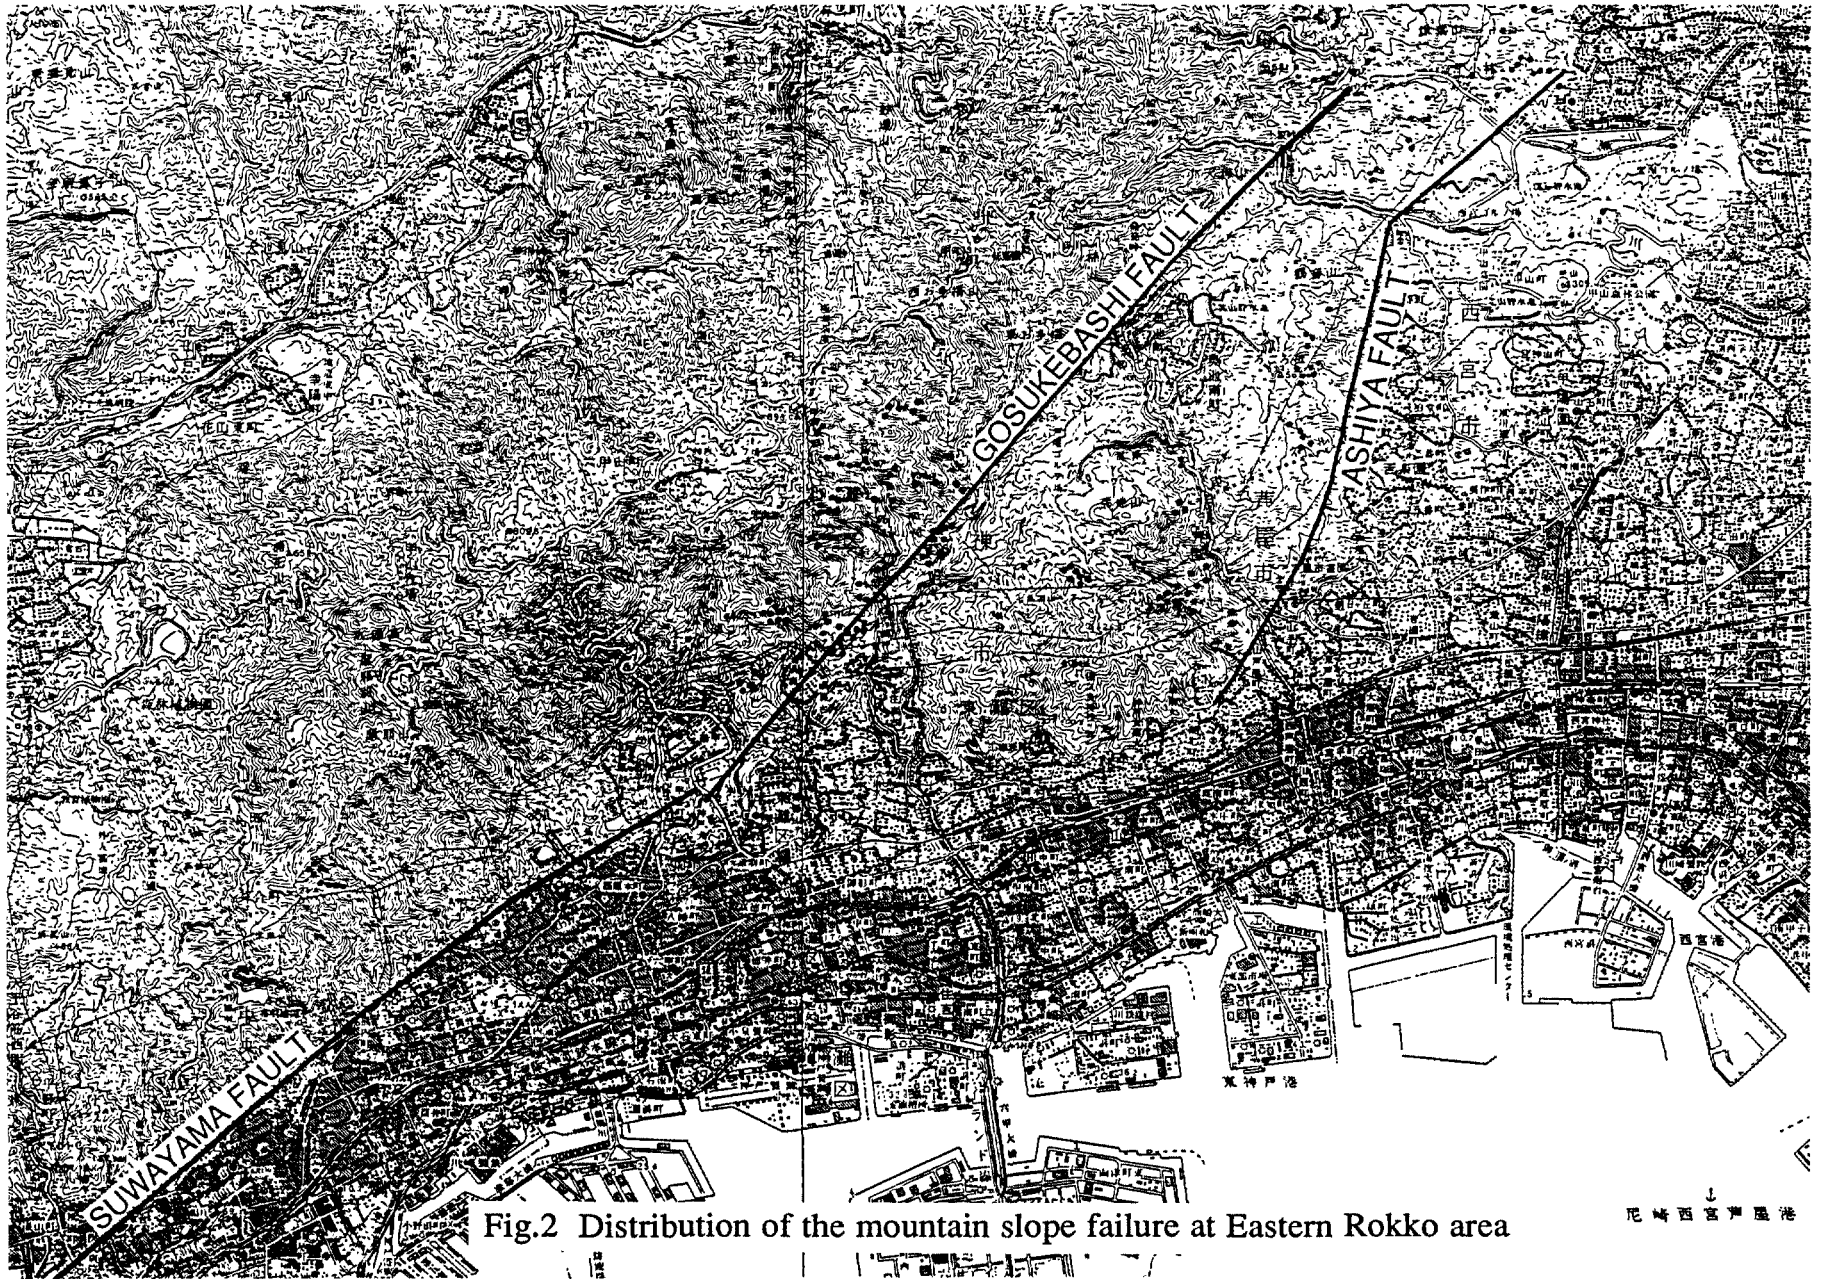
Fig.2 Distribution of the mountain slope failure at Eastern Rokko area

Figure 2 shows the distribution of mountain slope failures at the eastern part of Rokko mountains. It seems that as a whole, these failures are distributed along two belts. In this figure, the big faults named as Suwayama, Gosukebashi and Ashiya faults are shown. These failures occurred parallel to these faults. The reasons for these mountain slope failures distribution are thought to be: 1) shear movement of these faults by big earthquake, 2) these failures appeared from steep slopes which are usually seen along faults even if there are no shear movements, and 3) both 1) and 2). In future, the causes of failure distribution will be studied by using equi-acceleration maps.

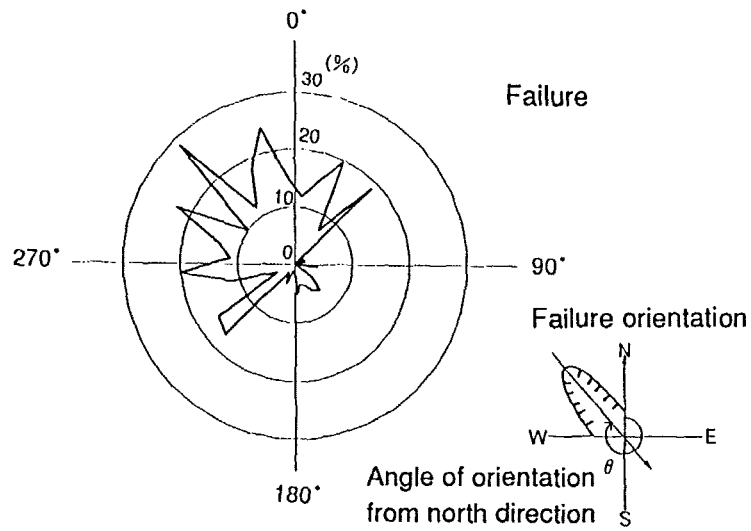
Fig.3 Orientation of the failure

Figure 3 shows the aspect of mountain slope failures caused by the earthquake. The failures occurred along the orientation from NW to SE direction. Many faults developed in Rokko mountains perpendicular to this direction as seen in Figure 2. In order to get the aspect distribution of Rokko mountains, we used the digital map whose mesh spacing is 231 by 286 m. The results are shown in Figure 4. From this figure, it can be seen that there are more slopes that formed with the crest along the NE to SW direction compared to the opposite orientation. The ratio of the mountain slope failures to their orientation is obtained by dividing the number of failures (Figure 3) to the number of slopes (Figure 4) respective to the orientation. The results are shown in Figure 5. There are many failures along the orientation from the NW to SE direction. In addition, some failures appeared along both the NE to SW and SW to NE orientations. It may be implied that the failures along the former orientation appeared on the terminal facets and the failures along the later orientations appeared on the side walls of the small valley which developed perpendicular to the direction of the main faults.

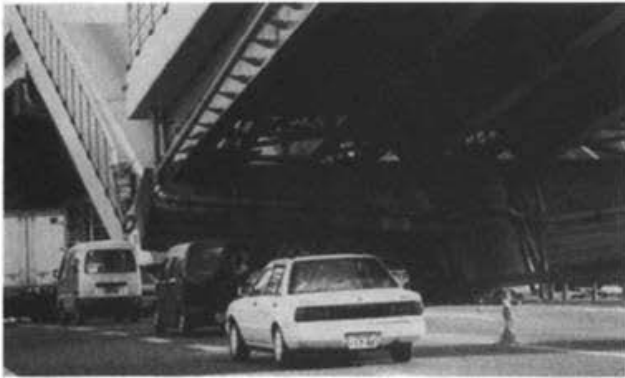
Photo 2.1.1 HANSHIN EXPRESSWAY  
(Nishinomiya City - Kusugawa-cho)

- Pier N. Shin 166-167**
- Bridge type : Super-structure : Simple steel plate girder.  
Sub-structure : T-Type RC bents composed by piers of circular section.
  - Foundation : RC basement.
  - damage situation : The bridge fall at both, east and westbounds by the collapse of the piers.
  - Picture 2.1.1

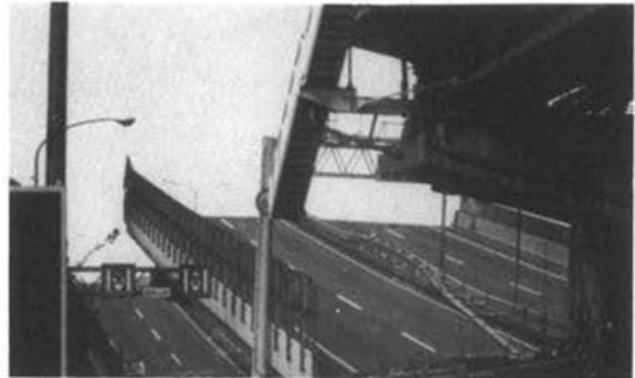
Photo 2.1.2 HANSHIN EXPRESSWAY  
(Nishinomiya City - Kurakake-cho)

- Pier N. Shin 39-40**
- Bridge Type : Super-structure : Simple steel box girder.  
Sub-structure : T-Type RC bents composed by piers of circular cross section.
  - Foundation : RC basement.
  - Damage situation : The bridge fall at the eastbound due to the failure of bearing supports.
  - Picture 2.1.2

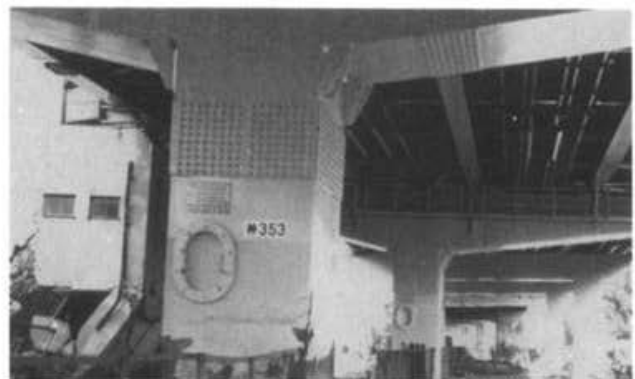
Photo 2.1.8 HANSHIN EXPRESSWAY  
(Chuo-Ward - Wakihama-cho)

- Pier N. shin 352-353**
- Bridge type : Super-structure : Simple steel plate girder bridge.  
Sub-structure :  $\Pi$  type bents composed by columns of rectangular cross section.
  - Damage situation : Foundation : RC basement.  
Buckling of pier accompanied with collapse of contiguous building.
  - Picture 2.1.8

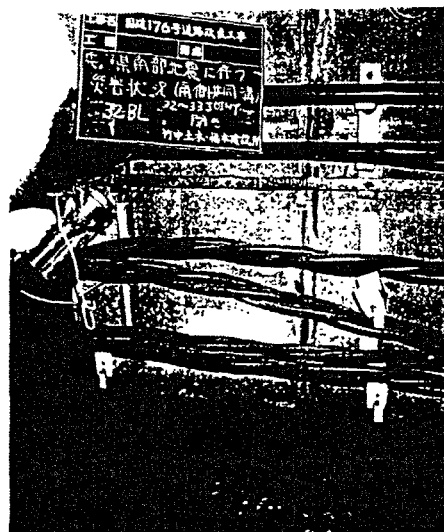
**Photo 4 : Damage to Rubber Joints and Leakage of Water**

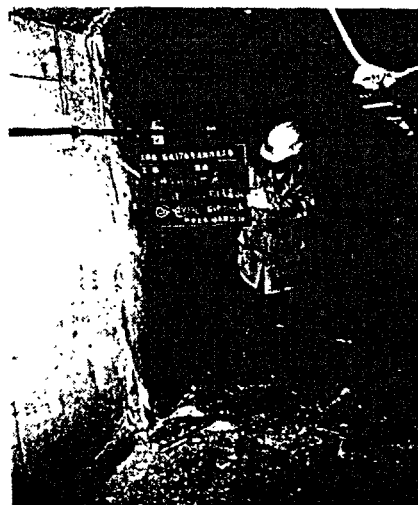
**Photo 6 : Separation and Damage of Concrete Walking Sheets**
