資料－3 発表論文

神戸高速鉄道大開駅被害状況

DAMAGE TO DAIKAI SUBWAY STATION, KOBE RAPID TRANSIT SYSTEM AND ESTIMATION OF ITS REASON

Damage to Daikai Subway Station of Kobe Rapid Transit Railway during the 1995 Hyogoken-Nambu Earthquake

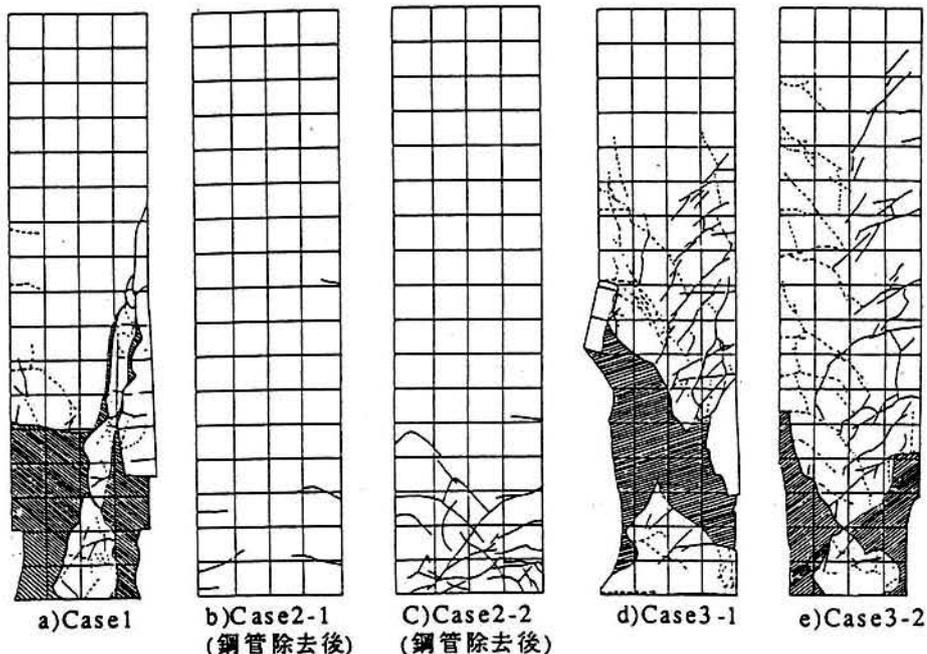
図-5 各ケースの最終ひび割れおよび破壊状態
 (実・破線:正・負加力時発生ひび割れ, 斜線部:コンクリート剥離)

破壊したCase1, Case3-1についてみると、Case1では最大耐力の生じる前にコンクリートに圧壊が生じており、Case3-1では最大耐力の生じる直前に鉄筋の降伏が生じている。これらのことから、両ケースの破壊モードは曲げせん断破壊であると考えられる。また、破壊に至らないケースは最大耐力の生じる前に鉄筋の降伏が生じている。このことか

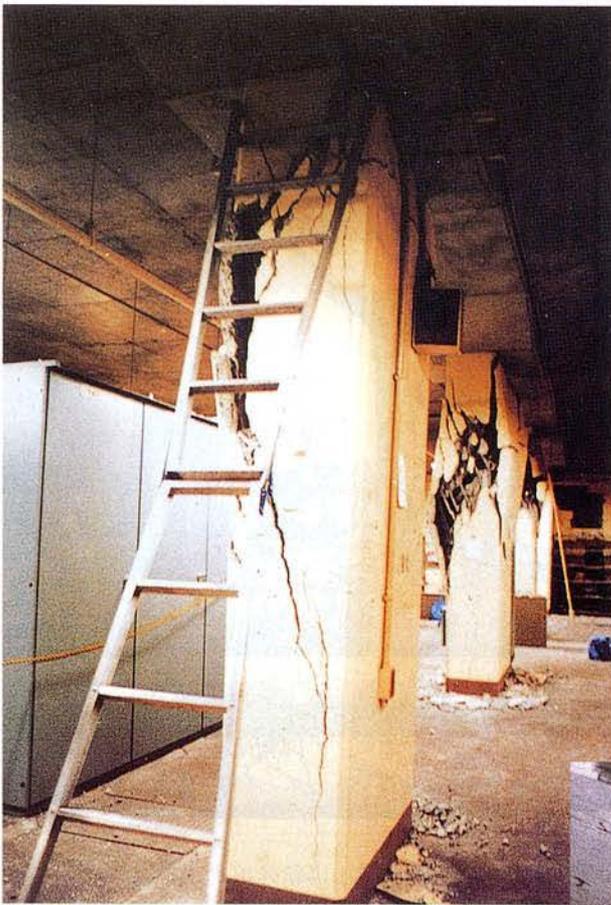
上沢駅は大開駅から約400mほど離れており、震度Ⅶの地域にある。写真は3層2径間構造の上層中柱の被災状況である。主たる破壊は、ほぼ一様に北側上方(写真では左上)から南側下方(同右下)の方向に生じていることが特徴的である。

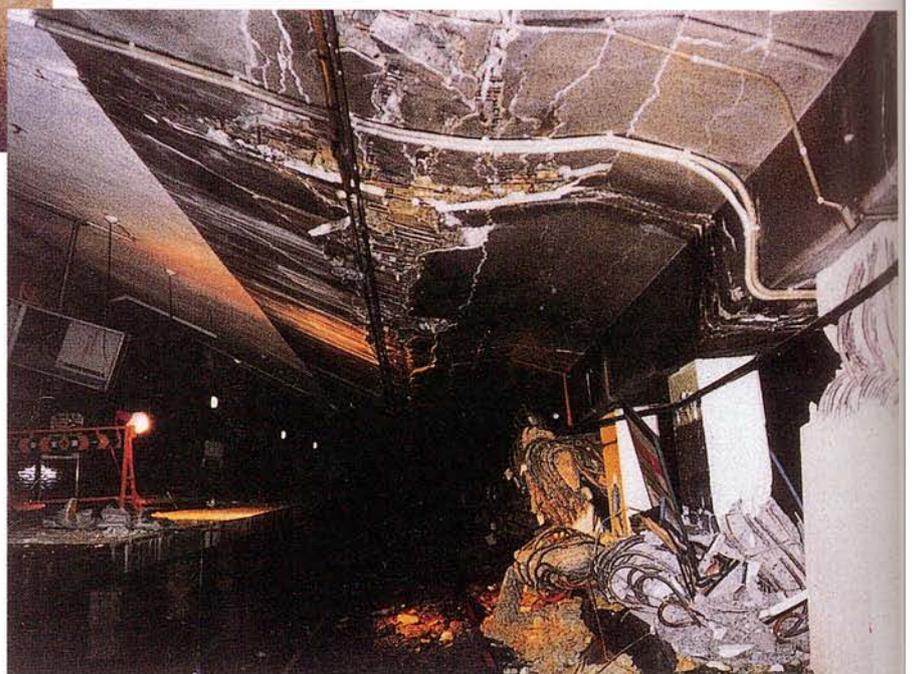
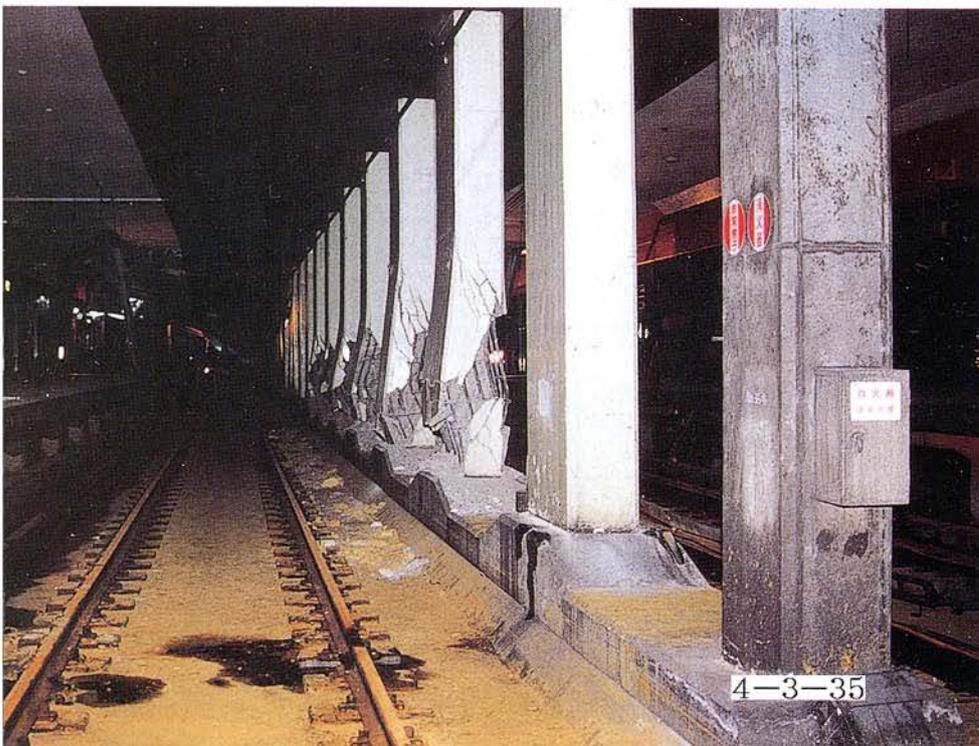
写真-9

大开駅コンコース部より高速長田駅側の中柱が完全に圧壊している。上床スラブは中央から1.75～2.00mの位置にて幅15～20cmの亀裂が発生し、最大2.5mの沈下が生じている。

中柱の損傷

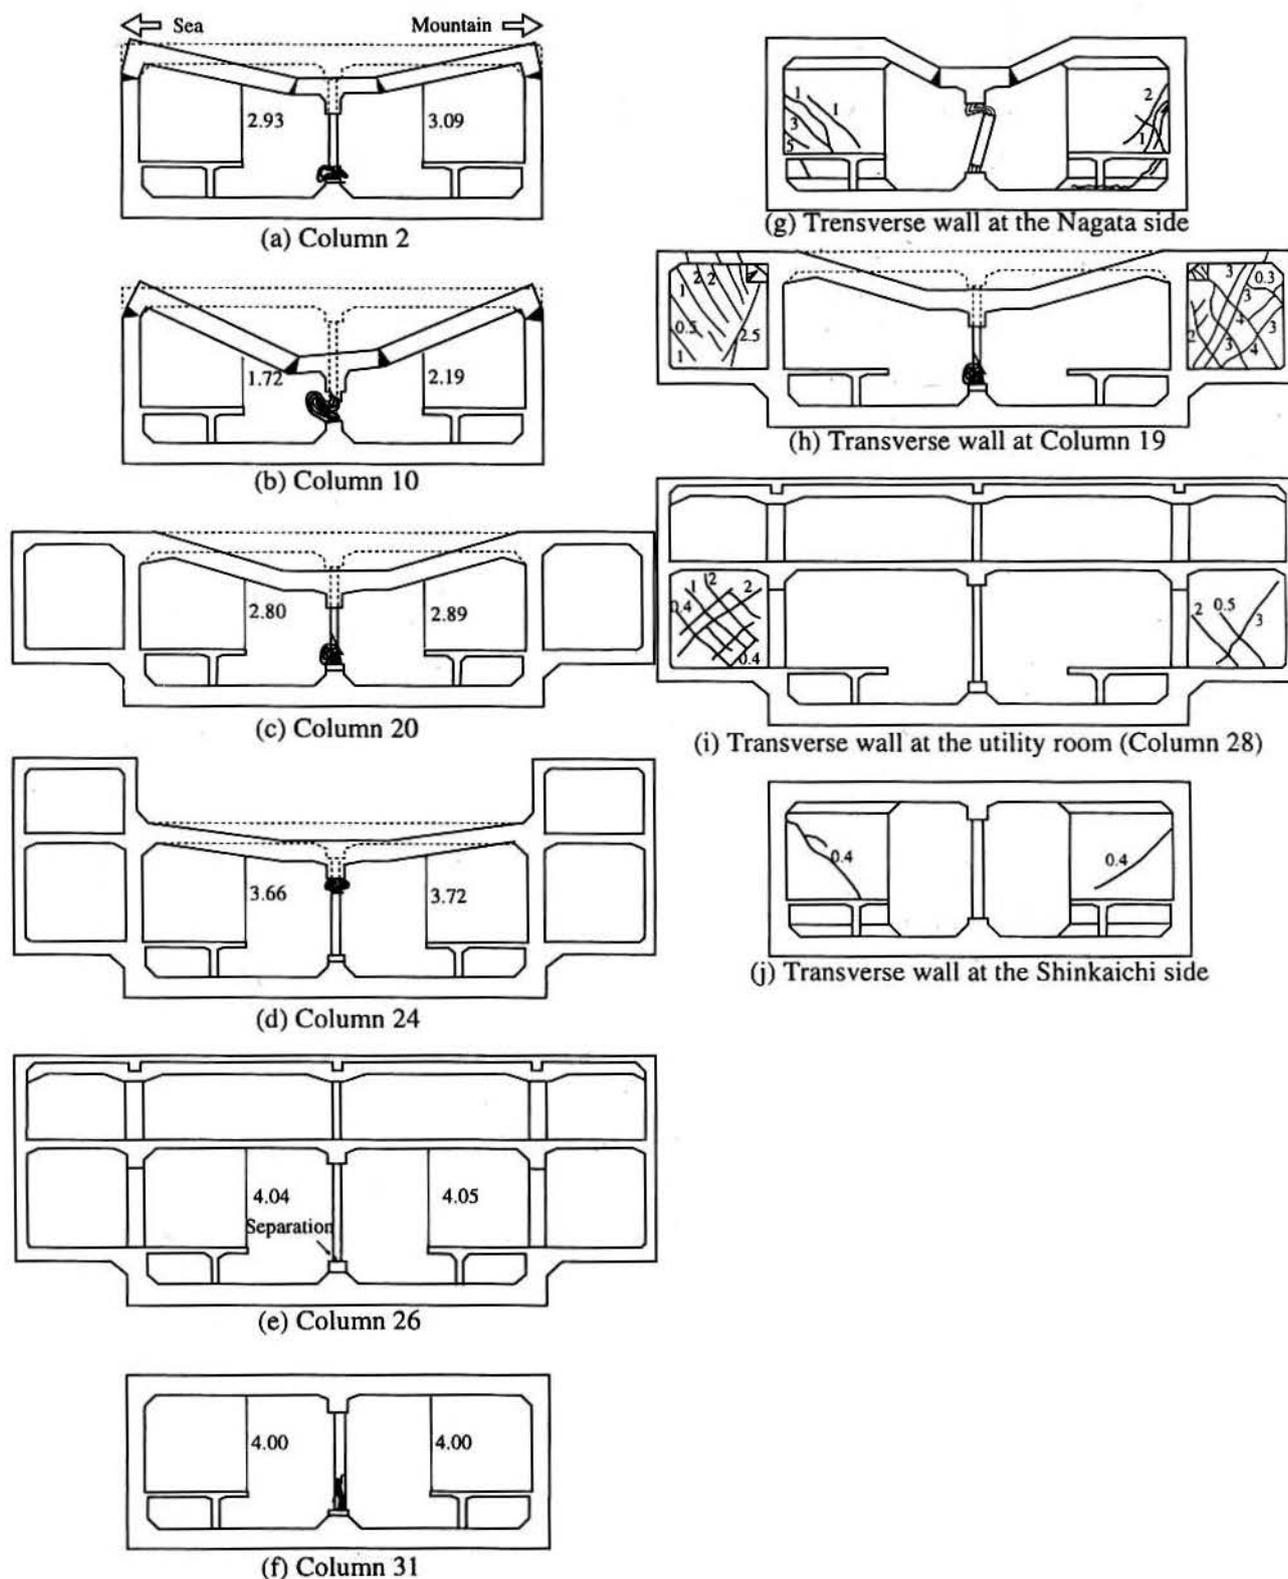
Fig. 12. Schematic figure showing the damage patterns in the transverse direction. Numbers in (a) to (f) are clear height in m measured after the damage, and numbers in (g) to (j) denote crack width in mm

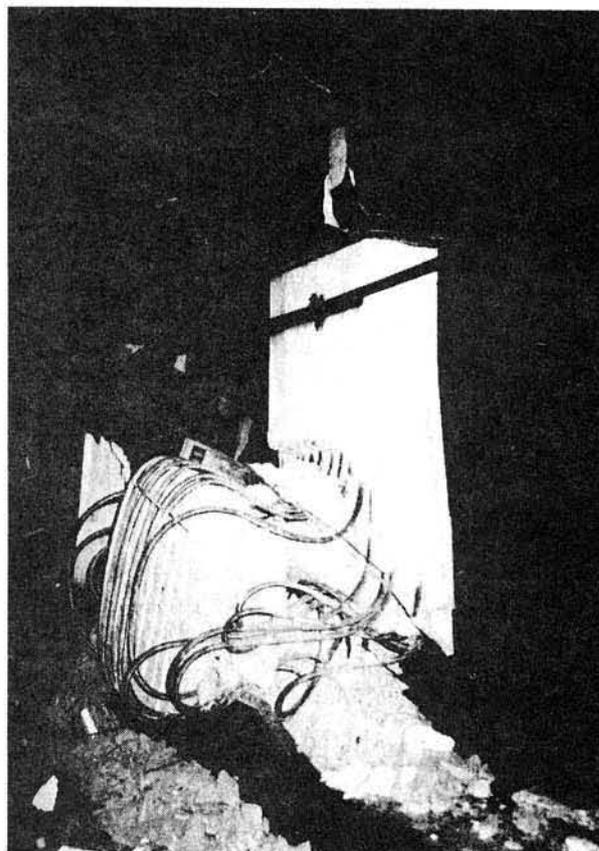
Photo. 5. Damage to center column No. 20

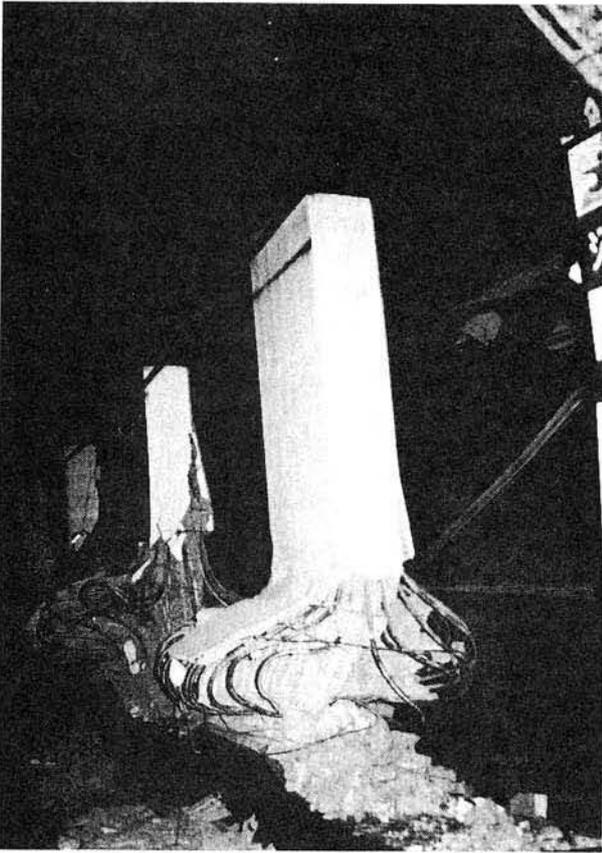
Photo. 6. Damage to center column No. 23

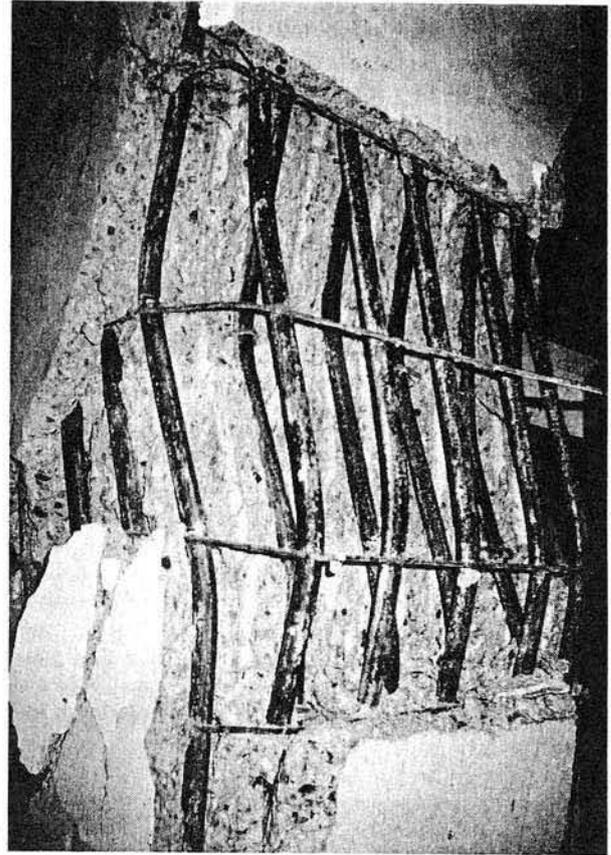
Photo. 7. Damage to center column No. 34. Only every other reinforcing bar buckled indicating that the zigzag arrangement of the reinforcing steel (See Fig. 5) worked well to retain the core concrete

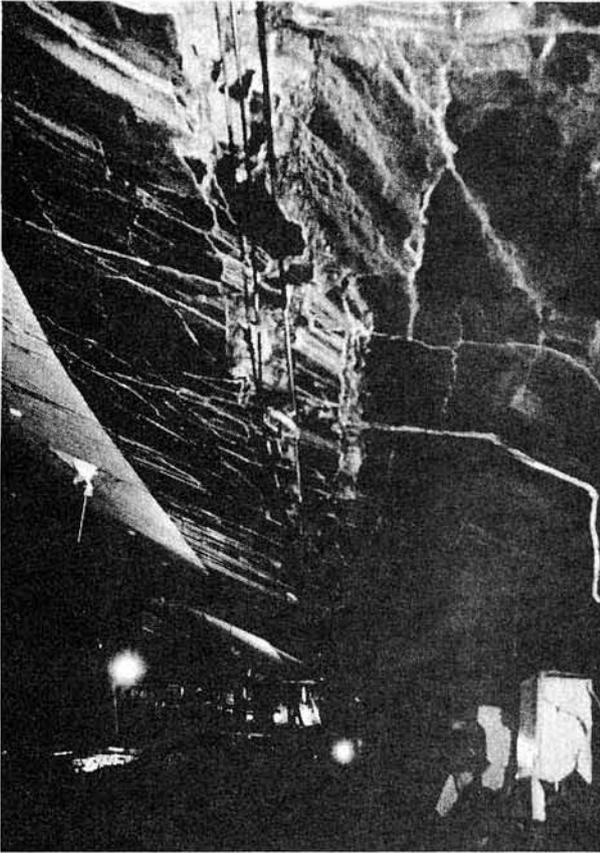
In zone A, the ceiling slab kinks and cracks 150–250 mm wide, appeared in the longitudinal direction about 2.15 to 2.40 m from the center line of the columns as shown in Fig. 11(a) and Photos. 2 and 8. Referring to

Photo. 8. Damage to ceiling slab: view toward Nagata side from column No. 18

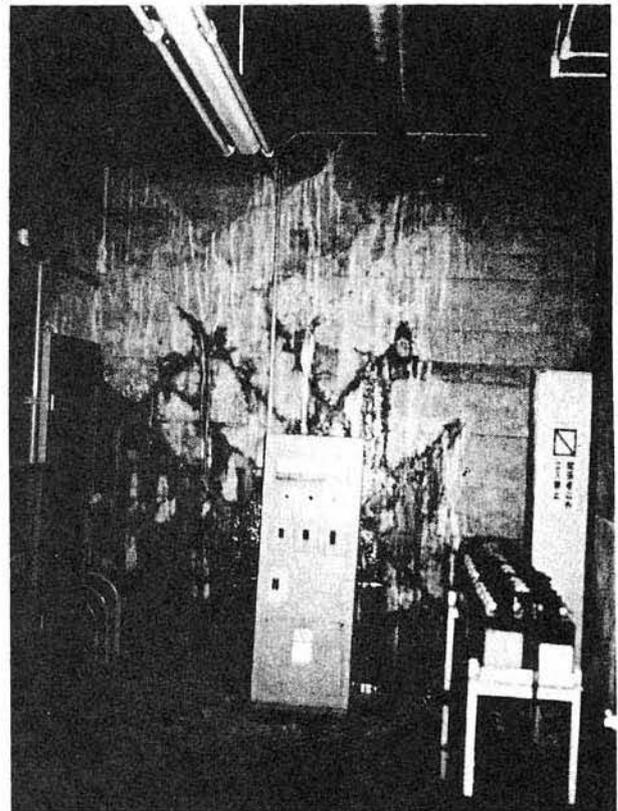
There are several walls in the transverse direction: both ends, utility rooms, etc. The damage pattern of these walls is shown in Fig. 12(g)-(j) and Photos. 9 to 11. Di-

Photo. 11. Damage to transverse wall at the electric facility room

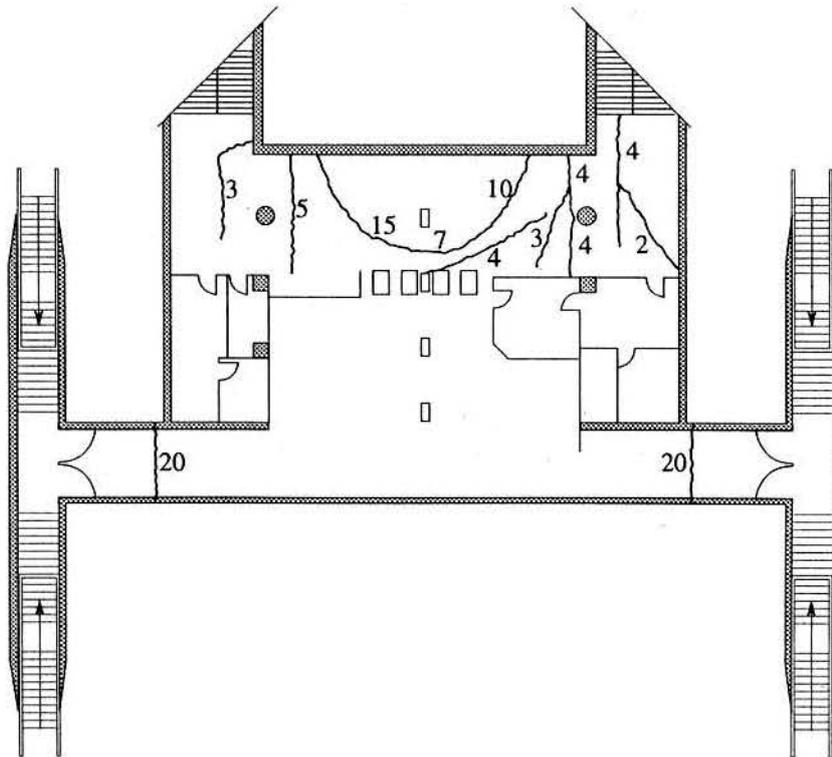
Fig. 13. Crack patterns in the B1 floor: Numbers in the figure are crack width in mm

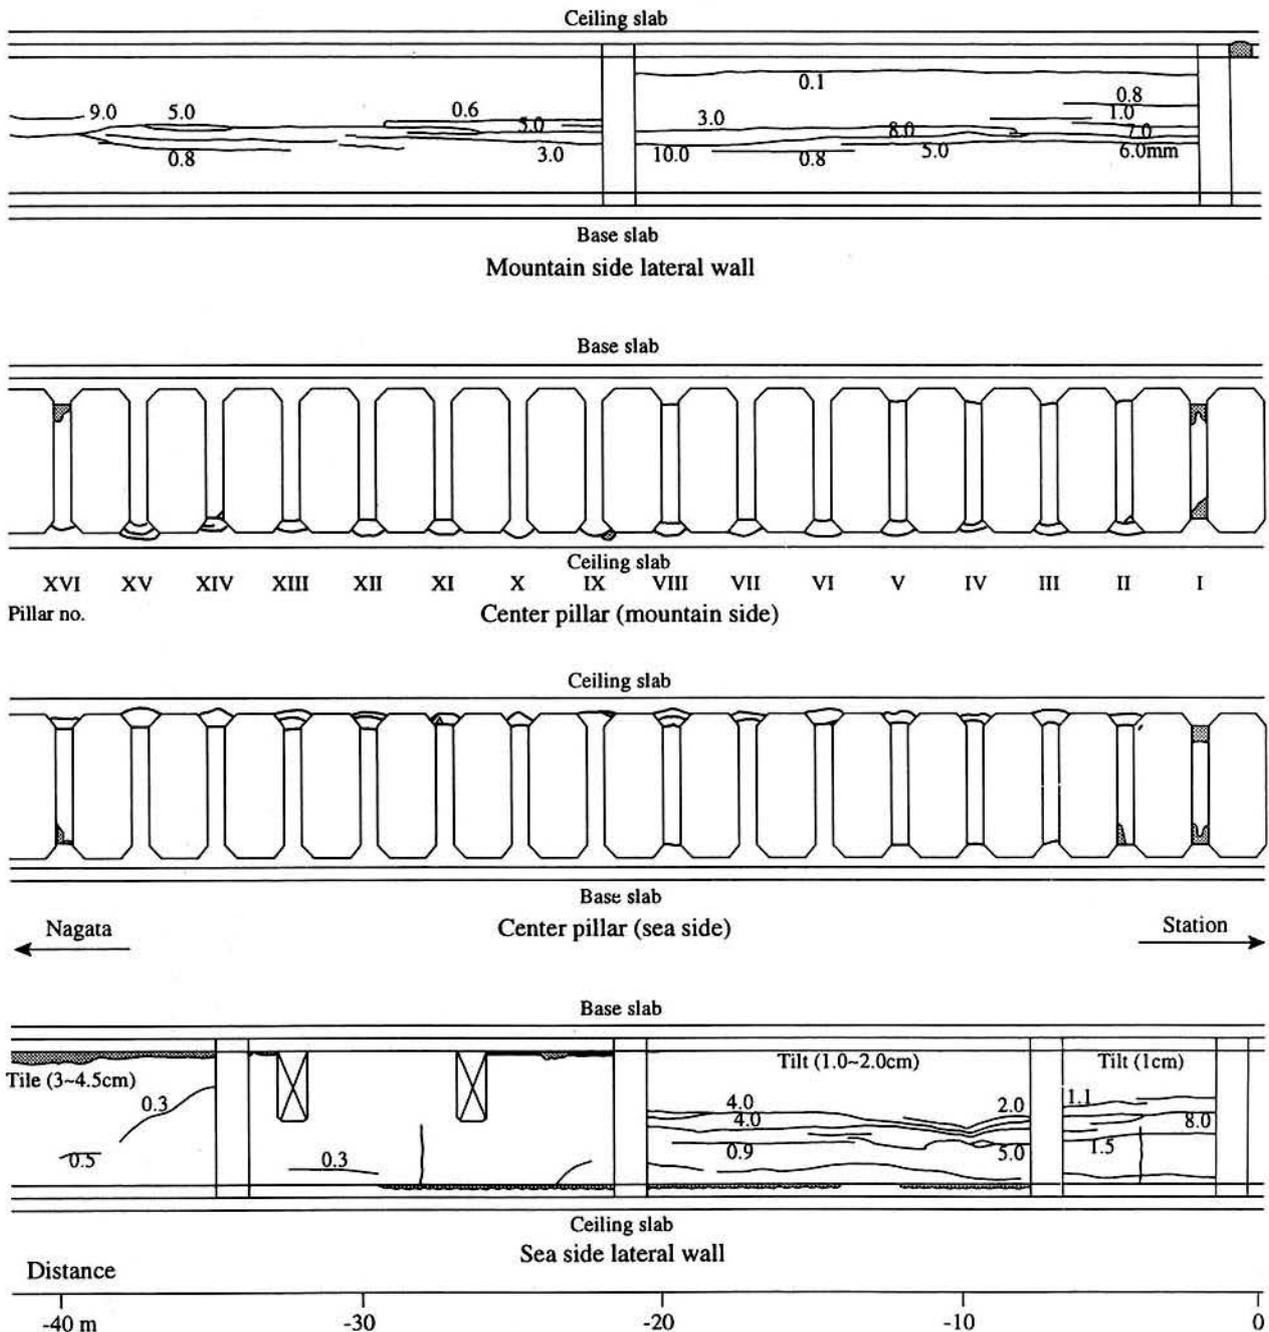
Investigation was also conducted beyond the limits of the station. The damage pattern just beyond the station on the Nagata side is shown in Fig. 14 and Photos. 12 and 13, and on the Shinkaichi side in Fig. 15. Here station 0 in Fig. 14 corresponds to the end of the Nagata

Fig. 14. Schematic figure showing the damage away from the station in Nagata side. Small numbers denote crack width in mm

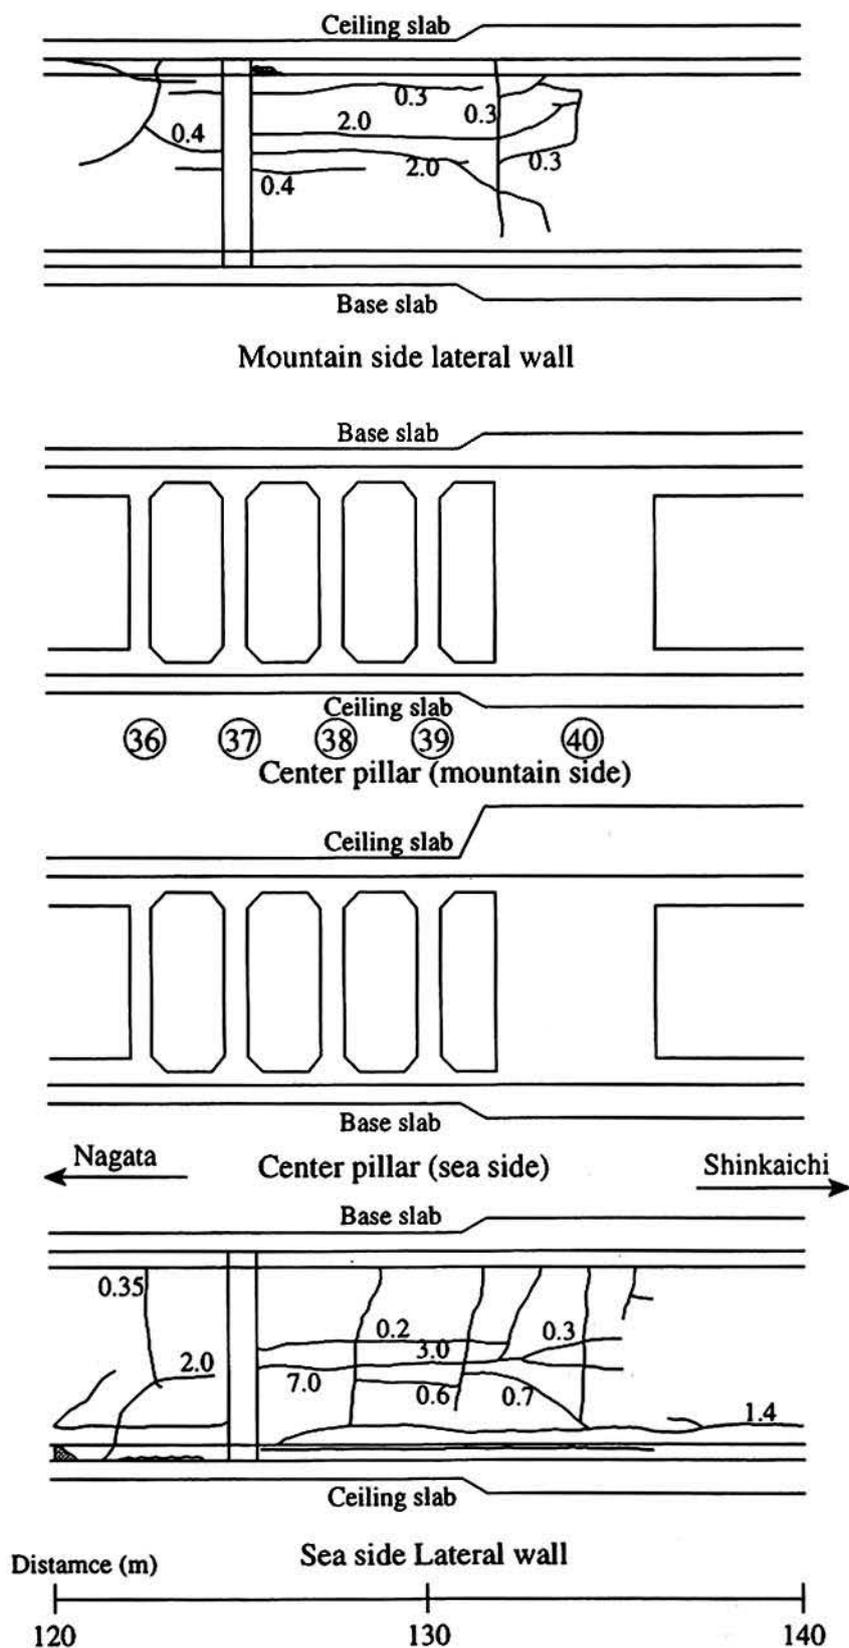
Fig. 15. Schematic figure indicating the damage away from the station on Shinkaichi side. Small numbers denote crack width in mm

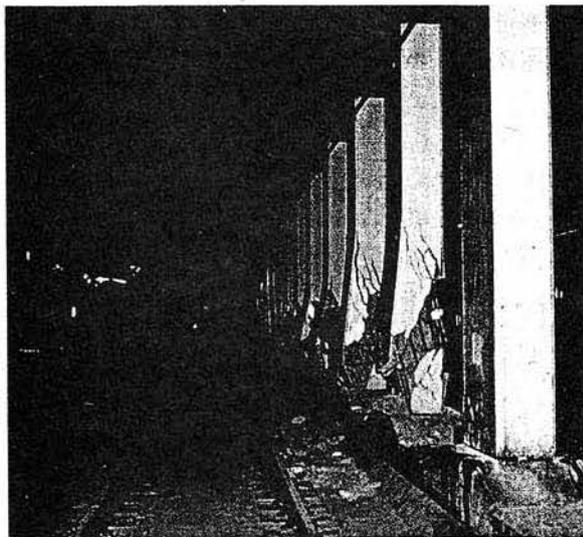
写真-4 中柱の損傷

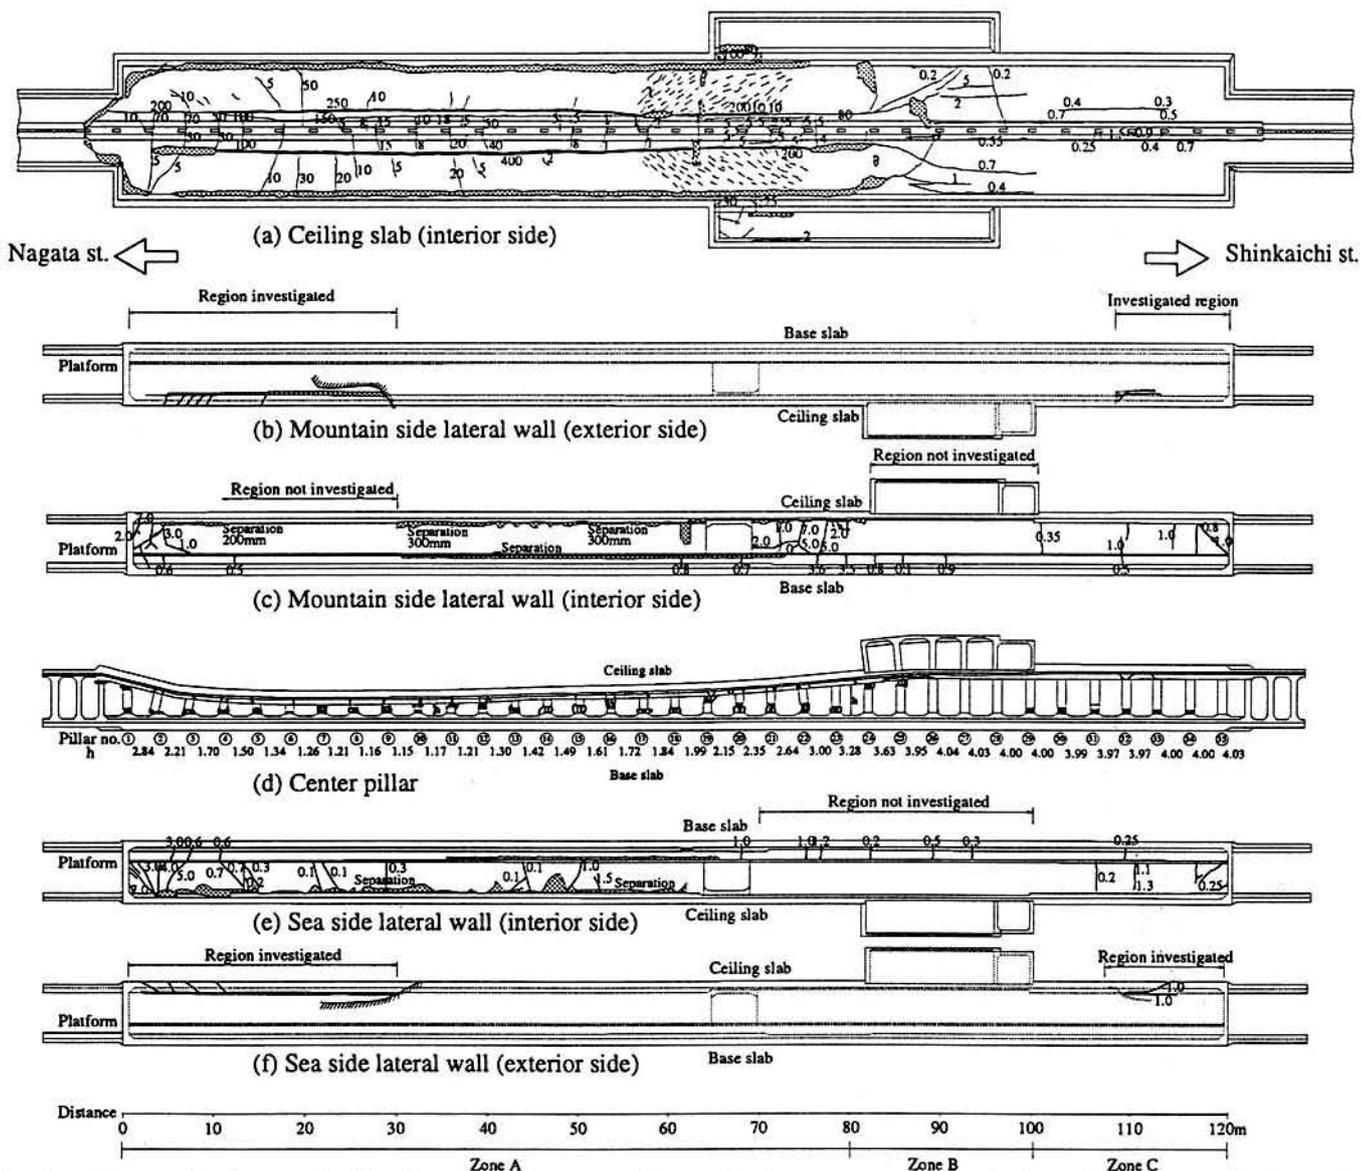
Fig. 8 Schematic figure indicating the damage. Here, h denotes measured clear height, circled number denotes column number. Numeral denotes crack width in mm.

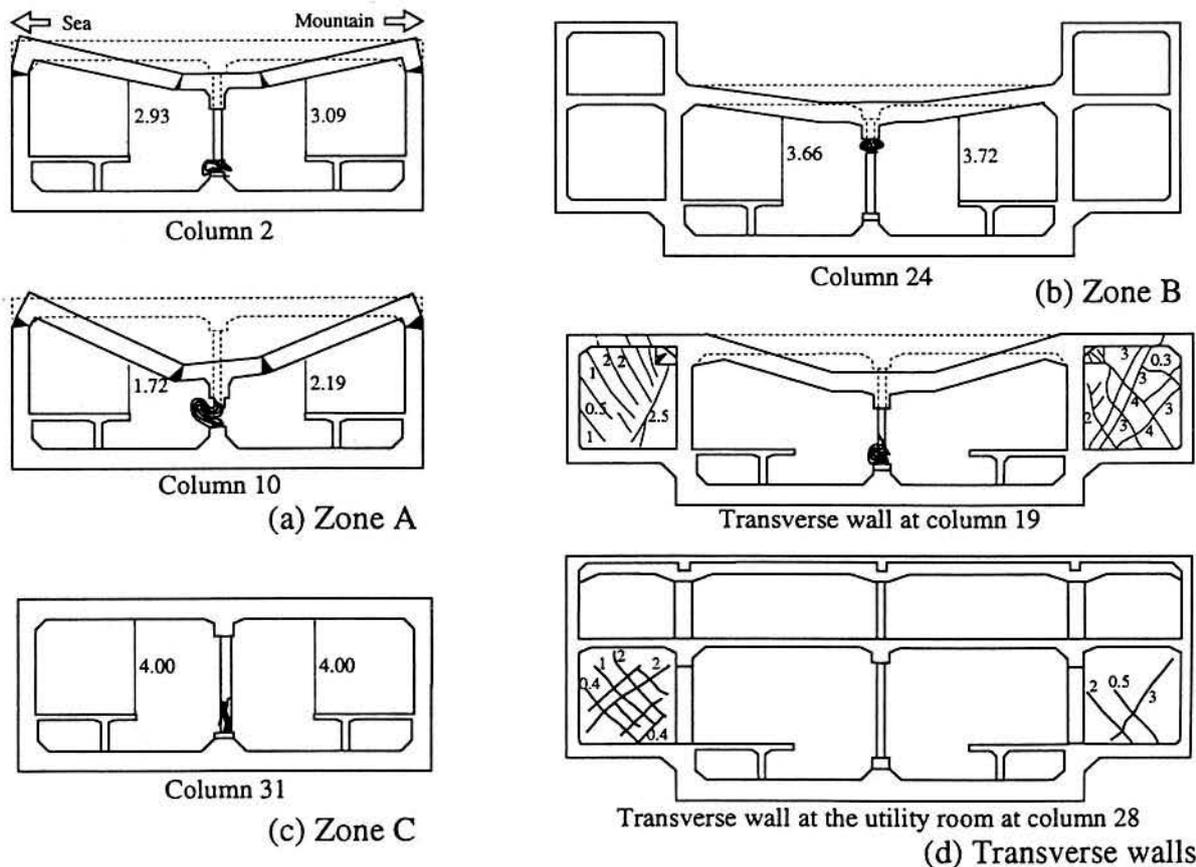
Fig. 9 Schematic figure showing the damage pattern in the transverse direction

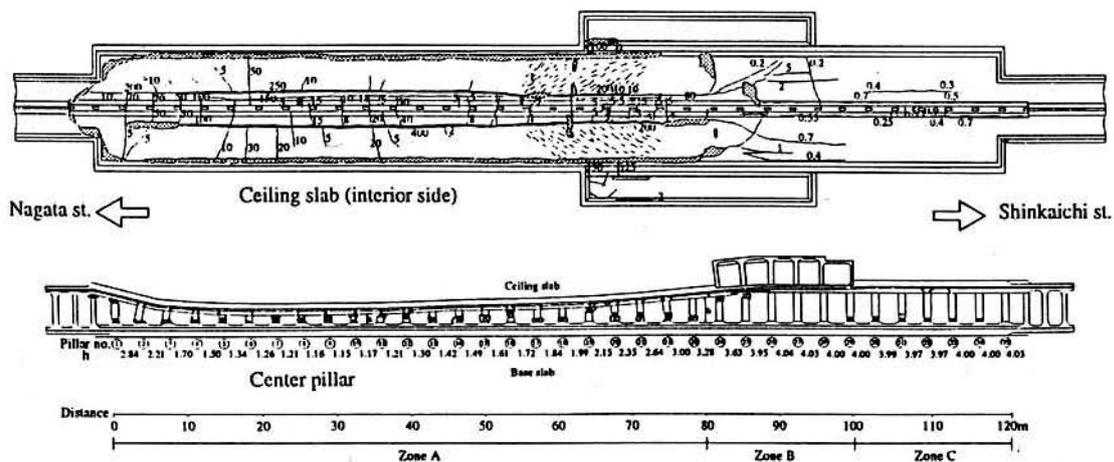
Based on the observation of the damage to these columns and walls, the mechanism of the damage of the collapsed column in zone A is evaluated to be as follows: 1) Due to strong horizontal force, the member reaches its strength under the combination of bending moment and shear force acting near the end of the column, which resulted in collapse of the end of the column. 2) The load carrying capacity of the box frame was reduced, and therefore excess relative horizontal displacement occurred.

Figure 6 Schematic figure indicating the damage. Here, h denotes measured clear height, circle number denotes column number.

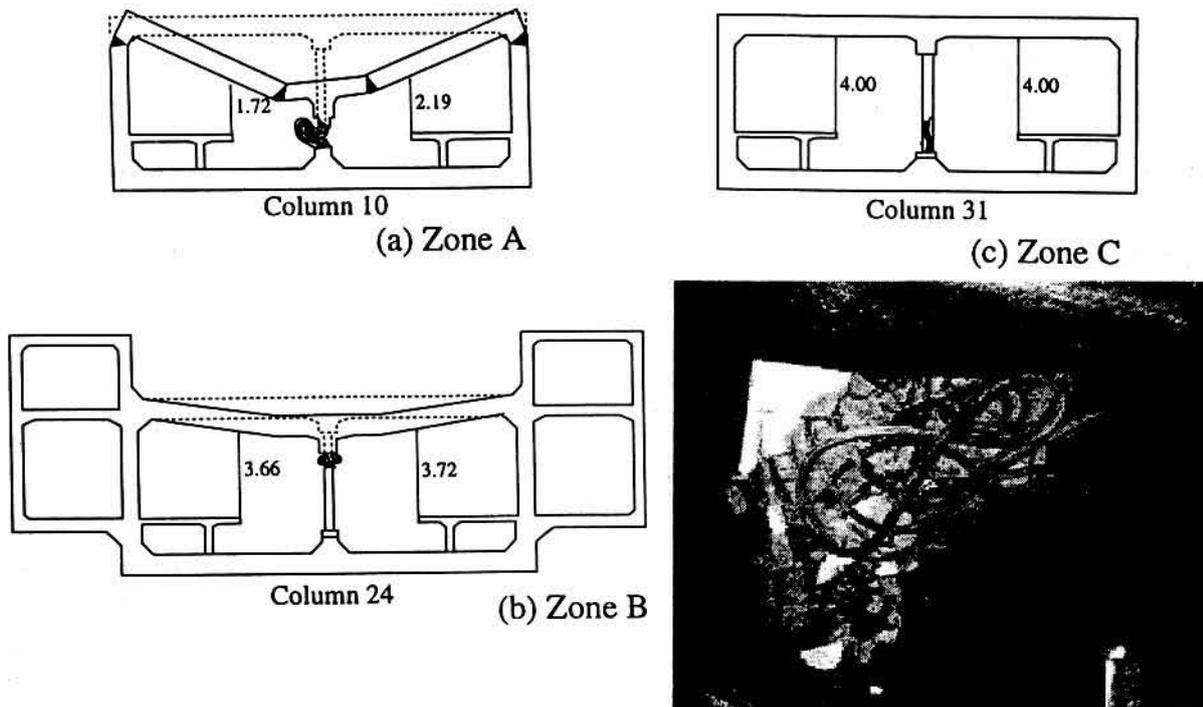
Figure 7 Schematic figure showing the damage **Photo 1** Collapse of No.10 column in zone A pattern in the transverse direction

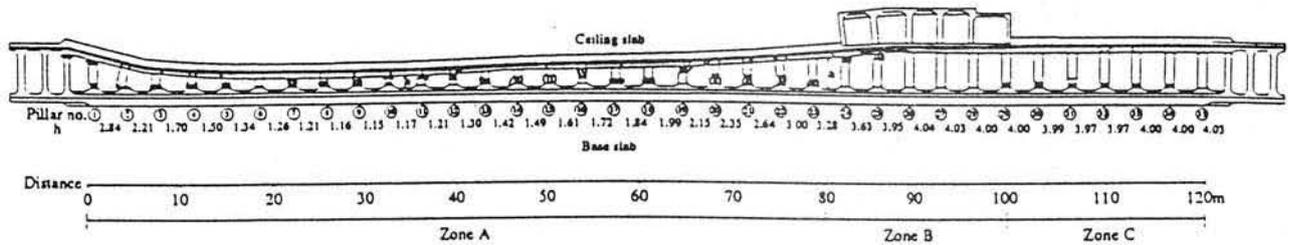
Figure 5 shows schematic diagrams of the damage

Figure.5 Schematic figure indicating the damage of the center pillar. Here, h denotes measured clear height, circle number denotes column number.

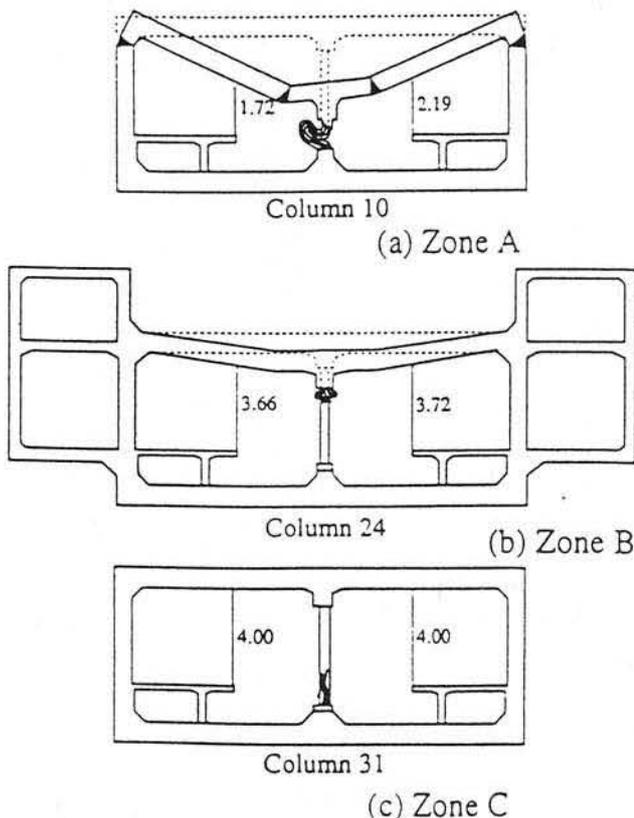
In zone B, as shown in Figure.6(b), the collapse of the column occurred in the upper portion and reinforcing steel buckled into a symmetrical shape for columns 24 and 25. The upper longitudinal beam connecting the center columns was bent at a point between columns 25 and 26. The small separation of the corner concrete of the center columns is observed at the mountain side of upper portion and at sea side of lower portion, in columns 26, 27 and 28. Although the structural system in zone C was the same as that for zone A, damage was less in zone C compared with that in zone A. In the lateral wall, separation of cover concrete was observed near both the top and bottom haunches. According to the investigation of the exterior surface, wide cracks in the longitudinal direction were observed along the intersection with the haunch. Under the platform, a significant separation of cover concrete was observed on the both side lateral walls.

Figure.6 Schematic figure showing the damage pattern in the transverse direction

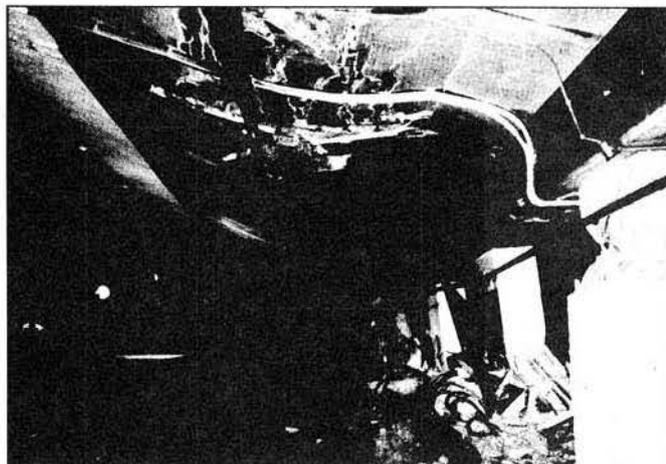
Photo 2 - Collapse of the station in Zone A

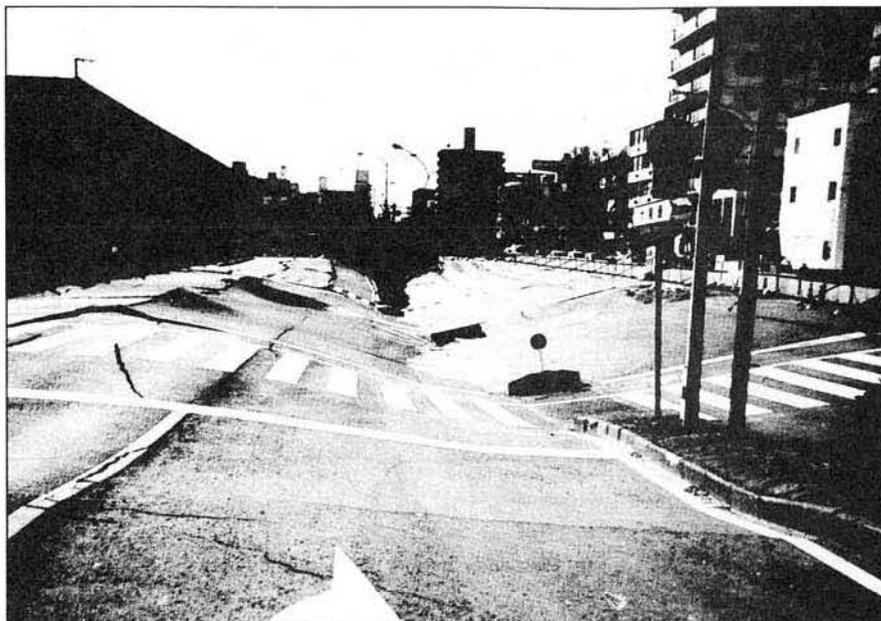
Photo 1 - Settlement of National Road N° 28 that runs above the Daikai Station

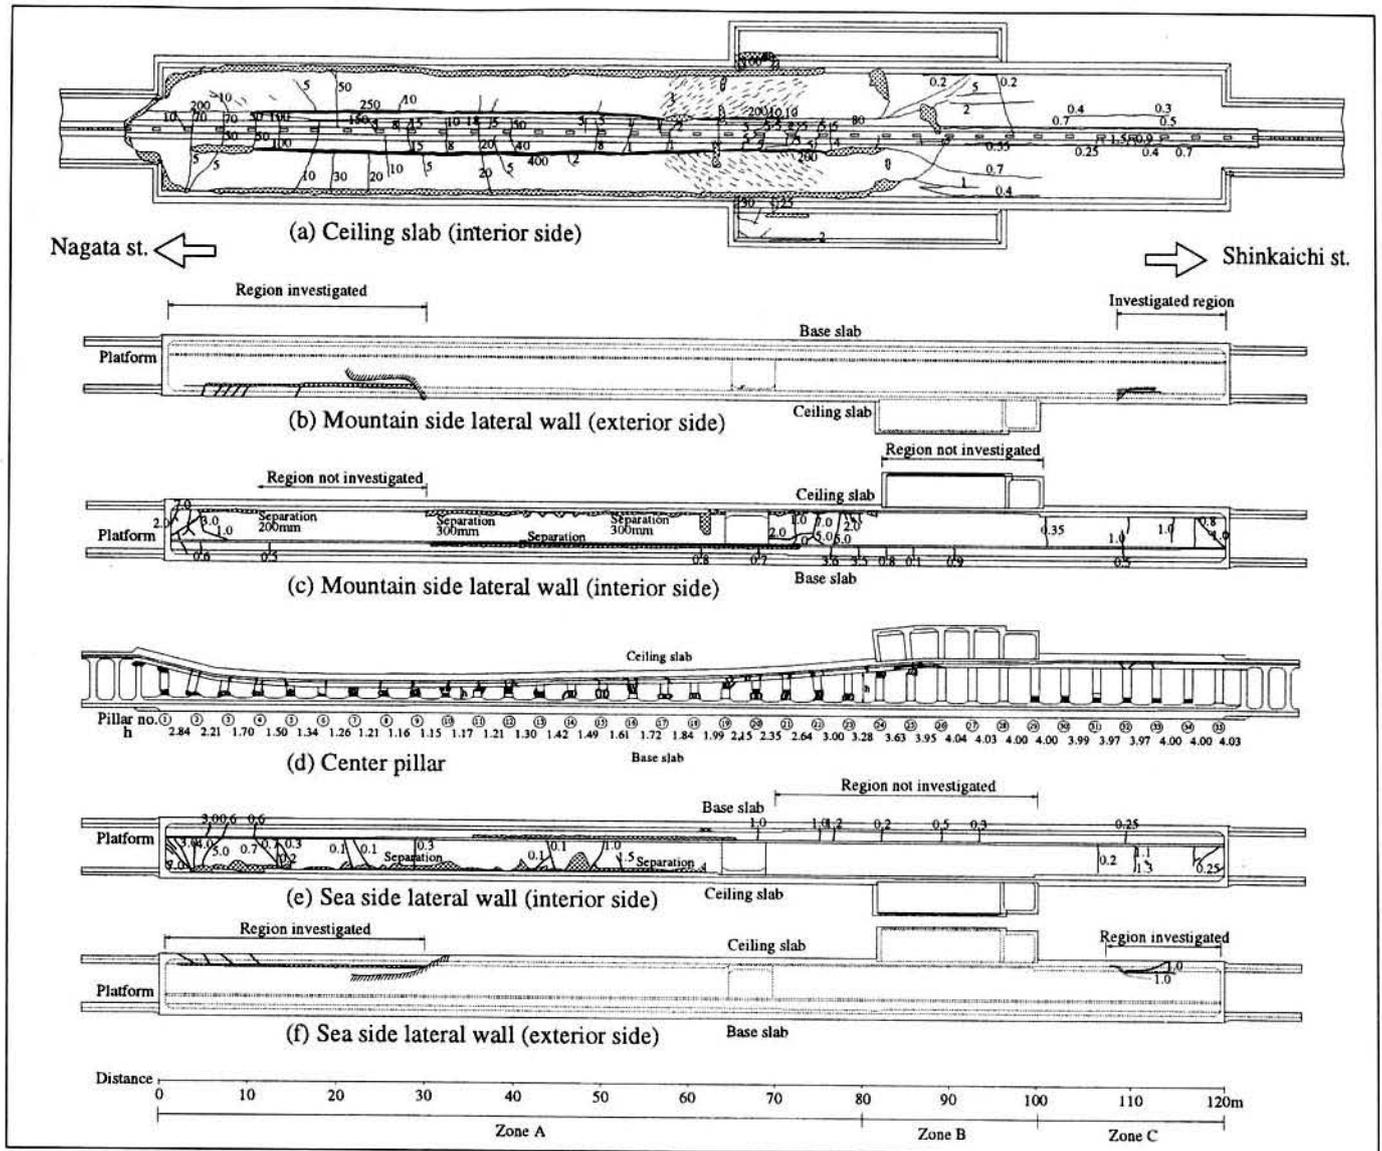
Figure 8 - Schematic figure indicating the damage. Here, h denotes measured clear height in m, circled number denotes column number. Numeral denotes crack width in mm.

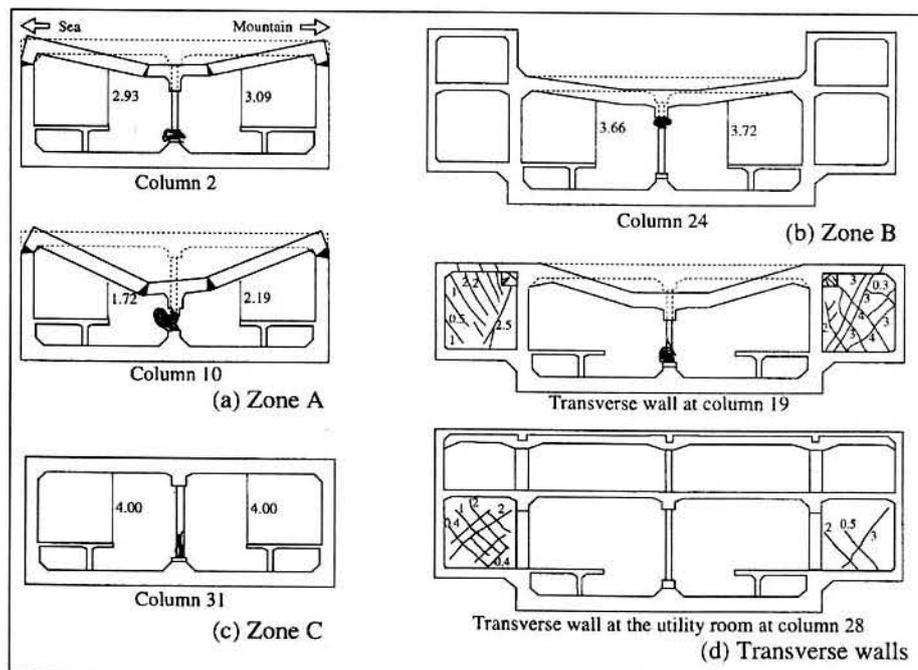
Figure 9 - Schematic figure showing the damage pattern in the transverse direction. Larger numeral is clear height between top slab and platform in m measured after the earthquake, and small numeral is crack width in mm

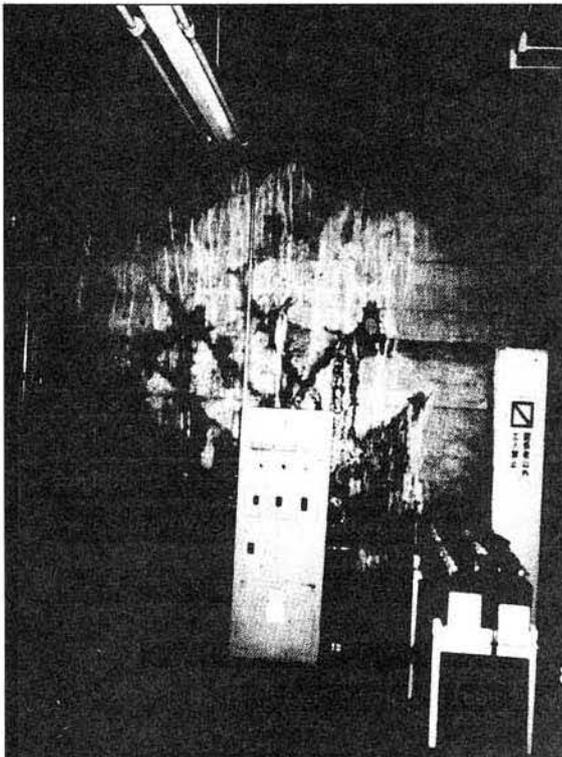
Photo 4 - Cracks in the transverse wall in electric facility room
