# **Damages and disasters caused by the Great Hanshin Earthquake, Japan 1995**

Takashi Okimura 1)

**Abstract:** On 17 January 1995, a big earthquake, registering magnitude 7.2 on the Richter scale hit the western part of Japan, claiming 6,394 lives, injuring at least 40,071 people, and destroying properties and infrastructures, causing an estimated damage of between 95 to 140 billion U. S. dollars. This paper gives a detailed description of the disaster and attempts to provide a scientific explanation to the disaster.

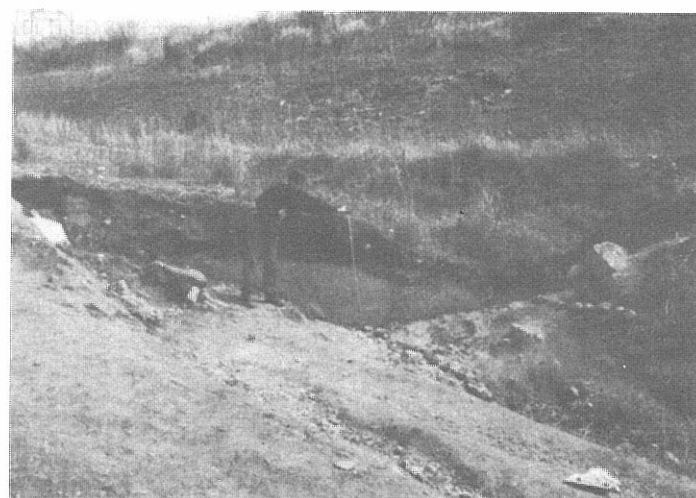
lateral movement, from south-west to north-east. The compression in the east to west direction caused shear to occur in the south-west to north-east direction. The maximum horizontal and vertical displacements observed on the ground, as shown in Photo. 1, are about 1.8 and 1.3m, respectively.

Photo 1 Movement of Nojima fault (source of quake)

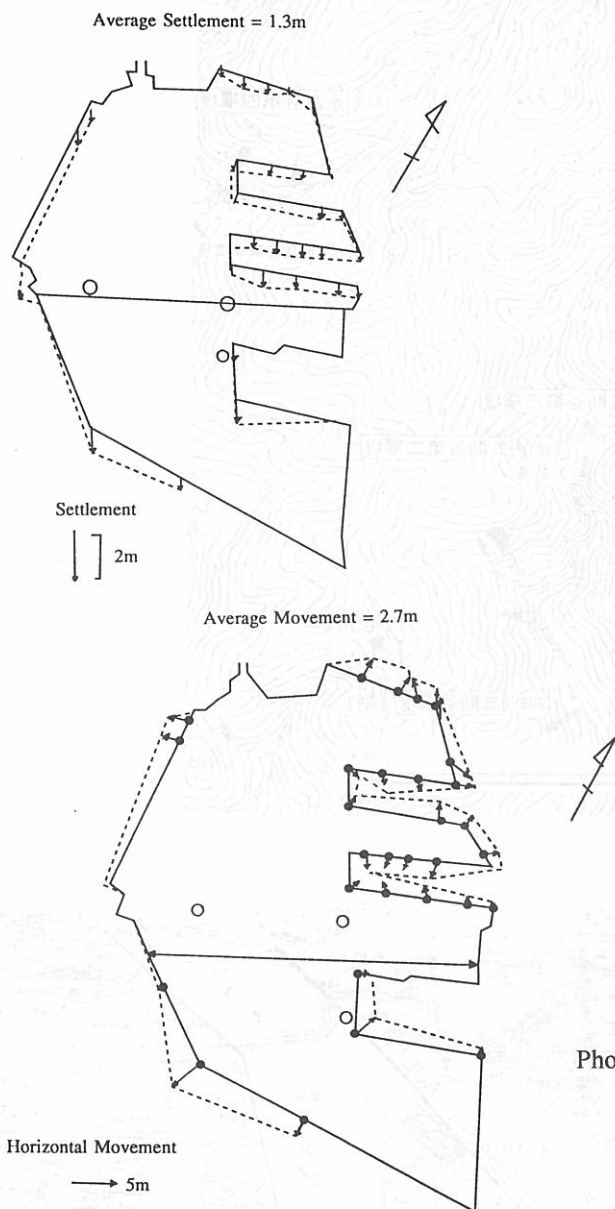
The quake destroyed the structures constructed along the shore-line of these islands with extensive liquefaction and large lateral movements of breakwater structures. These damages are typical of other damages suffered on reclaimed land. Typical examples are shown in Photos 2 and 3. Due to the liquefaction, ground settlements occurred and they were estimated to be between 5-60 cm in depth in Port island. Tilting and large horizontal movement of the concrete caisson accompanied by settlement and horizontal movement of the granular fill behind the caisson were typical failure modes. The movements of the shore-line were surveyed by using satellites and the measurements at Port Island are shown in Figure 11. The figure shows that the shore-line moved 2-3 m horizontally and settled on the average by about 1 m.

Figure 11 Settlement and horizontal movement of Port Island's shore line

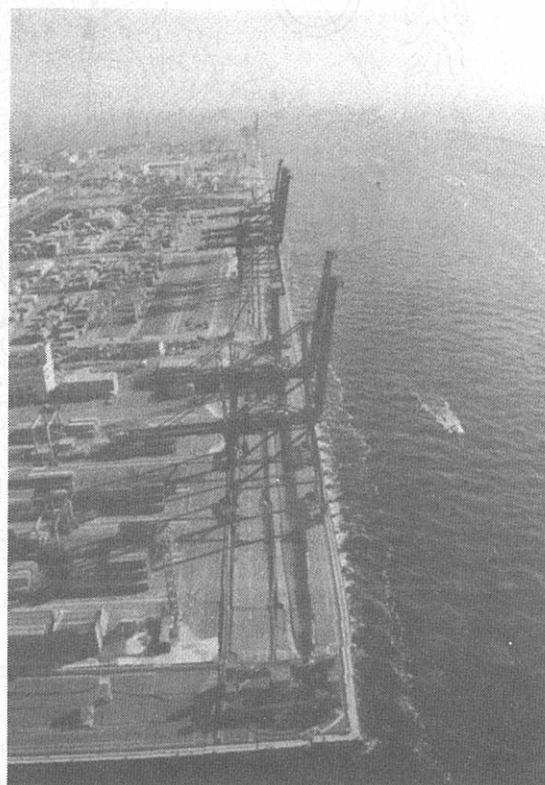
The possible cause of the sea-wall failure seems to be the combination of ground liquefaction behind the caisson, the lateral movement of the caisson due to the seismic force and liquefaction of the sandy fill behind the caisson. Due to the large movements of the shore-line, huge cargo cranes in container yards and port facilities sustained severe damages, and more importantly, many foundations of bridges and facilities connecting the man-made islands to the mainland were also damaged. For example, a section of the elevated track for the new automated train line connecting Rokko Island to the mainland fell more than 20 m because its pier foundation tilted and moved horizontally.

Photo 2 Damages to the seawall along south end of Rokko Island

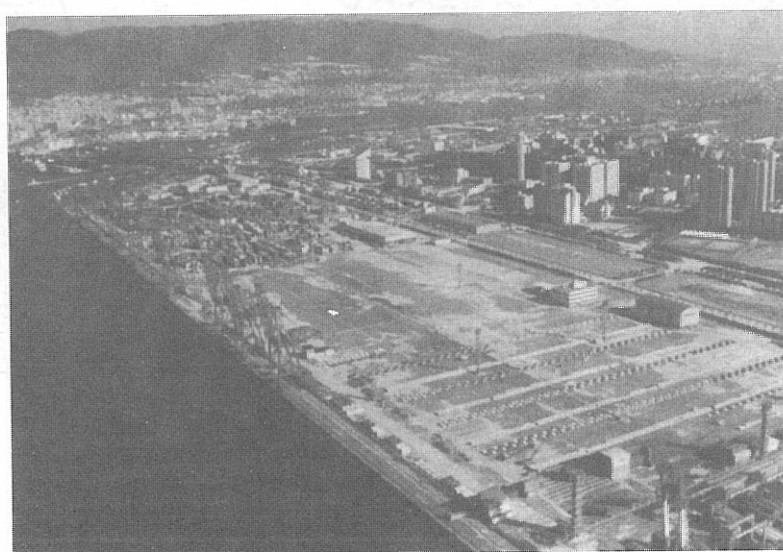
Photo 3 Liquefaction of container yard at the western part of Port Island

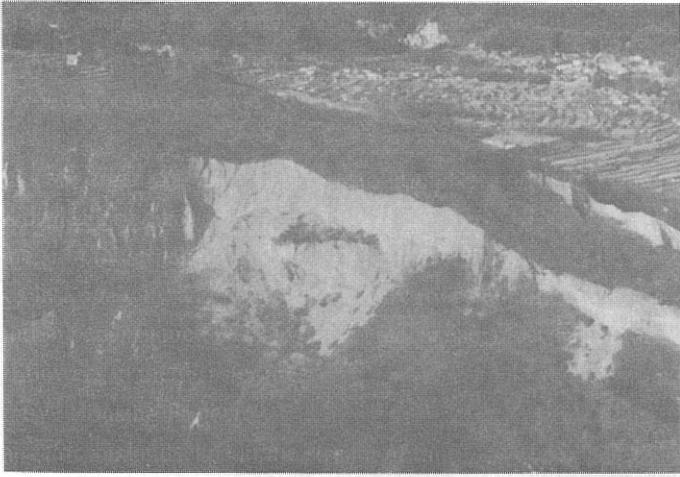
In order to get the distribution of mountain slope failures in Rokko mountains, failure distribution figure was made by using aerial photographs. The scales of the aerial photographs are 1 to 8000 and 1 to 4000 which were taken 3 days after the quake. Topography maps of scale 1 to 10000 were used as base maps. Figure 12 shows a part of the failure distribution which was reduced to a scale of 1 to 10000. The area of this map is Gosuke and Momiji valley, situated at the upper region of the Sumiyoshi river in Kobe. From this figure, it can be seen that (1) as a whole, there were many cases of small area failures, (2) the failures were mainly on very steep slopes, (3) flowed and eroded areas were very small, (4) the failures appeared on planar and/or crest slopes, (5) failures often appeared at knick points downwards from gentle to steep gradients, (6) some failures appeared at outcrop, (7) unstable rock mass failed and rolled along the slopes, as shown by example in Photo 4, and (8) big cracks developed along the mountain slopes which have not failed yet.

Photo 4 Mountain slope failure

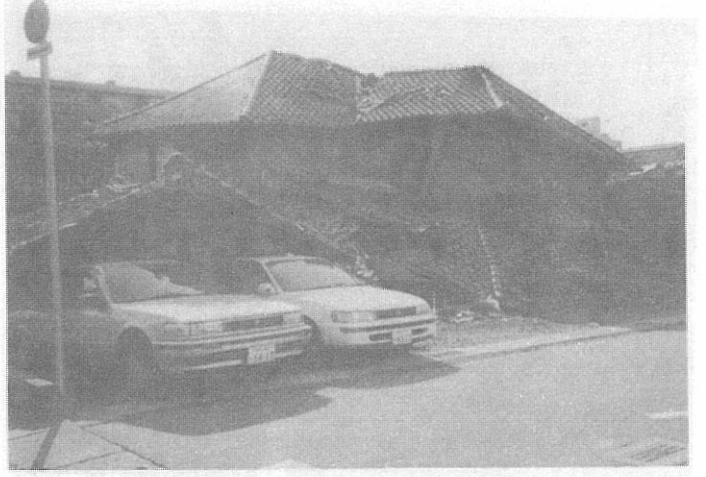
The failure modes of timber structures were: (1) tilting, (2) collapse of the first floor and (3) total collapse. The main reasons for these are: (1) aging of the materials, (2) there were no structural elements such as bracing to resist the lateral force, (3) poor connections between vertical and horizontal elements, (4) nonrigid floor and roof, (5) relatively heavy materials on the roof, and (6) impact forces from neighboring collapsed buildings. Examples of collapsed timber structures are shown in Photos 5 and 6.

Photo 5 Collapse of timber houses with heavy roof tiles

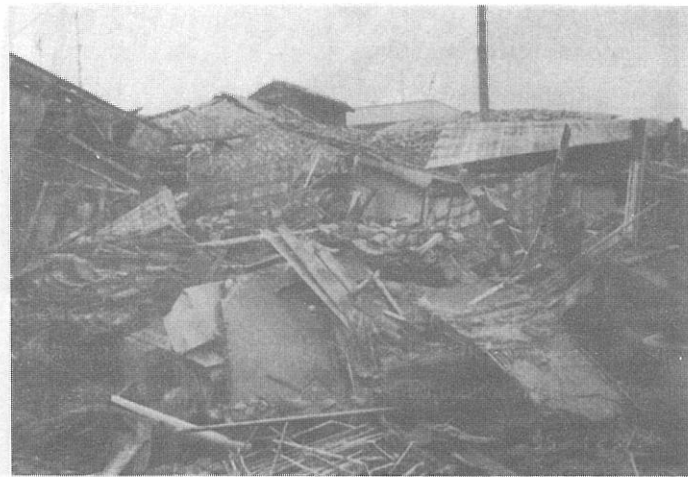
Photo 6 Total collapse of a timber house in Kobe

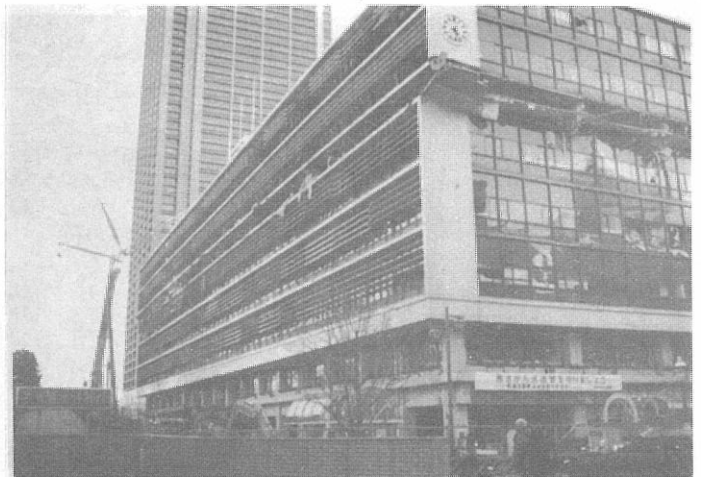
A large number of private residential reinforced concrete buildings overturned or collapsed at the first floor while the taller public housing, business and commercial buildings failed at one of their intermediate floors. The possible causes for these are: (1) interaction between the different modes of vibration causing maximum stresses and strains in one of the intermediate floors, (2) effect of construction methods on the shear resistance of the columns, (3) lack of shear and/or internal walls or having many wide openings in walls especially in external walls, and (4) combined effects of the vertical and horizontal vibrations on the shear resistance of the floors.

Some of the other factors that contribute to the damages are: (1) aging of materials, (2) poor quality of concrete, (3) lack of bond between concrete and reinforcing bars because of the use of smooth surface bars, and (4) the distance between stirrups and their arrangement were not appropriate. Examples of collapsed reinforced concrete buildings are shown in Photos 7,8 and 9.

Photo 7 Collapse of the 6th floor of one of Kobe city hall buildings

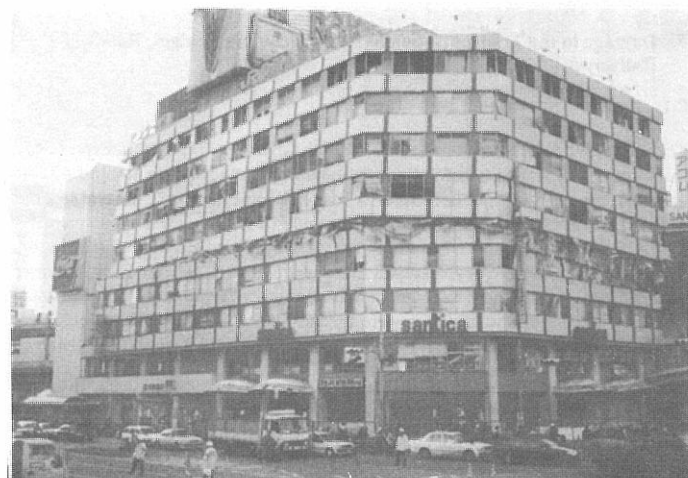
Photo 8 Collapse of the 5th floor of Sannomiya traffic center building

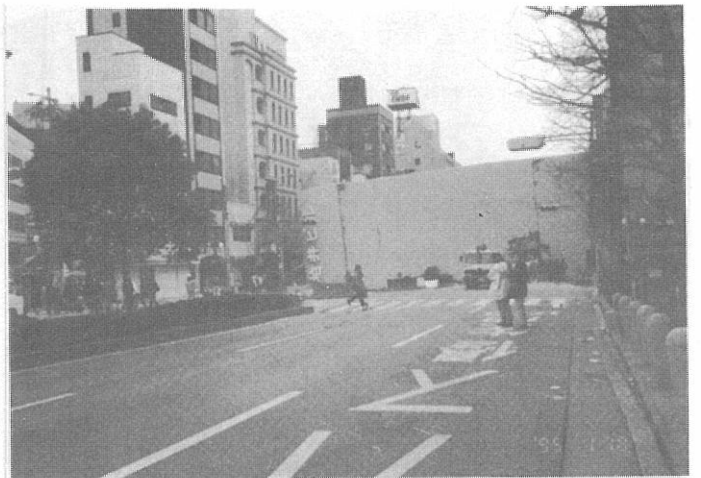
Photo 9 Collapse of a tall RC building onto the road below in Kobe

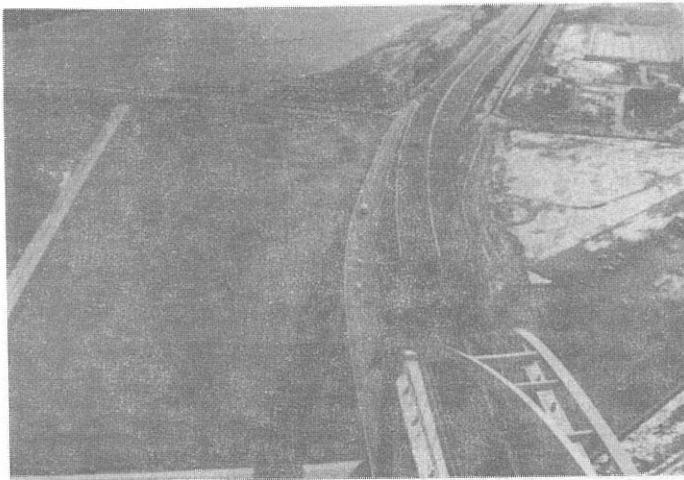
One section of the Hanshin expressway, Wangan route fell, while 30 piers cracked and damages were spotted at 440 locations along the route. All the damaged piers can be repaired. The collapsed section fell because of ground liquefaction which caused the foundation to settle as well as move laterally. Thus, the connection bolts ruptured and the bridge fell. This 52 m long by 27 m wide bridge was designed to withstand a horizontal earthquake acceleration of 0.2 g.

Photo 10 Collapse of a part of Hanshin expressway, Wangan route due to liquefaction and lateral movement

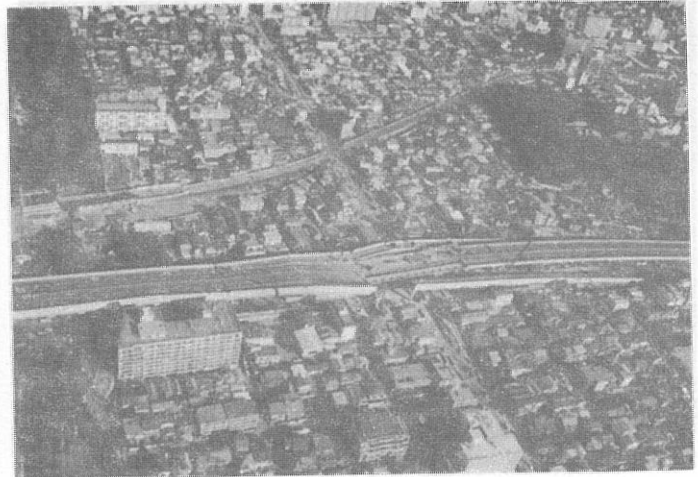
The columns in the 635 m section of the Hanshin expressway, Kobe route which collapsed had only half the number of links required under the current anti-quake standards. Each of these columns are cylindrical in shape with a diameter of 3 m, having 180 vertical steel reinforcement of 35 mm diameter. Hoops of 16 mm diameter were put transversely at 20-30 cm intervals. Studies have shown that hoops can help the column to withstand severe transverse force and are effective in preventing the collapse of columns under severe earthquake. Under the new standards, hoops should be installed at 10-15 cm interval, especially in the lower part of the columns.

Photo 11 Collapse of a part of Hanshin expressway, Kobe route due to column failure

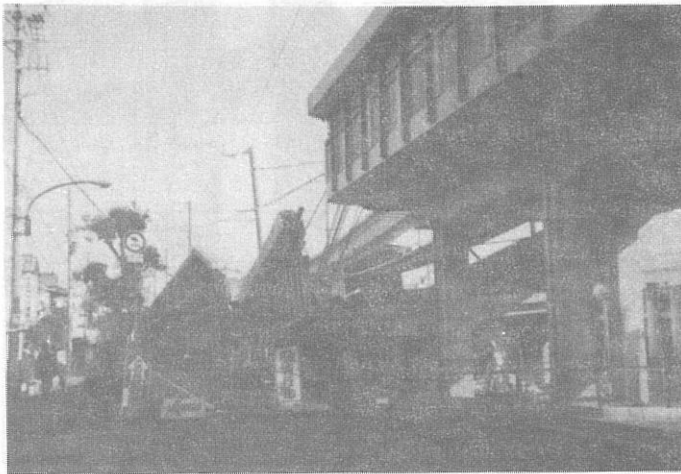
Photo 12 Shinkansen line at Itami

The elevated Sanyo Shinkansen tracks were constructed to withstand lateral movements greater than those recorded in this quake, but it was not constructed to withstand such high vertical movements. Nine elevated sections collapsed. The collapsed sections looked as though they had been smashed by some downward pressure. Seismic records in that particular area indicated that vertical movements were greater than lateral movements. Two tunnels along this Shinkansen line were severely damaged. The Rokko tunnel between Shin-Osaka and Shin-Kobe stations which is about 16.5 km long had cracks in about 8 km of its length. Among the 1,800 viaduct supports of the east end of Rokko tunnel, 400 had been damaged, out of which 100 had collapsed. Tunnels constructed by the open-cut method were badly affected by the quake.

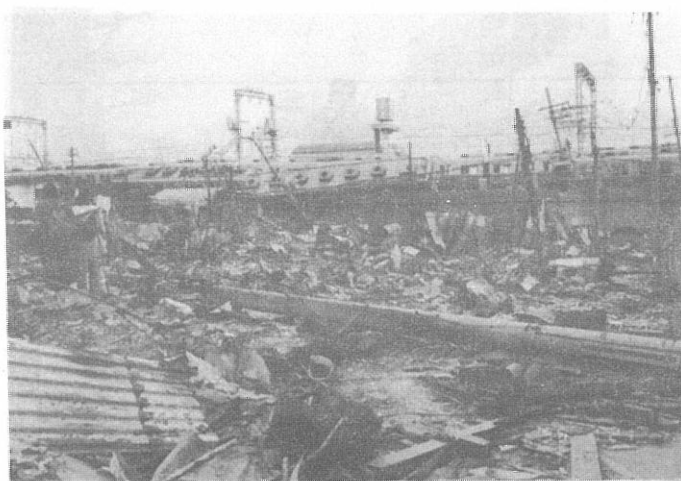
Photo 14 Hanshin line at East Kobe

A number of elevated sections of the JR, Hanshin and Hankyu lines collapsed. Some of their stations were completely destroyed. 15 trains were derailed. One of the badly damaged Kobe city subway station's tunnel and 30 out of its 35 reinforced concrete columns collapsed. As explained in Section 4, the Port liner and Rokko liner both suffered severe damages with tilted, settled or collapsed columns, failed connections and/or joints, displacements of girders, etc. Examples of the damages sustained by the railway network are shown in Photos 12-15. The distribution of the damages is shown in Figure 19.
