Investigation of microtremors observed at historic masonry townhouse buildings after Nepal earthquake

The Gorkha earthquake in 2015 was a recent large-scale earthquake that caused severe damage to many historic masonry buildings in the Kathmandu Valley, Nepal. The authors conducted a visual inspection survey of seismically damaged buildings after the earthquake in the historic town district of Bhaktapur in the Kathmandu Valley. The first part of this paper reports the distribution of the historic masonry buildings for each damage level in the surveyed area. A concentrating zone of severely-damaged buildings was explicitly found in the damage-level distribution map. Almost half of all the surveyed buildings were severely damaged during the earthquake, and most of these were historic masonry townhouse buildings. In the second part, the ambient vibration characteristics of the conventional historic masonry buildings in Bhaktapur are investigated. Typical dwelling houses in a historic town district in Nepal, which generally formed terraced houses built around a courtyard, were targeted for the measurement. Thus, the influence of adjacent buildings, which makes it difficult to identify

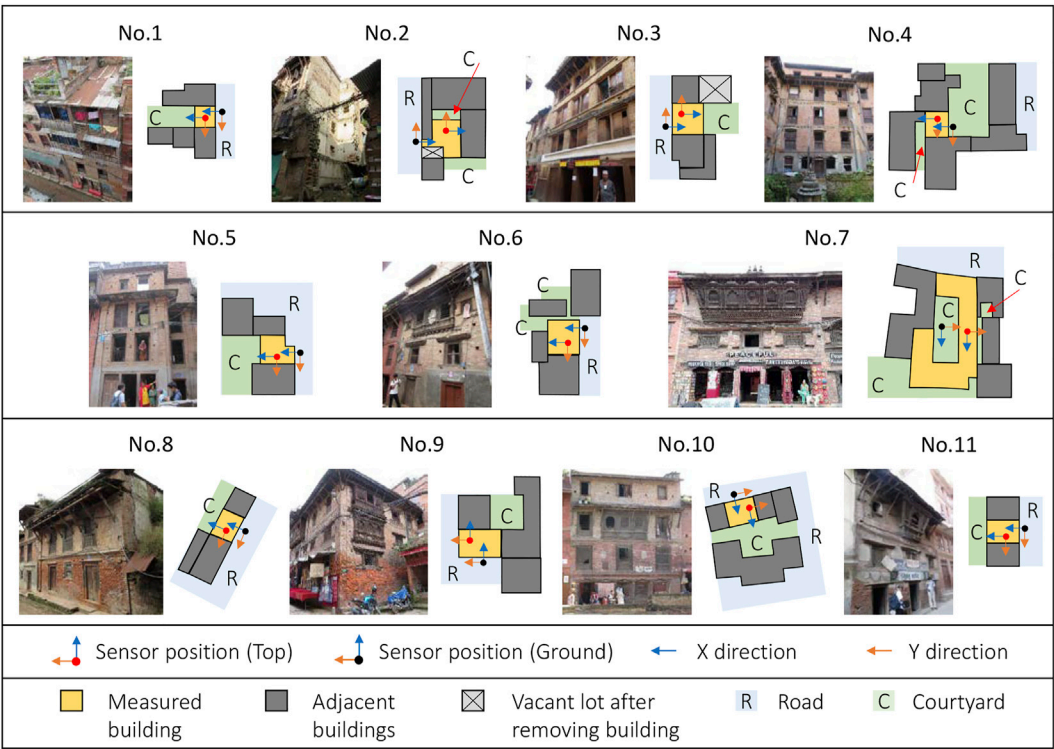
FIGURE 3
Building arrangement and exterior view of the measured buildings.

Table 3 shows the building information: floor numbers, damage condition after the earthquake, roof type, wall specification, eaves height, typical floor area, and total building weight. The “wall specification” refers to the state of the masonry brick and joint mortar at the exterior wall of the lowest story; the assigned classification notations are “BM” for brick masonry with mud mortar, poorly built; and “BMW” for brick masonry with mud mortar, well built. These abbreviations have been used in the study by Japan International Cooperation Agency (JICA) on earthquake disaster mitigation in the Kathmandu Valley (JICA, 2002).

The “Damage condition” of the building after the Gorkha earthquake was clarified using the damage categories listed in Table 1. The buildings classified in Category C were reclassified to “Moderate” or “Slight” according to the damage or cracks observed on walls. The roof floors of Buildings 3 and 10, which collapsed during the Gorkha earthquake, were repaired after the Gorkha earthquake.

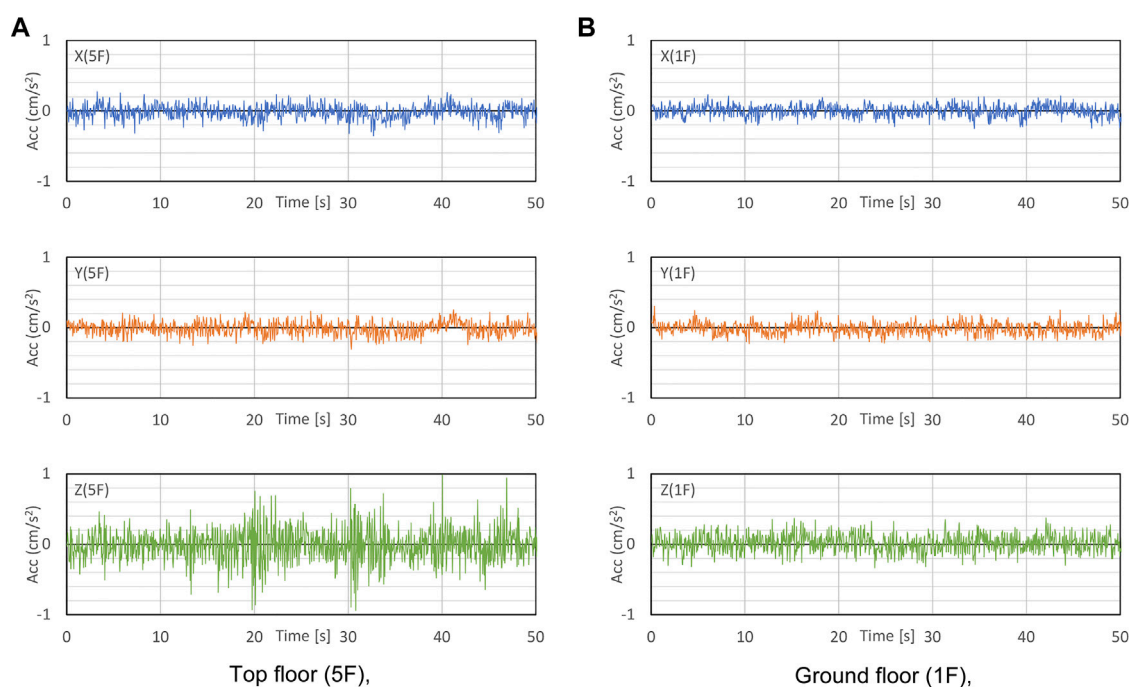
FIGURE 4

A part of the measured microtremors in Building 4. (A) Top floor (5F), (B) Ground floor (1F).

Figure 4 depicts the three component waveform of the measured microtremors in Building 4. Measurements of the 11 buildings were conducted in the daytime. Vibrations accompanying the daily life of residents were considered in the measured vibrations. As seen at the bottom in Figure 4A, the influence of the activity of residents has mostly been observed in the Z (vertical) direction of the floor. Figure 5 depicts the TF and MATF of X (depth) and Y (frontage) directions for the 11 measured buildings. The candidate points of the first natural frequencies were detected by searching the local peak on the MATF curves in the range from 2.5 to 7.5 Hz. The inversed triangular marks "▼" indicate the possible points correlating to the first natural frequency of the measured building. In the followings, these values are expressed by $f_1^m(a)$, ($a = X$ or Y). Blue marks are used for the X-direction, and red marks are used for the Y-direction in Figure 5. Multiple marks are placed for the cases where multiple peaks were observed. The detected value/values as the first natural frequency $f_1^m(a)$ of all the measured buildings are listed in Table 4. As seen in Figure 5, there are various patterns of the configuration of the local peaks on the MATF curves. The local peaks on the MATF curves could be distinctly observed at most buildings measured in this

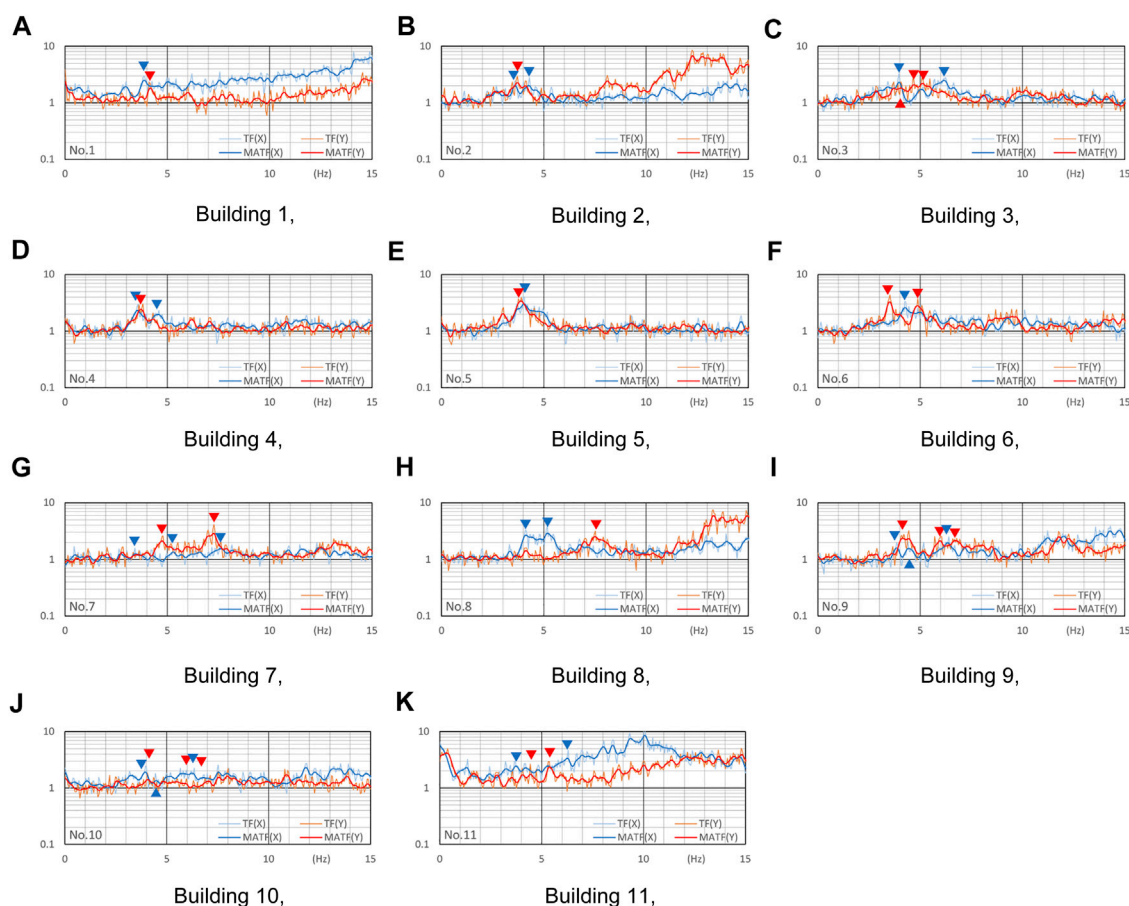
FIGURE 5

TF and MATF of the top vs. ground floor levels. (A) Building 1, (B) Building 2, (C) Building 3, (D) Building 4, (E) Building 5, (F) Building 6, (G) Building 7, (H) Building 8, (I) Building 9, (J) Building 10, (K) Building 11.
