# Damage characteristics of conduits in irrigation earth dams

Paddy and Water Environment, 19(1):239-247

In this study, we report the damage characteristics of conduits in irrigation earth dams based on the surveys conducted on four dams with different conduit types (cast-in-place and precast types) and diameters (600–1000 mm). The damage condition (cracks, leakage, and joint separation) and the deformation of conduits were observed using a self-propelled measuring system with an inertial measurement unit (gyroscope and accelerometer) and a CCD camera. Results reveal that cracks were scarce in conduits, and most conduit deformations were accommodated by the joint separation. In particular, in the precast conduits, because the number of joints per unit length was more, the deformation tended to be allocated to several joints. Moreover, settlements of conduits were not simply convex in accordance with the overburden pressures but were significantly affected by intake structures and structural cutoff walls. Although, in the future, it is necessary to develop conduits with joints having both high sealing performance and flexibility, the results obtained from this study will provide i

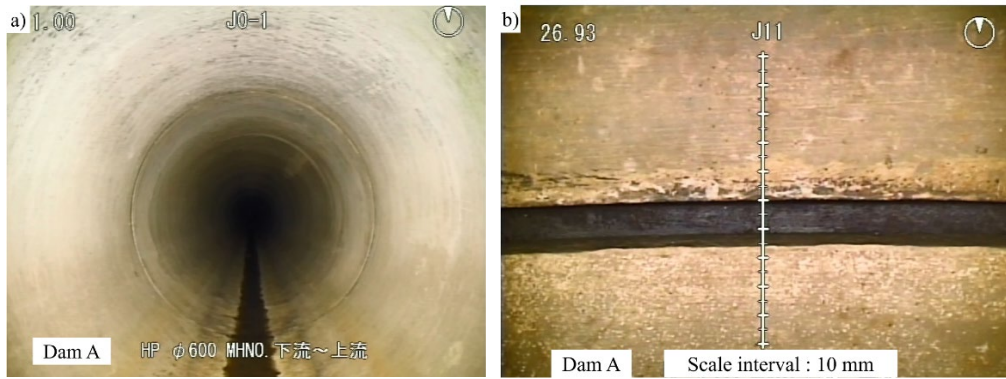
Joint separations were observed in five out of eleven joints as illustrated in Fig.5. The joint separation in the upstream end of the conduit was over 15 mm (large gap) as shown in Fig.3(b), and the relative vertical displacement was -38 mm at the same location. These were likely caused by the settlement of the intake structure. In addition, a crack and leakage were present at the connection with the intake structure.

**Fig. 3** Photographs taken by the camera of the self-propelled measuring system

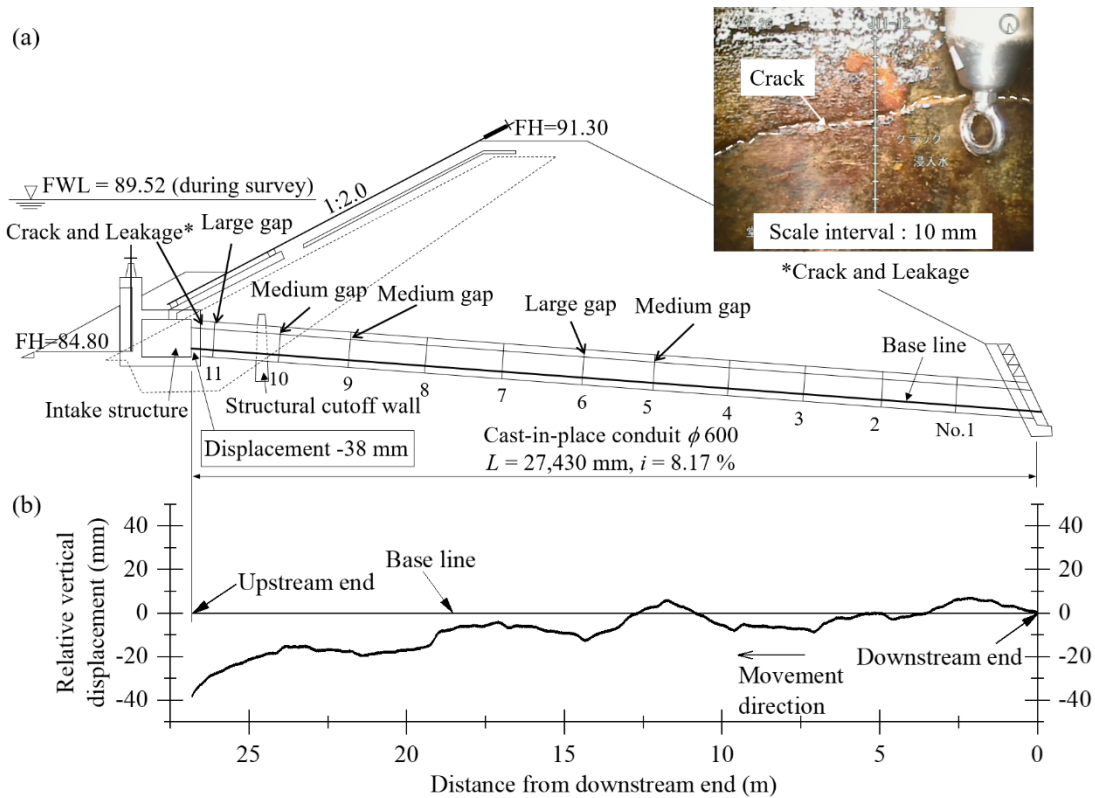
The cast-in-place conduits in Dams A and B displayed in Figs.5 and 6 exhibit joint separations representing medium and large gaps. Contrarily, in Figs.7 and 8, for the precast conduits in Dams C and D, the joint separations are characteristic of no or small gaps. In particular, in Dam D, because the length of one block is 1 m and the number of joints per unit length is more, no joint separation greater than 5 mm exist. Although the maximum values of relative vertical displacement in Dams C and D are smaller than that in Dam A, the vertical displacements against their total length in Dams C and D are greater than that in Dam A. Therefore, the deformation in the precast conduits is likely accommodated by the several joints. However, in Dams C and D, leakage is present, with sealing still an issue in precast conduits.

**Fig. 5** Survey results in Dam A: (a) the damage conditions (the emergence of cracks, leakage, and joint separations) and (b) the relative vertical displacement

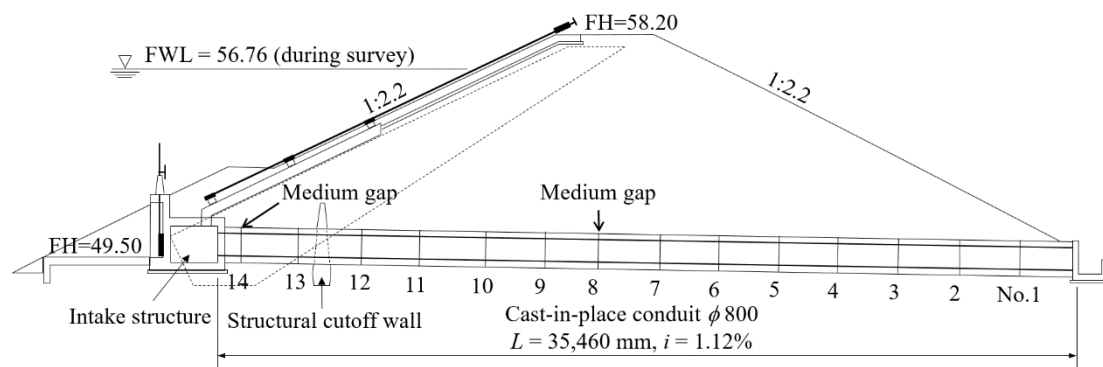
Two medium joint separations of approximately 10 mm (medium gaps) occurred at the center and the upstream side of the conduit, without any crack or leakage as exhibited in Fig.6.

**Fig. 6** Survey results in Dam B (the emergence of joint separations)

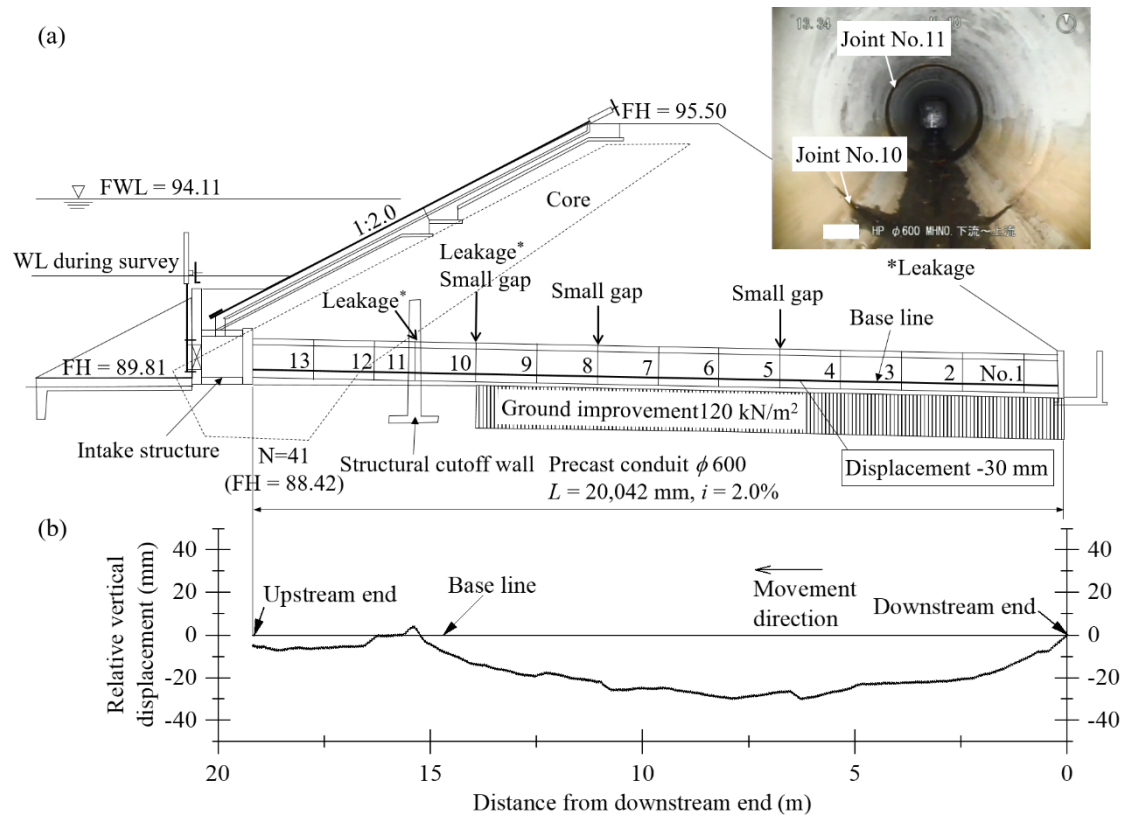
The survey results for Dam C in Fig.7 reveal joint separations of approximately 5 mm (small gaps) at three locations, while leakage emerged at two spots in the downstream side of the core. Moreover, although the base foundation improved, the relative vertical displacement was -30 mm.

**Fig. 7** Survey results in Dam C: (a) the damage conditions (the emergence of leakage and joint separations) and (b) the relative vertical displacement

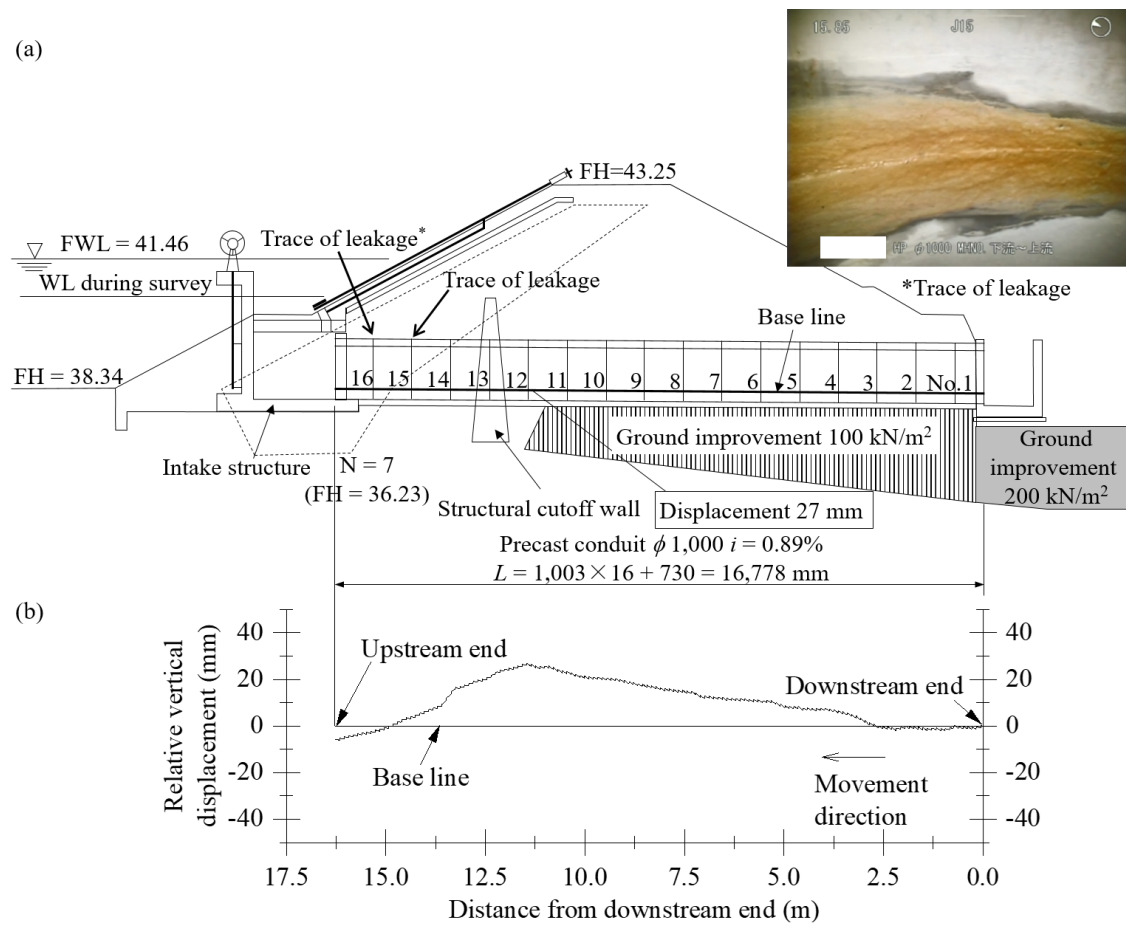
Although there was no crack, and no joint separation that exceeded 5 mm (small gap), two traces of leakage occurred, with the relative vertical displacement of 27 mm (Fig.8).

**Fig. 8** Survey results in Dam D: (a) the damage conditions (the emergence of leakage) and (b) the relative vertical displacement

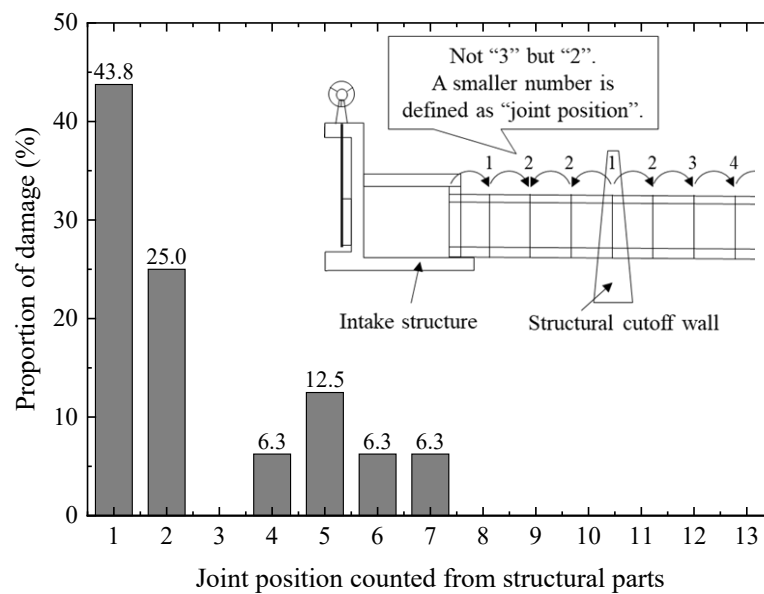
The number of damages and the occurrence positions are presented in Table 2, while the proportions are displayed in Fig.9. From Fig.9, approximately 70 % of the damage concentrates at the first or second joint from structural parts. Therefore, intake structures and structural cutoff walls significantly affect damage and deformation of conduits. In Dam A, judging from the distribution of the relative vertical displacements (Fig.5), the settlement of the intake structure likely occurred. In Dams C and D, the structural cutoff walls probably served as fulcrums (Figs.7 and 8). In particular, in Dam D, the N value of 7 is significantly lower compared with that in Dam C (N value = 41), and the settlement of the intake structure likely caused the positive vertical displacement near the structural cutoff wall. Note that the standard penetration test in both dams were performed directly below the upstream end of the conduits before retrofitting dams, and the above N values were obtained in the vicinity of the core bottom.

**Fig. 9** The proportion of damage at joint positions counted from structural parts
