# Observed structural bridge damage report for the 2023 Turkey-Syria earthquake

**Abstract:** On February 6, 2023, a series of seismic events, comprising two consequential earthquakes characterized by robust ground shaking, unfolded in the geographical expanse spanning southern Turkey and Western Syria. The repercussions of these seismic disturbances reverberated across a vast terrain, resulting in widespread devastation to both built structures and critical infrastructural networks. In the wake of these seismic events, the authors embarked on an investigative expedition to the affected region, more than three months after the occurrence of the seismic events. Through a meticulous examination and systematic elucidation of the facets above, this report aims to contribute valuable empirical knowledge to the scholarly discourse surrounding seismic vulnerability and resilience of critical infrastructure networks, particularly focusing on bridges, in regions affected by the events on February 6, 2023.

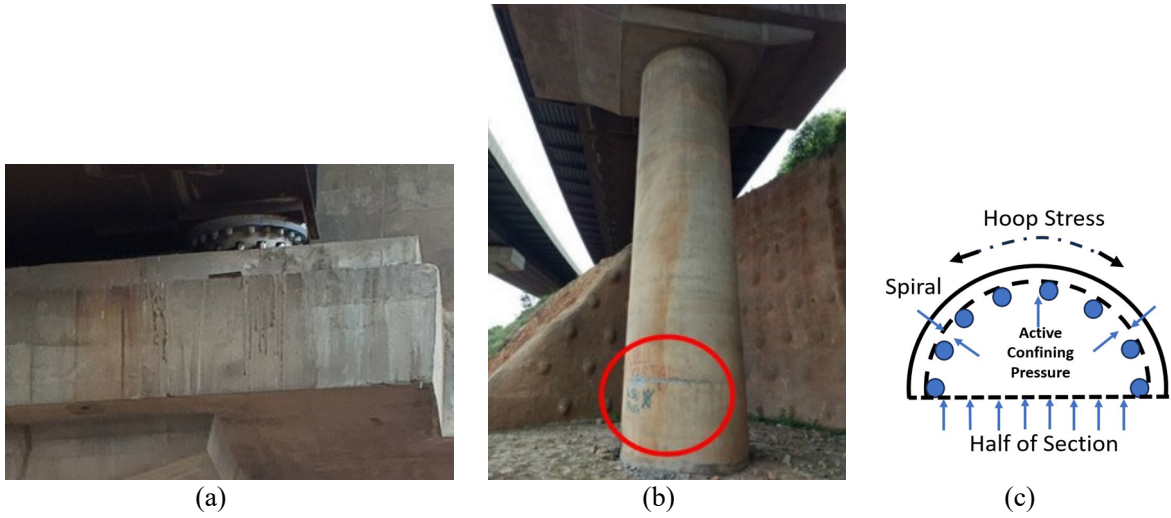
Figure 6 Viaduct damage of Case A: (a) Base isolation system of the bridge, (b) Plastic hinge formation, (c) Confining effect of the spiral lateral reinforcement

At two adjacent bridge structures within the broader framework of the examined bridge, the formation of a plastic hinge in two columns is observed shown in Figures 6, 7 and 8, with one located at the bottom as anticipated, and the other positioned elsewhere within the column, contrary to expectations. Specifically, the plastic hinge in the latter column materialized approximately 25% up the column height, manifesting in the transverse bridge direction. This deviation from conventional expectations warrants thorough investigation and analysis. A plausible explanation for the occurrence of the plastic hinge at a location deviating from the column/footing interface, as typically expected, may be attributed to the presence of vertical bar cutoffs at this juncture. These cutoffs could have resulted in a reduction of the moment capacity, thereby exacerbating the moment demand-to-capacity ratio at this elevated position compared to the column base. Notably, the manifestation of spalling of unconfined cover concrete on both sides of this plastic hinge underscores the nonlinear cyclic behavior prevalent in the transverse direction of the bent. The observed compressive concrete strains of at least 0.005 (and potentially surpassing 0.01) in both loading directions corroborate the nonlinear nature of the structural response<sup>10</sup>. An alternate scenario pertains to the phenomenon of vertical rebar buckling, indicative of nonlinear cyclic behavior characterized by steel yielding and significant strain accumulation in tension before direction reversal. This dynamic results in compressive stresses and forces in the rebar preceding any significant compression from the combined section moment and axial force within the concrete. It is noteworthy that such occurrences typically do not transpire under monotonic loading conditions, where concrete consistently experiences compression on one side of the neutral axis. The manifestation of vertical rebar buckling within a column plastic hinge signifies a precarious structural condition, suggesting imminent failure with only a few additional cycles needed to precipitate complete collapse. While the presence of bar cutoffs stands as the most plausible explanation for the nonconforming plastic hinge location, it is conceivable that other factors may have contributed to the heightened moment demand at this juncture. Notably, the combined effects of transverse mass and rotational mass inertia from the extensive bridge structure may have elevated the moment demand, particularly significant for single-column-bent bridges. The freedom of rotation at the top of the column in the transverse direction, inherent in the displacement of the bridge transversely, underscores the intricacies associated with structural response under dynamic loading conditions.

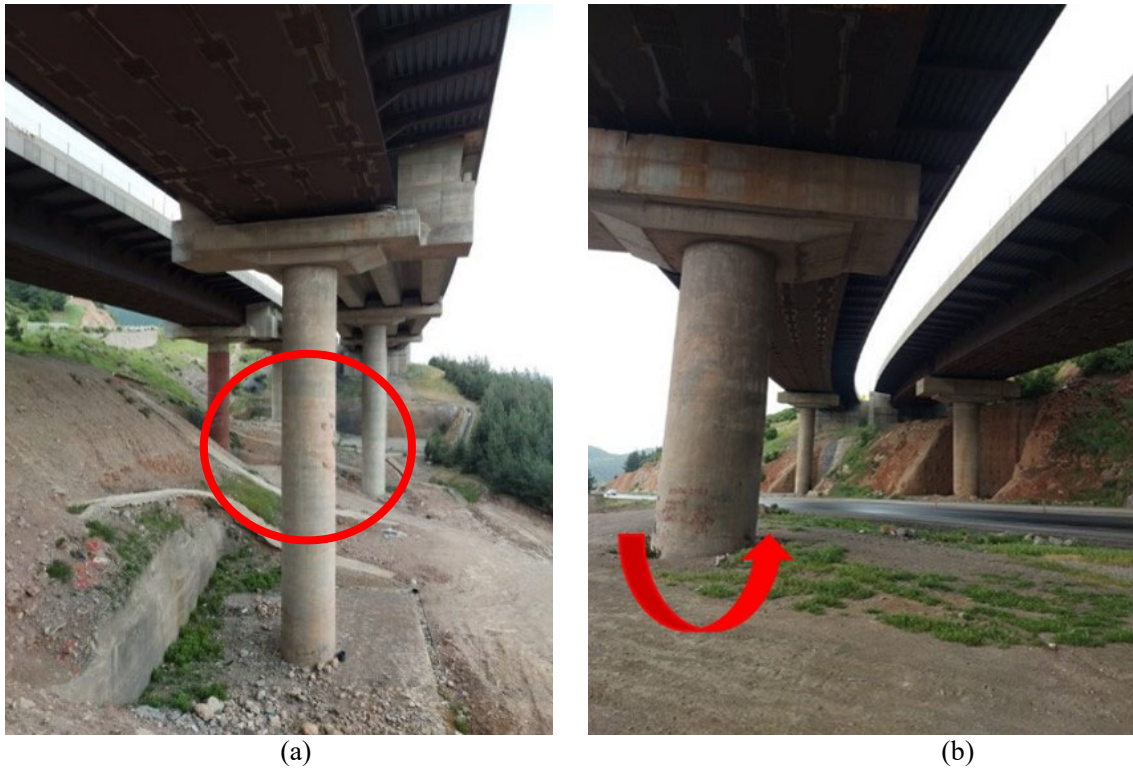
Figure 7 Plastic hinge formation and temporary repair of column and settlement and rotation of the column

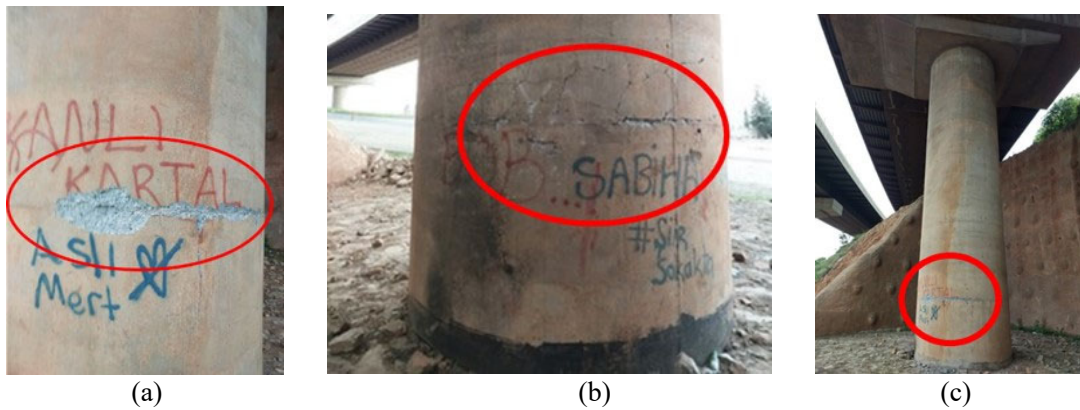
Figure 8 Different views of plastic hinge formation

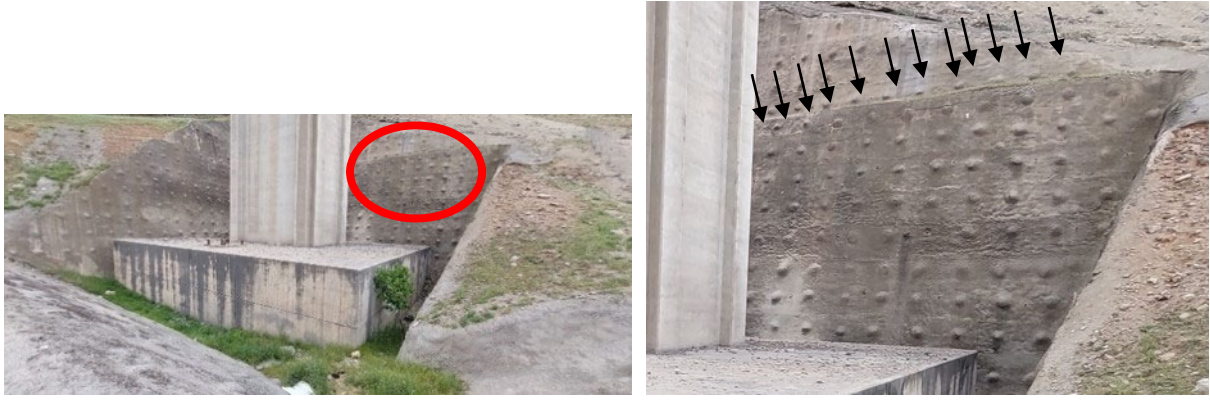
Bridge cases B and C are multiple single piers, Precast, Pre-stressed I girder superstructure with RC Columns, including two parallel lines with a slight minor curve Figure 9, located at GPS coordinates 37°11'20.3"N, 36°43'03.3"E and elevation of 641 m. No structural damages were observed in the main body of the bridge but some minor cracks on the retaining wall created for the piers were observed in Figure 10.

Figure 10 Damage to retaining wall surrounding the pier: (a) View of the bridge pier with minor cracks on the wall and (b) Enlarged view

Because of the minor cracks that were observed on the retaining wall created for the piers of the bridge Figure 10, it is still important to take them seriously and assess their potential impact on the overall structure. While these cracks may not immediately jeopardize the main body of the bridge, they could indicate underlying issues that require attention to prevent further deterioration. The cracks should be assessed and determine their severity and potential implications for the bridge's stability. Monitoring the cracks to observe any changes in size, shape, or propagation is important. This can help identify if the cracks are stable or if they are expanding over time. Also, depending on the evaluation, repairs may be necessary to prevent further cracking and address any potential weaknesses. The repairs could involve techniques such as crack injection,

grouting, or other suitable methods. It is important to have ongoing inspections to establish a schedule for routine inspections to monitor the condition of the retaining wall and the overall bridge structure. This will help ensure that any future issues are detected early and addressed promptly by qualified professionals for any structural concerns to maintain the safety and integrity of the bridge.

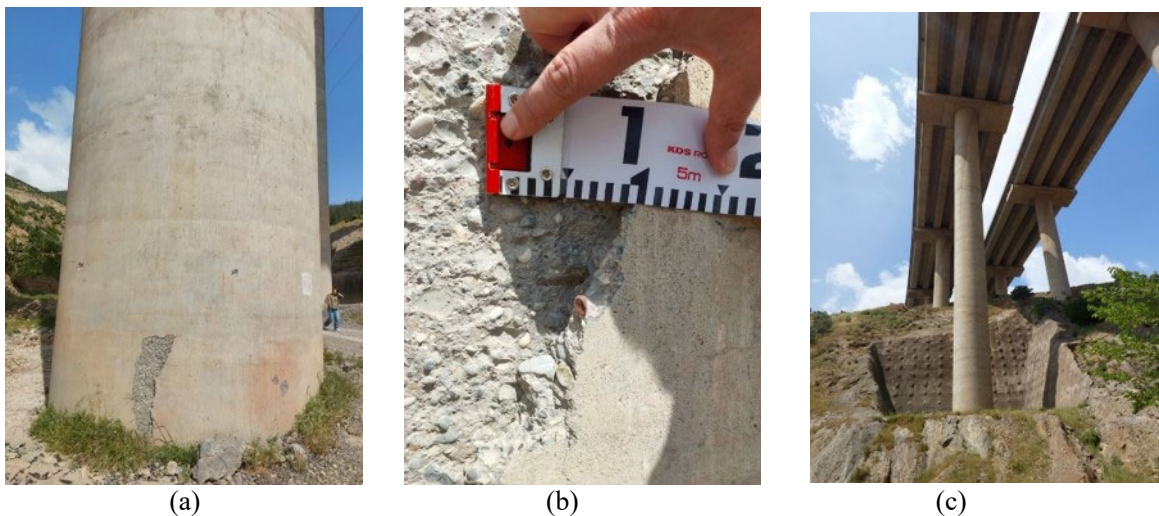
Figure 11 Spalling of column cover during the earthquake and detailed view Spalling of column cover during the earthquake.

during seismic events can engender the development of cracks within the column covers, precipitating instances of spalling and consequent loss of cover material, as illustrated in Figure 11(a) and (b). The occurrence of spalling, characterized by the detachment or disintegration of cover material from the surface of the columns, underscores the deleterious effects of seismic loading on bridge infrastructure. These manifestations of structural distress not only compromise the aesthetic appeal of the bridge but also herald potential structural vulnerabilities, necessitating comprehensive inspection and remedial measures to mitigate further deterioration. The propagation of cracks and subsequent spalling within column covers underscores the paramount importance of robust design considerations and material selection processes aimed at enhancing the resilience of bridge structures to seismic hazards.

The occurrence of spalling in column covers during seismic events serves as a conspicuous indicator of potential deficiencies in the bridge's design or maintenance regimen, warranting thorough investigation and remedial action. If spalling is observed, it may suggest that the thickness of the column cover was inadequate to provide adequate protection against environmental corrosion, thereby unveiling underlying vulnerabilities in the bridge's structural integrity. Inadequacies in the protective coating applied to the column cover, compounded by deterioration over time, may facilitate the ingress of moisture and other corrosive agents into the column, culminating in the corrosion of the underlying structural elements. Figure 11 illustrates instances of insufficient cover observed in the bridge piers, accentuating the urgent need for diligent examination and rectification of such deficiencies. Furthermore, if the column cover fails to effectively shield the reinforcement from moisture or other corrosive agents, it predisposes the steel bars to corrosion-induced degradation. Corrosion compromises the structural integrity of the steel, precipitating spalling and subsequent deterioration of the bridge's load-bearing components.

In the aftermath of spalling incidents during seismic events, which unveil inadequate protection against environmental corrosion, a proactive approach towards corrective measures is imperative to uphold the structural integrity and longevity of bridge infrastructure. The severity of the damage and the overall condition of the bridge dictate the nature and extent of remedial interventions required. Potential solutions encompass a spectrum of strategies aimed at mitigating corrosion-induced deterioration and reinforcing the resilience of the bridge structure. One plausible course of action involves the targeted repair of spalled areas by meticulously removing the damaged concrete and applying new protective coatings or materials to inhibit further corrosion progression. This approach necessitates meticulous attention to detail to ensure the effective restoration of structural integrity and the prevention of future corrosion-related deterioration. Additionally, conducting a comprehensive inspection of the entire bridge is essential to identify other areas vulnerable to corrosion or structural deficiencies, thereby facilitating the formulation of a holistic remediation strategy. The implementation of a comprehensive maintenance plan emerges as a cornerstone of sustainable bridge management practices, encompassing regular inspections, cleaning protocols, and the periodic reapplication of protective coatings. By proactively addressing existing and potential corrosion issues through diligent maintenance activities, authorities can preemptively mitigate the risk of structural deterioration, ensuring the long-term viability of the bridge infrastructure. In considering long-term solutions, it is imperative to deliberate upon strategies aimed at fortifying the bridge columns and enhancing protective measures against environmental corrosion. This may entail the implementation of strengthening measures, such as the addition of supplementary reinforcement or the incorporation of protective layers to augment the resilience of the structural elements. Furthermore, the replacement of column covers with more durable materials or enhanced designs may be deemed necessary to fortify the bridge against future corrosion-induced degradation. Central to the efficacy of remedial interventions is the need for a meticulous assessment of the specific circumstances

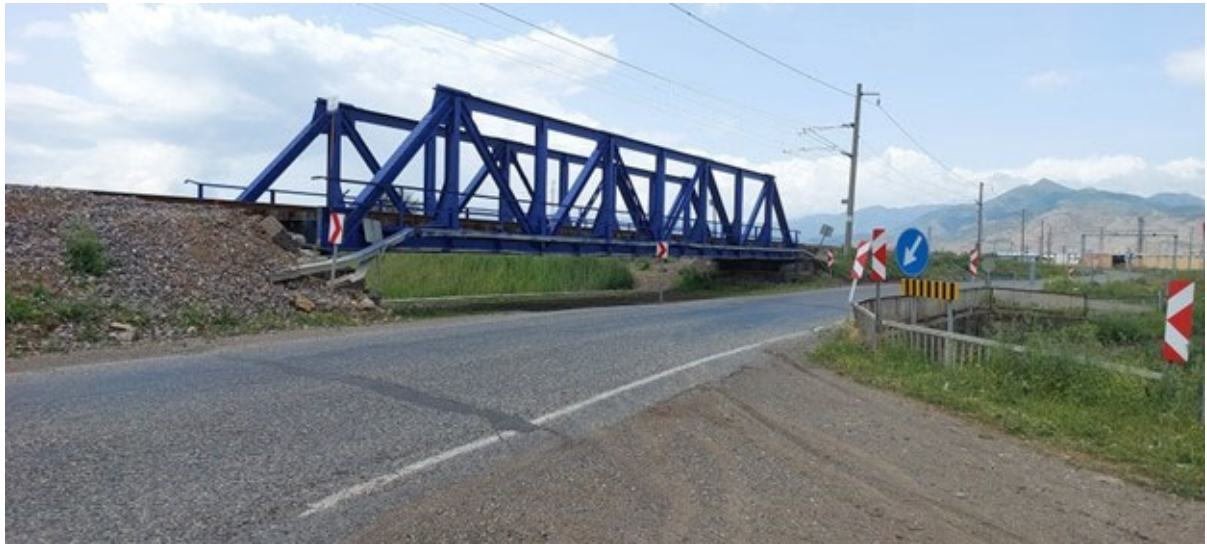
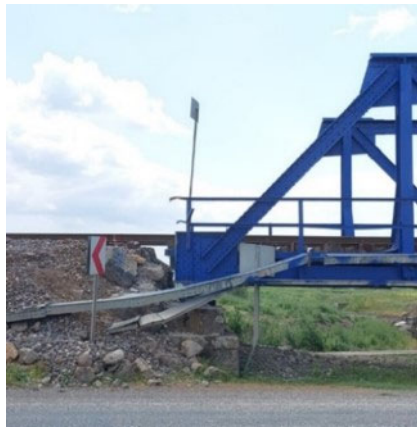
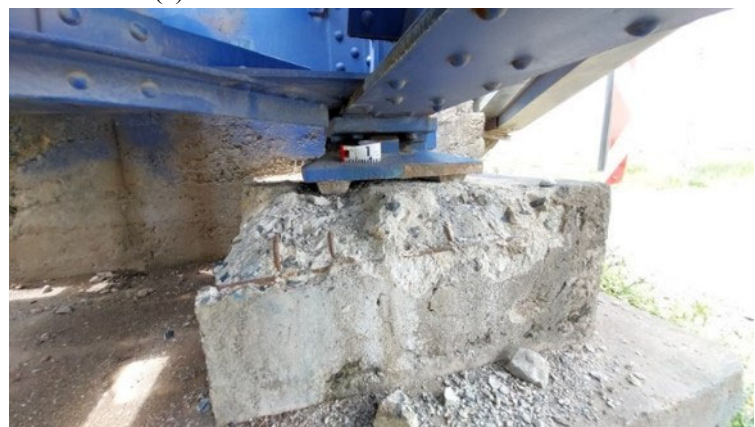
Figure 12 Damage to steel truss bridge in Türkoğlu: (a) General view of the damaged railway bridge, (b) View of the damaged railway bridge abutment, and (c) View of the damaged railway bridge abutment

During seismic events, such as earthquakes, steel truss bridges like the one depicted in Figure 12 are subject to vigorous ground shaking, inducing dynamic forces that reverberate through their components. These forces elicit vibrational responses within the bridge structure, resulting in stress and strain in its structural elements. Steel truss bridges are designed with inherent flexibility to absorb and dissipate seismic energy through ductile deformation mechanisms. However, if the magnitude of the earthquake exceeds the bridge's design thresholds or if deficiencies exist in its design or construction, the structure may incur damage or failure. Pounding, a prevalent type of damage observed in steel truss bridges during seismic events occurs when the bridge lacks adequate provisions to accommodate horizontal movements induced by seismic forces. This can lead to collisions between adjacent bridge elements, as depicted in Figures 12 (b) and (c), resulting in damage or collapse. Addressing the aftermath of such damage requires tailored repair or rehabilitation measures depending on the specific nature and extent of structural degradation. Potential remedial interventions include replacing or reinforcing damaged steel members, rectifying connection failures, and fortifying the bridge foundation. The effectiveness of the repair process relies on specialized expertise and meticulous planning to restore the bridge's safety and structural integrity.

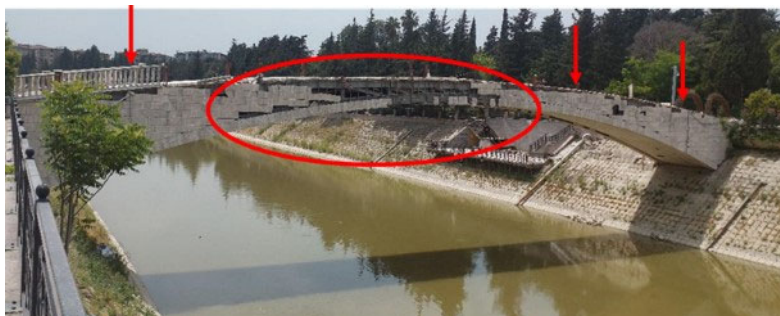
Figure 13 (a) No damaged bridge before the earthquake (b) Google Maps location (c) Non-structural damages of concrete blocks and hangers (d) Damages to structures at the opposite side of the bridge

Concrete blocks and hangers are essential components contributing to the stability and functionality of bridges, supporting various auxiliary systems such as lighting, signage, and utilities. The observed damages, ranging from fractures and dislodgements to deformations and displacements, underscore the susceptibility of these elements to seismic loading. Understanding the nature and extent of non-structural damages is imperative for devising effective mitigation strategies and enhancing the seismic resilience of bridge infrastructure.

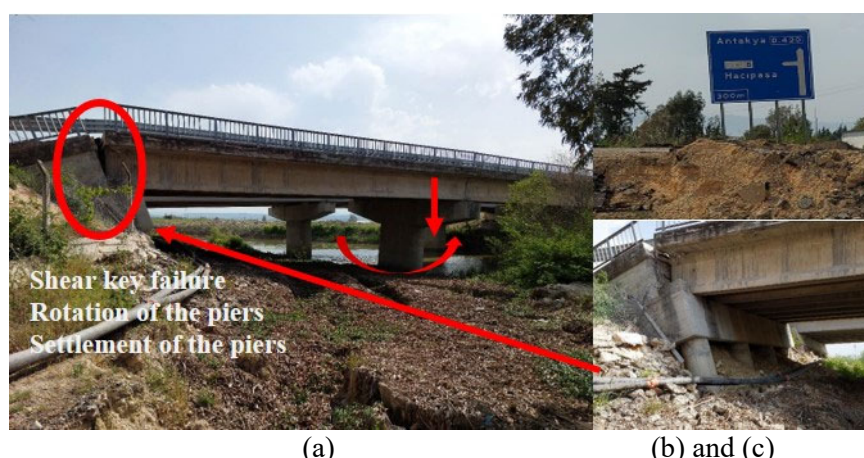
Embankment failure represents a critical geotechnical hazard with profound implications for transportation infrastructure. As depicted in Figure 14 (a), (b) and Figure 16 (i), embankment failure entails the collapse or deformation of earthen structures supporting roadways or railways, often triggered by factors such as inadequate compaction, excessive water infiltration, or seismic activity. Liquefaction, another geotechnical phenomenon, poses significant risks to infrastructure stability, particularly in regions with loose, water-saturated soils. As illustrated in Figure 14 (c) and Figure 15 (d), liquefaction occurs when seismic activity induces a reduction in soil strength, transforming solid soil into a liquid-like state. This phenomenon compromises the bearing capacity of the ground, leading to settlement or lateral spreading. Moreover, significant tilting of bridge piers further complicates the structural integrity of transportation infrastructure in seismic-prone regions. Combining embankment failure, liquefaction, and pronounced tilting of bridge piers, as evidenced in Figure 14 (a) and Figure 15(e), underscores the multifaceted challenges posed by earthquake events. Tilting of bridge piers compromises load-bearing capacity, disrupts traffic flow, and increases the risk of collapse. This is particularly relevant in regions like Antakya, known for seismic activity and its proximity to fault lines. Figures 15 (f) and 15 (g) show the rupture and deck separation at the surface, along with general damages to the road. Moreover, In Figures 16 (h) and (j) Insufficient cover of concrete, coupled with corrosion of the rebars. When concrete cover is inadequate, it fails to provide the necessary protection for reinforcing steel against environmental elements, leading to corrosion. Figures 16 (j) and (k) depict pullouts of the reinforcements and failure of the concrete column which is due to moment demand and moment capacity when bars are cut off. Addressing these complex interactions demands a holistic approach to seismic design, encompassing rigorous structural engineering, comprehensive geotechnical assessments, and effective risk mitigation measures tailored to site-specific conditions. Through proactive planning and diligent implementation of mitigation strategies, the resilience of transportation infrastructure can be enhanced, ensuring the safety and functionality of vital networks in the face of seismic threats.

Figure 14 Damages in the bridge Demirköprü, Antakya; (a) Shows shear key failure, rotation of the piers, and settlement of the piers (b) another angle of shear key failure (c) location of the damaged bridge

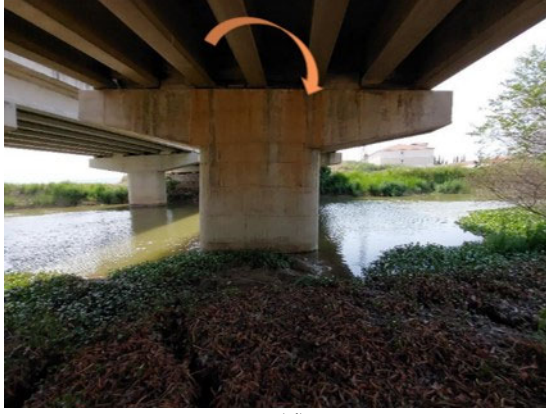
Figure 15 Damages in the bridge Demirköprü, Antakya; (d) tilted pier (e) embankment failure and column failure (f) rupture and deck separation at the surface including general damages of the road (g) surface crack of the asphalt at the beginning of the bridge with deck separation

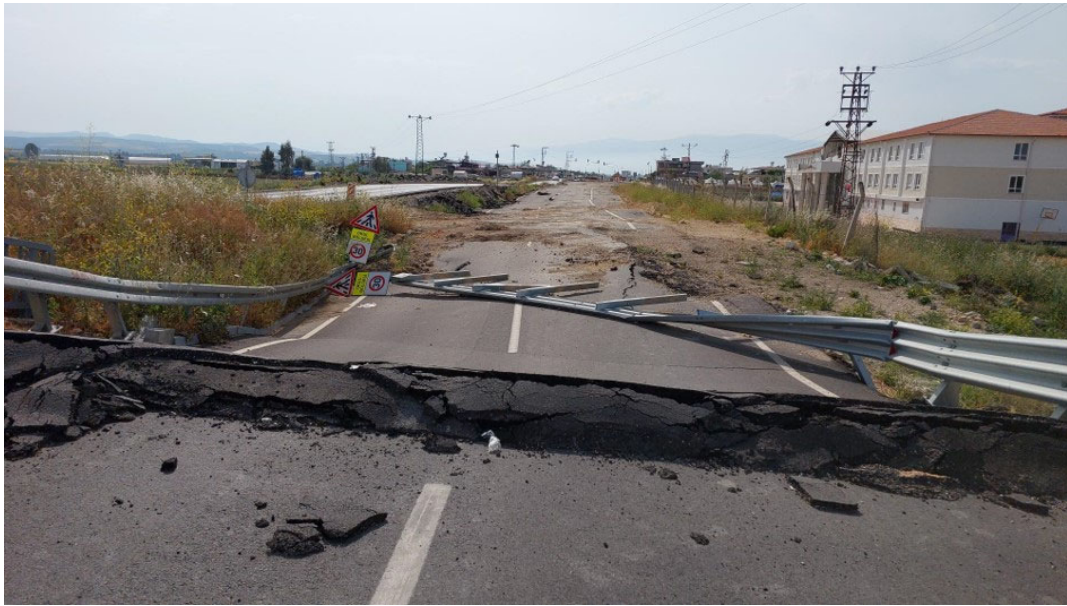
(f)

Deck separation

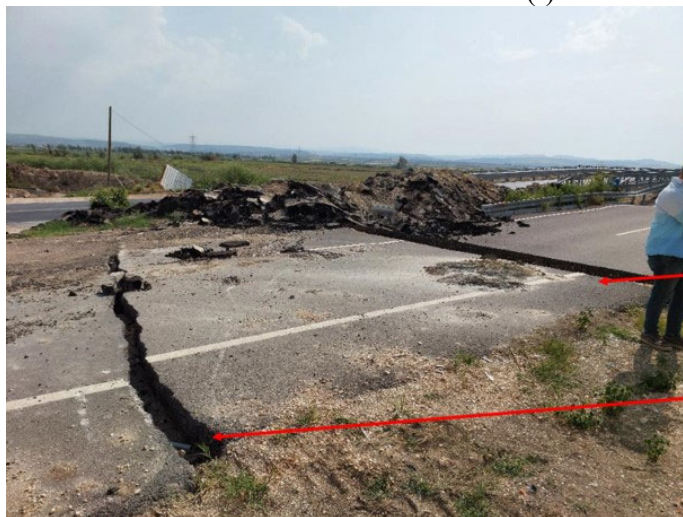
(g)

Surface crack of the asphalt  
at the beginning at the  
bridge

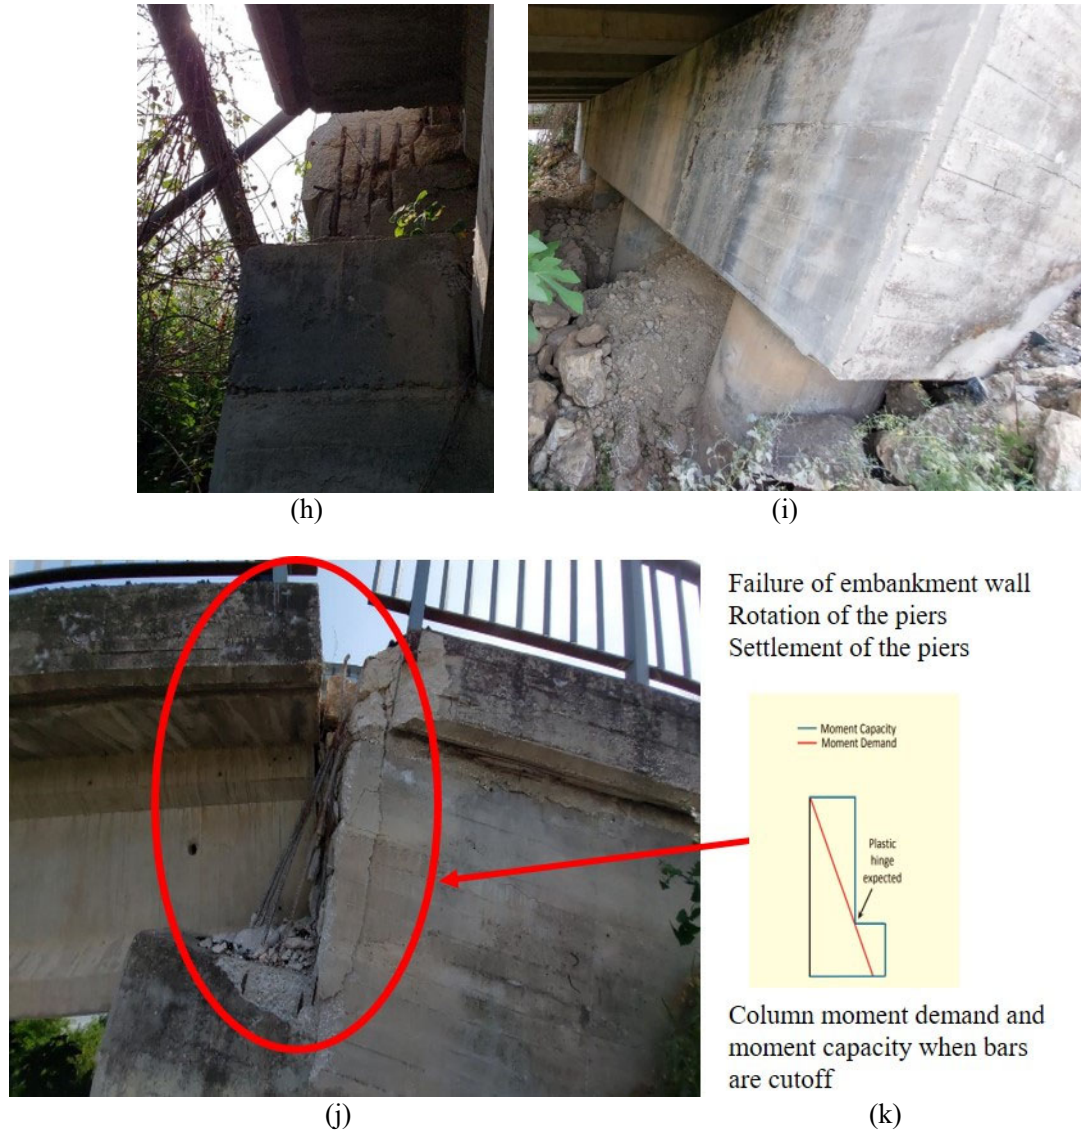
Figure 16 Damages in the bridge Demirköprü, Antakya; (h)insufficient cover of the concrete and corrosion of the rebars (i) failure of embankment wall including rotation of the piers (j) pullouts of the reinforcements and failure of concrete (k) column moment demand and moment capacity when bars are cut off

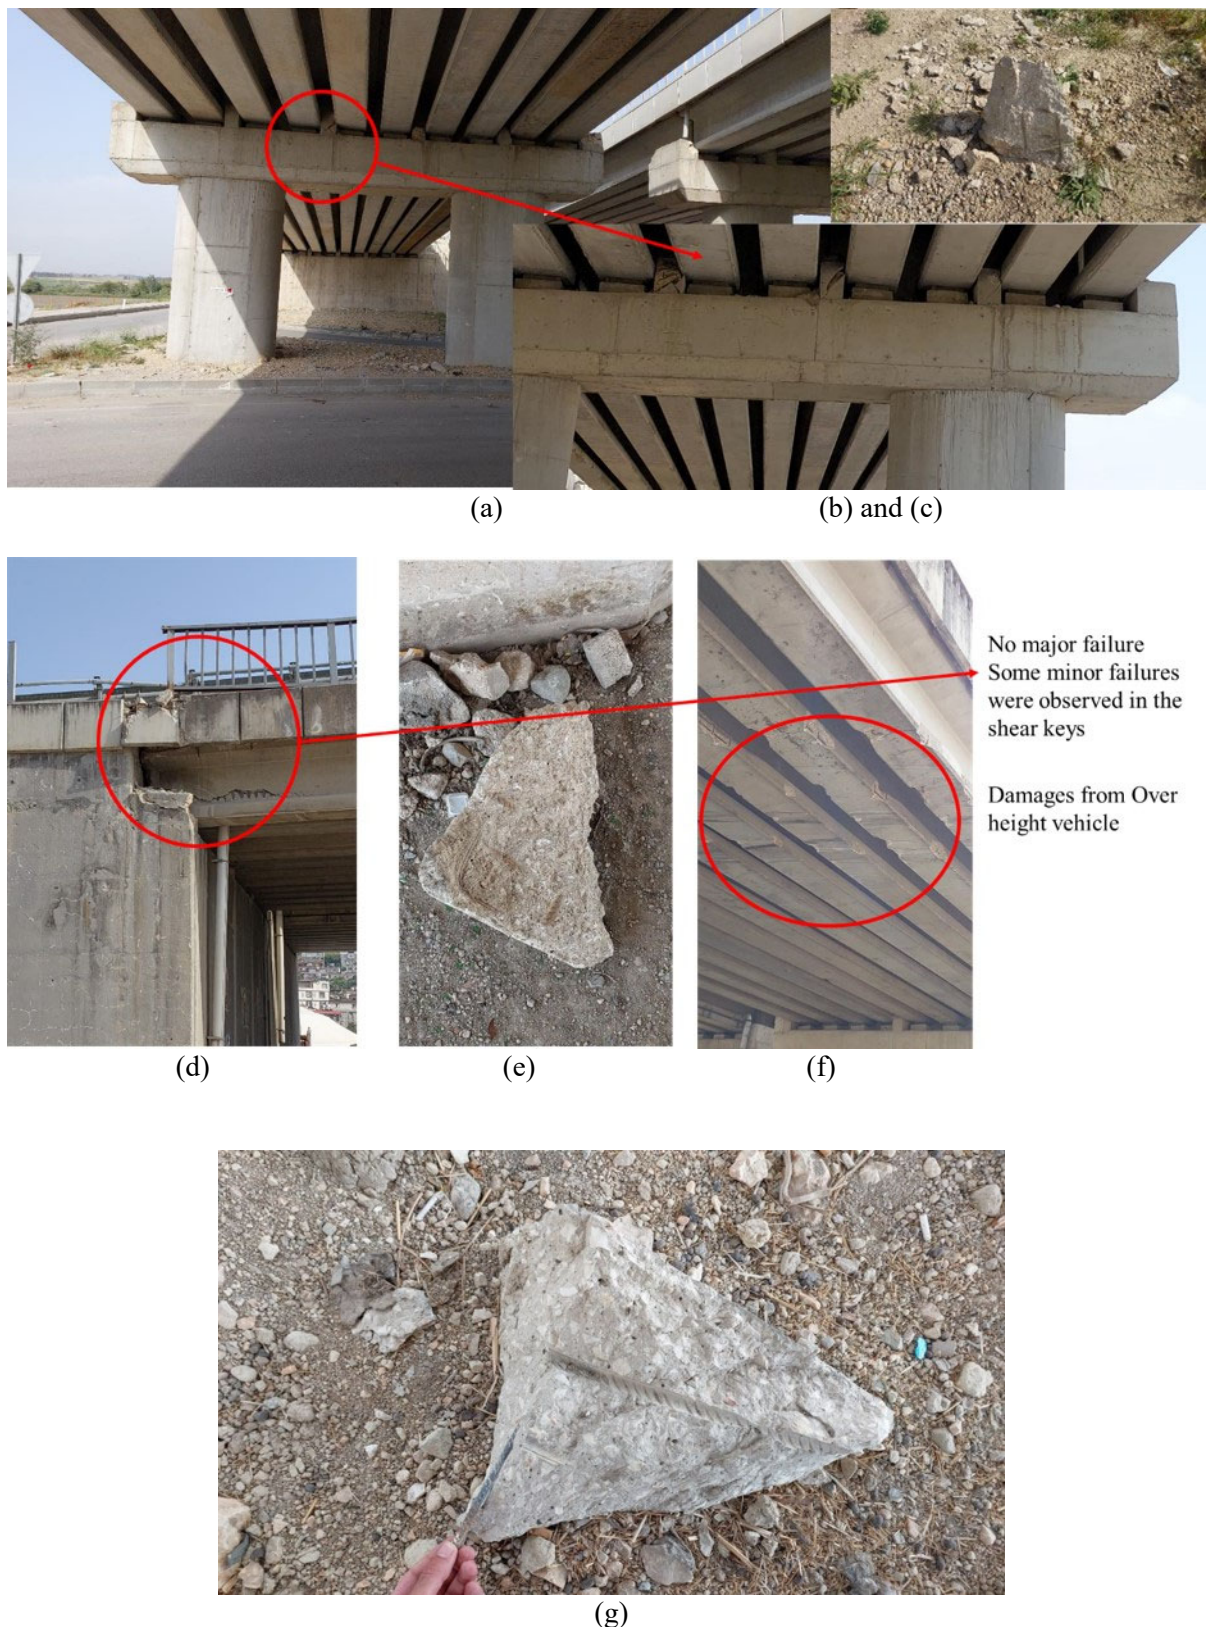
The findings presented in Figure 17 reveal substantial damage inflicted upon the ends of girders within the bridge structure, despite the absence of complete collapse. This damage manifests prominently at the shear keys and girder terminations Figures 17 (a) to (e), where severe structural impairment is evident. Notably, the concrete encasing the vertical and horizontal reinforcing bars exhibits signs of deterioration, accompanied by deformation of the reinforcing bars themselves, indicative of a significant reduction in shear strength at the girder ends. Considering the possibility that these girders are prestressed concrete beams, the prevailing stress conditions become a matter of considerable concern, particularly in light of potential failures within the concrete cross-section.

The close proximity between the link slab support and the girder end exacerbates the situation, resulting in collisions between the girder ends, the link slab support, and the shear keys. The absence of diaphragms at the girder ends further compounds the vulnerability of these structural elements Figure 17 (d). Theoretically, such collisions may concentrate energy on the girder ends, particularly in the absence of end diaphragms, thereby exacerbating damage. Alternatively, transverse loading on the girder webs could arise due to inertial loads transmitted from the deck slab to the bearings or shear keys, potentially leading to damage under out-of-plane flexure and shear conditions.

Figure 17 Viaduct in Antakya city; (a) and (b) failure of shear keys (c) falling off concrete segments (d) shear key failure and shear crack formation in the deck (e) segment falling (f) damages by over height vehicles (g) rebar pullout and insufficient effective length

The observed damage underscores the importance of adhering to seismic principles governing the location and design of damage within bridge structures. The absence of end transverse girders is identified as a critical factor exacerbating the extent of damage observed. Remarkably, similar damage patterns were

Figure 17 (f) depicts damages inflicted by over-height vehicles representing a persistent challenge to infrastructure integrity and public safety. Over-height vehicles can shear off signage, scrape against support beams, or even dislodge sections of infrastructure, leading to costly repairs and potential disruptions in transportation networks. Moreover, such accidents may necessitate temporary closures for inspection and repair, causing inconvenience and traffic congestion.

discerned on the girder ends at the abutment and shear keys of another elevated bridge of identical structural typology within the same city. Given the recurrence of damage across multiple bridges of similar structural composition, there is a compelling imperative to enhance the typical structural details pertaining to girder ends.
