Study of deposit associated with discharge in micro-pixel gas chamber

Nuclear Instruments and Methods in Physics Research Section A: Accelerators, Spectrometers, Detectors and Associated Equipment, 599(1):47-52

2009-02

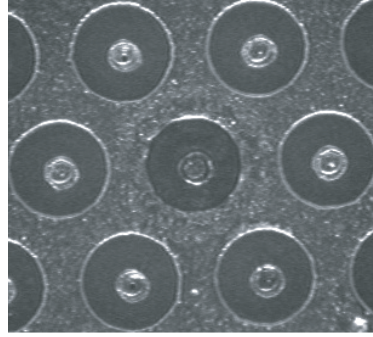
Fig. 3. A microscope image of a damaged pixel. Some hazy material covering the pixel with a little larger circle than that of the pixel (diameter 236 μm) can be observed.

For some tests, μ -PICs, irradiated with an ^{55}Fe RI source (Mn-K_α), with an anode voltage of 500 ~ 550 V, stimulated continuing current flow. Figure 3 shows a typical microscope picture of a damaged pixel. In the center of the image we can see the damaged pixel covered with a hazy material, which forms a little larger circle than the pixel circle. There could be various degrees of damages for each pixel. Figure 4 shows SEI-images for one undamaged pixel (c) and two damaged pixels (a) (b). There are several methods of observing with a SEM. The SEI method is sensitive to insulating surfaces because of electron trapping on the surface of non-conductive specimens (charge up). When a surface has a high resistivity, electrons emitted from the SEM electron gun attach to the surface and then the secondary electron emission from the surface effectively increases. This results in brightening the SEM image in that region with high resistivity. This method is called charge contrast imaging (CCI). For an undamaged pixel, almost the entire surface of the dielectric material (polyimide) is brightened by the charge up (Fig. 4(c)). However, in

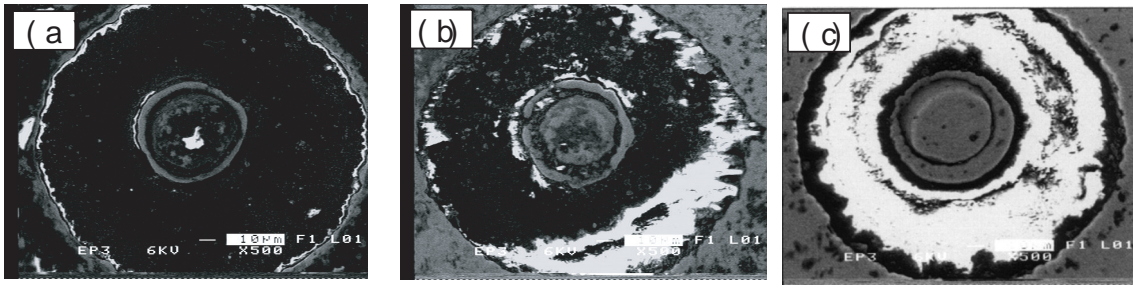
Fig. 4. A microscope image of a damaged pixel. Some hazy material covering the pixel with a little larger circle than that of the pixel (diameter $236\mu\text{m}$) can be observed.

Fig. 4(a)(b), most regions are black indicating no electron charge up. For the image of the damaged pixel shown in (b), some areas (lower right) are bright. This shows the tendency of discharge to take place between the narrow electrode gaps (upper left) because of the poor technique in pattern alignment (displacement $12\text{ }\mu\text{m}$ in average) in the early R&D stages of μ -PIC production. These SEI-images clearly show that certain kinds of conductive materials are deposited on the surface in the case of damaged pixels. We also investigated these deposits using the TOPO-mode of the SEM, which enhances an object's topological variation by scattering electrons with higher energy (more than 50 eV). In Fig. 5 (magnification $\times 5000$), all the images are aligned in the same order as the corresponding SEI-images. From these images, it is clear that the surfaces of the damaged pixels ((a), (b)) are smoothed by grains much smaller than the roughness scale of the polyimide surface of the undamaged pixel (Fig. 5(c)).

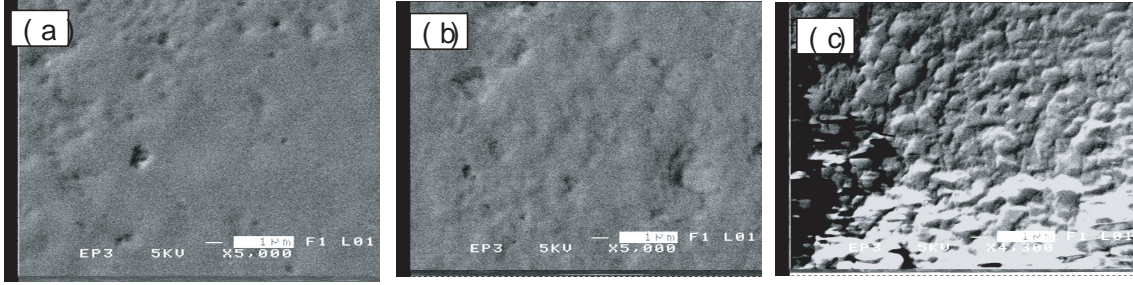
Fig. 5. TOPO-images (magnification $\times 5000$) of damaged area (a) (b) undamaged area (c). All images are in the same order as the corresponding SEI-images.

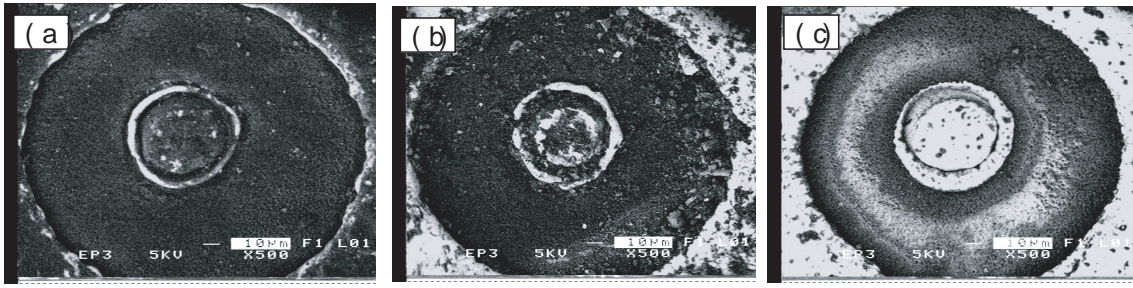
Fig. 6. COMPO-images of damaged (a) (b) and undamaged areas near the damaged pixel (c). Bright area shows metallic composition (Ni plated on Cu). For the damaged pixels, both anodes and cathodes are also covered with light elements. All images are in the same order as the corresponding SEI-images.

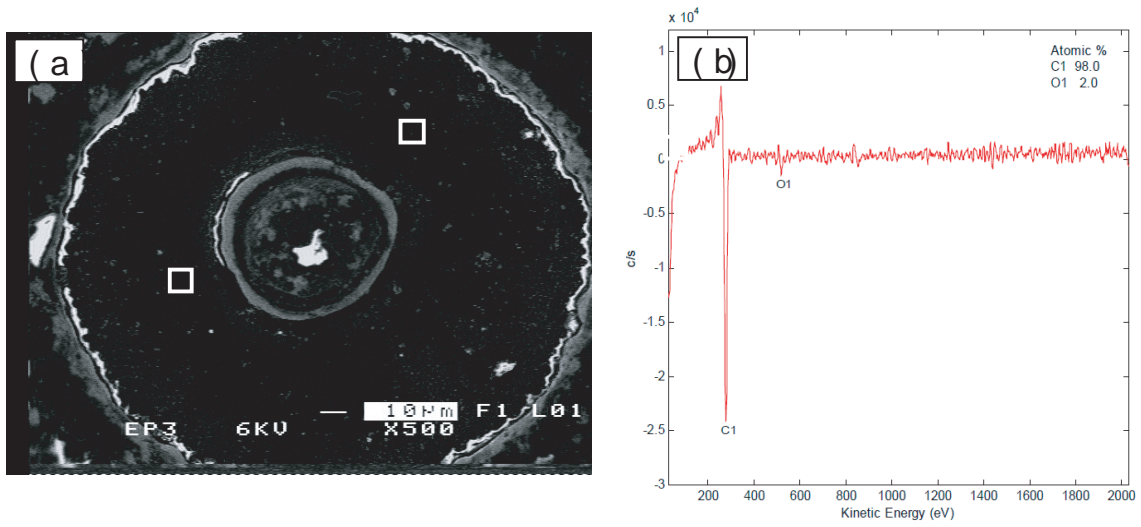
Fig. 7. Auger electron spectroscopy; (a) two $100 \mu\text{m}^2$ regions are the inspected points, (b) Auger electron spectrum for the upper right point (spectrum obtained for the lower left point is almost the same).

(Almost the same spectrum was obtained in lower left point.) shows 98% carbon atoms and 2% oxygen atoms. It should be noted that no nitrogen, which exists in polyimide, was identified in these spectra.

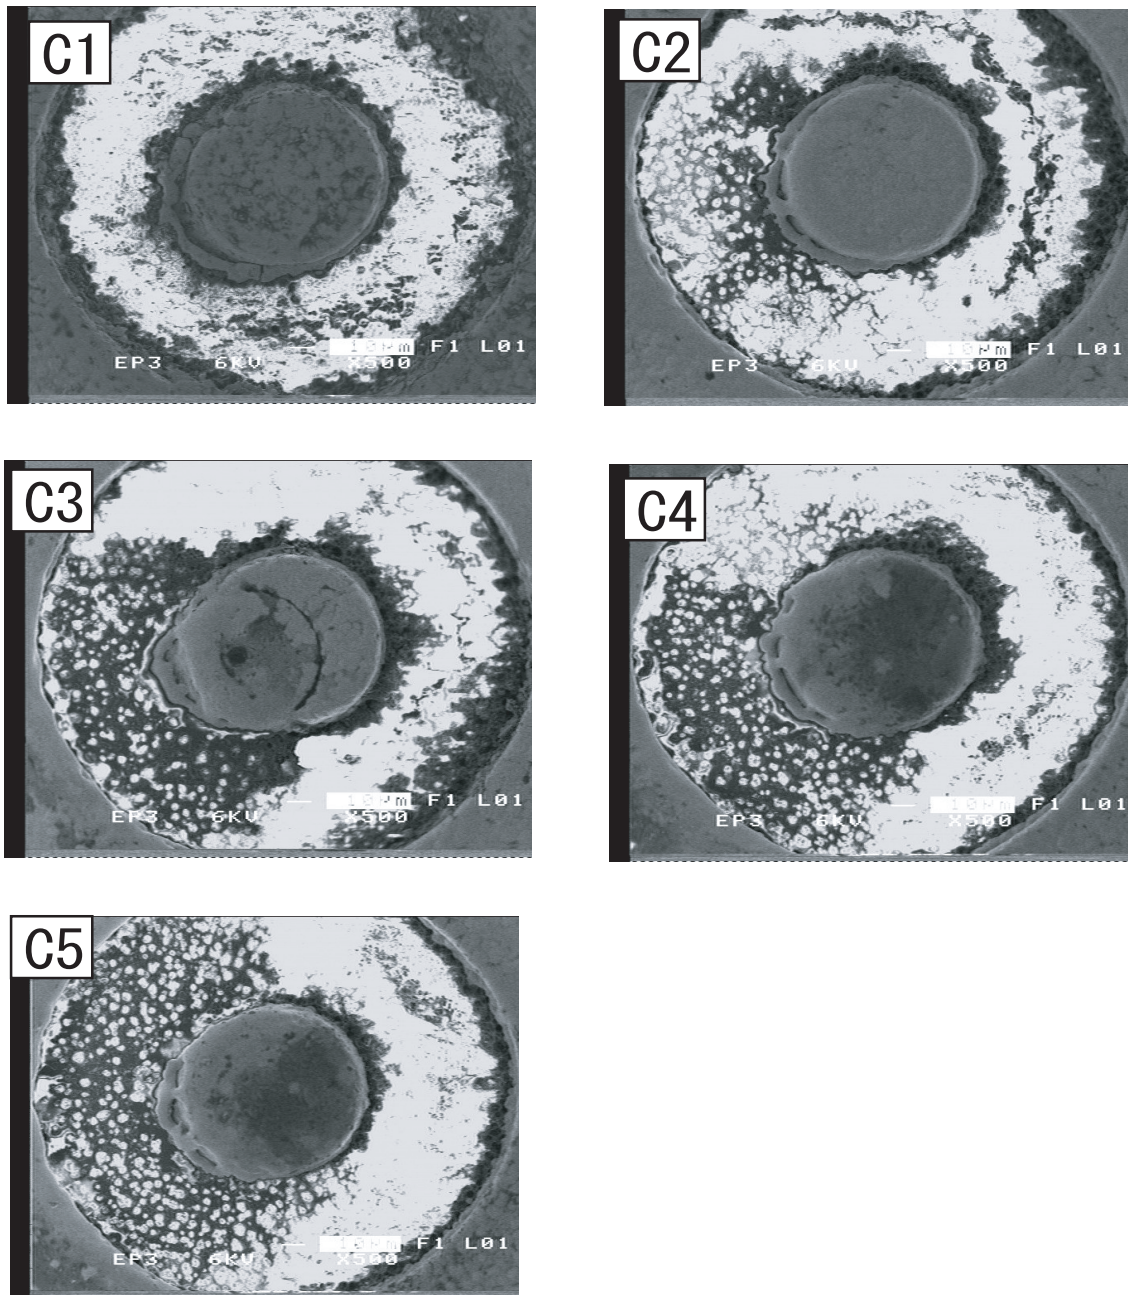
Fig. 8. SEI-images after discharging a definite number of times (5 for C1; 50 for C2; 150 for C3; 250 for C4 and 300 for C5) in Ar/C₂H₆ 50/50. Black area tends to increase with number of discharges. Spark gaps were mostly in the lower left electrode gap in the test. It should be noted that each pixel shown is a different one.

shown in Fig. 8. Some deformation in the anode shapes in these images has no relation with the sparks; just a poor production process.

A gradual increase in the black area on the polyimide surface are shown. Fig. 9 shows the dependency of the applicable high voltage after the spark test. The dependency of the decrease in the applicable voltage on the number of discharges was observed.

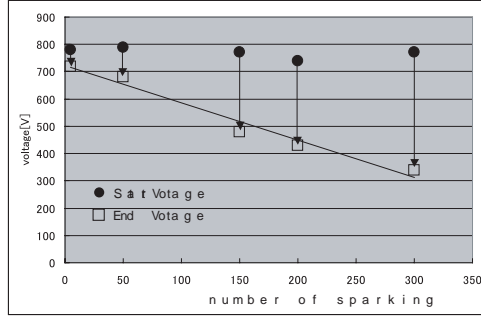
Fig. 9. Applicable voltage drop caused by spark test. Black circles show "start voltage". Squares show "end voltage". The dependency of decreasing in the applicable voltage on number of discharge is clear.

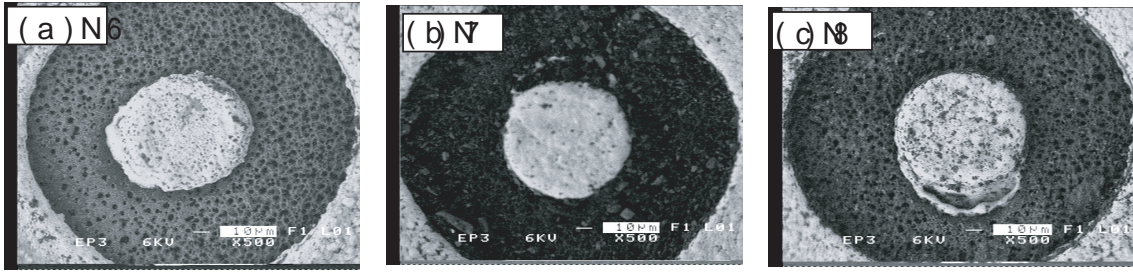
Fig. 10. COMPO-images of pixels after spark test in N_2 gas. No metallic component (such as Ni or Cu) on the surface was observed.

lower right for N8¹. No apparent and stable black areas were observed in N_2 compared with those in Ar/C_2H_6 50/50 though some black or gray areas were observed because of the unstable nature of the charge up. However voltage drops were observed in all three pixels tested in N_2 (Table. 2); pixel N6 50% drop, pixel N7 7% drop, and pixel N8 10% drop. The drop in pixel N6 is comparable to or more than that in Ar/C_2H_6 50/50. In Fig. 12, the TOPO-images of pixel N6 are shown; (a) magnification ($\times 500$), (b) damaged area by higher magnification ($\times 5000$), (c) undamaged area in the same pixel by higher magnification ($\times 5000$). Some smoothing in the damaged area (lower left) was observed compared to that in the undamaged area in the same pixel. This could be due to carbon deposits. As carbon could not have come from the gas, this voltage drop in N_2 could be an inherent character of the μ -PIC pixels against sparks. Therefore, the cause of some of the degradation in the applicable anode voltage after the test might be a kind of carbonization of the polyimide surface. Why did we not observe any apparent black areas in the SEI-images in the case of N_2 compared with the one in Ar/C_2H_6 50/50 although the voltage drop in N_2 was greater than that in Ar/C_2H_6 50/50? To explore this observation, two more pixels (N7 and N8) were subjected to the same spark test. But no clear deposits were observed from the SEM-images. However a few percentages in drop off were observed (Tab. 2). It seems to be that N6 was an extreme case. This might be attributed to the localization of the deposits in case of N_2 comparing in case of Ar/C_2H_6 50/50. To be clear about this hypothesis, it will be useful to measure local surface conductivity using AFM probing. Here we should note the difference between the source and spark tests on the degree of discharges. In the case of damages in source test, the TOPO-images showed deposits of small grains on the polyimide surface as discussed in the previous section (Fig. 5). And electron avalanche region is expected to be more extended to the drift plane region (Fig. 1) than the region stimulated by the spark test.

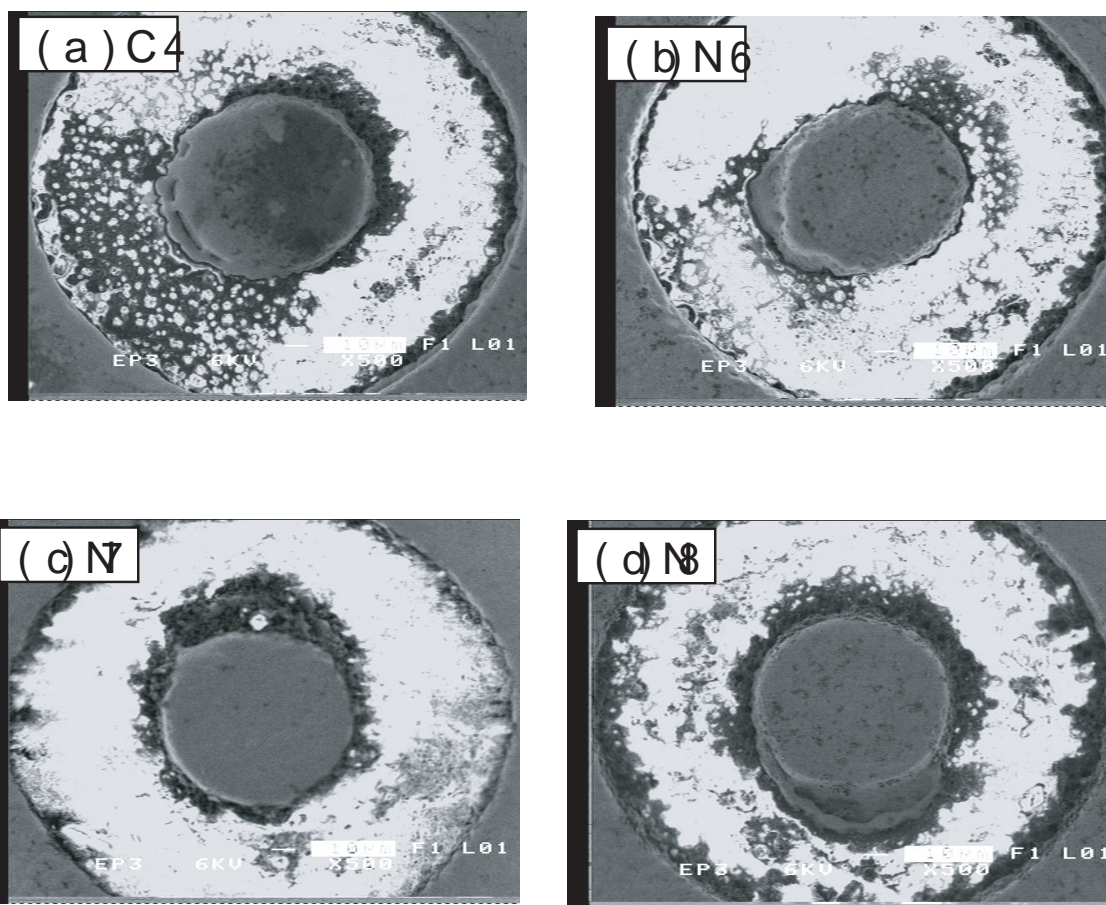
Fig. 11. SEI-images of pixels after the 200 discharges in $\text{Ar}/\text{C}_2\text{H}_6$ 50/50 (a) and in N_2 gas (b) ~ (d).

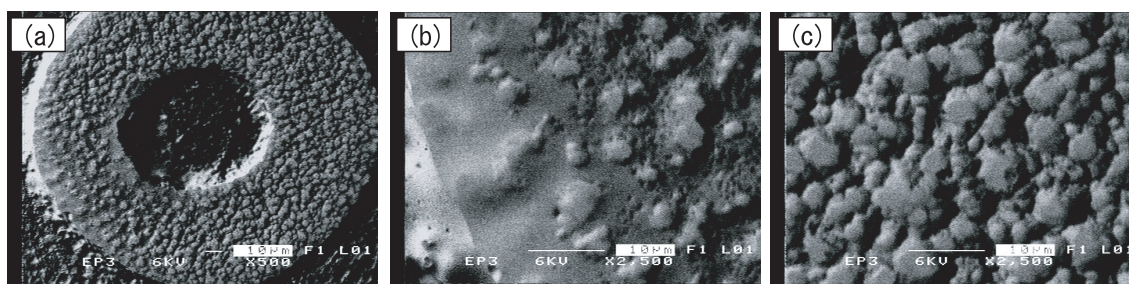
Fig. 12. TOPO-images of pixel N6 after 200 discharges in N_2 gas; (a) magnification ($\times 500$), (b) higher magnification ($\times 5000$), (c) the undamaged area on the same pixel.
