## Investigation on Improvement of Wide-area Damage Estimation Method for Historical Masonry Structures- Beyond The 2015 Gorkha, Nepal Earthquake -

doctoral thesis

Investigation on Improvement of Wide-area Damage Estimation

- Beyond The 2015 Gorkha, Nepal Earthquake –

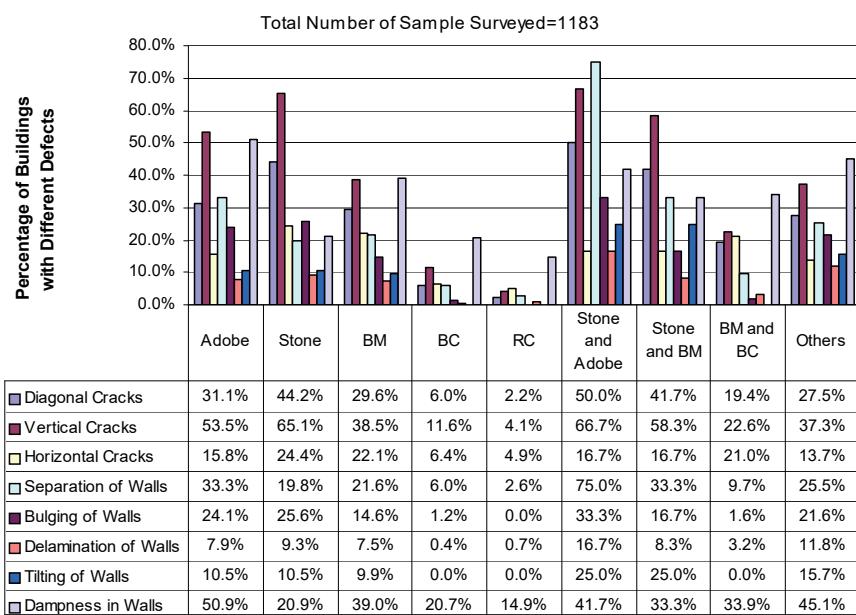
Mud-based buildings (AD, BM or ST with mud mortar) are the building types with the maximum of visible defects such as cracks, wall separation, bulging, and tilting of walls. Some kinds of the defects exceeded half of the sampled buildings. (**Figure 8**). They are mainly caused by the ground moisture, and also due the age-effects. These older type of structures were originally constructed by earlier generations of people based upon the prevalent practice of the time. Obviously, earthquake forces were not considered adequately.

On the contrary, the newer types of cement-based constructions such as BC and RC frames exhibited lesser extent of visible defects, perhaps also because they have a little more strength. However, about 12% of the surveyed BC type buildings exhibited vertical cracks, 6% showed diagonal and horizontal cracks, and about 6% showed separation of walls. Major problem in the RC construction (in about 5% of the buildings) is the development of horizontal cracks, mostly along the wall-beam contacts. This obviously is due to the poor construction process and the lack of quality control of the materials.

**Figure 8** Prevailing Defects in Kathmandu Valley Buildings.

Seismic reconstruction of existing vulnerable buildings in a mass-scale is not permitted by the existing socio-economic conditions of the Valley. Therefore, seismic retrofitting as structural means should be combined with non-structural mitigation measures for improving the seismic performance of existing buildings. Efficiency of seismic retrofitting can be further enhanced by researches such as detailed inventory survey of actual retrofit example, critical

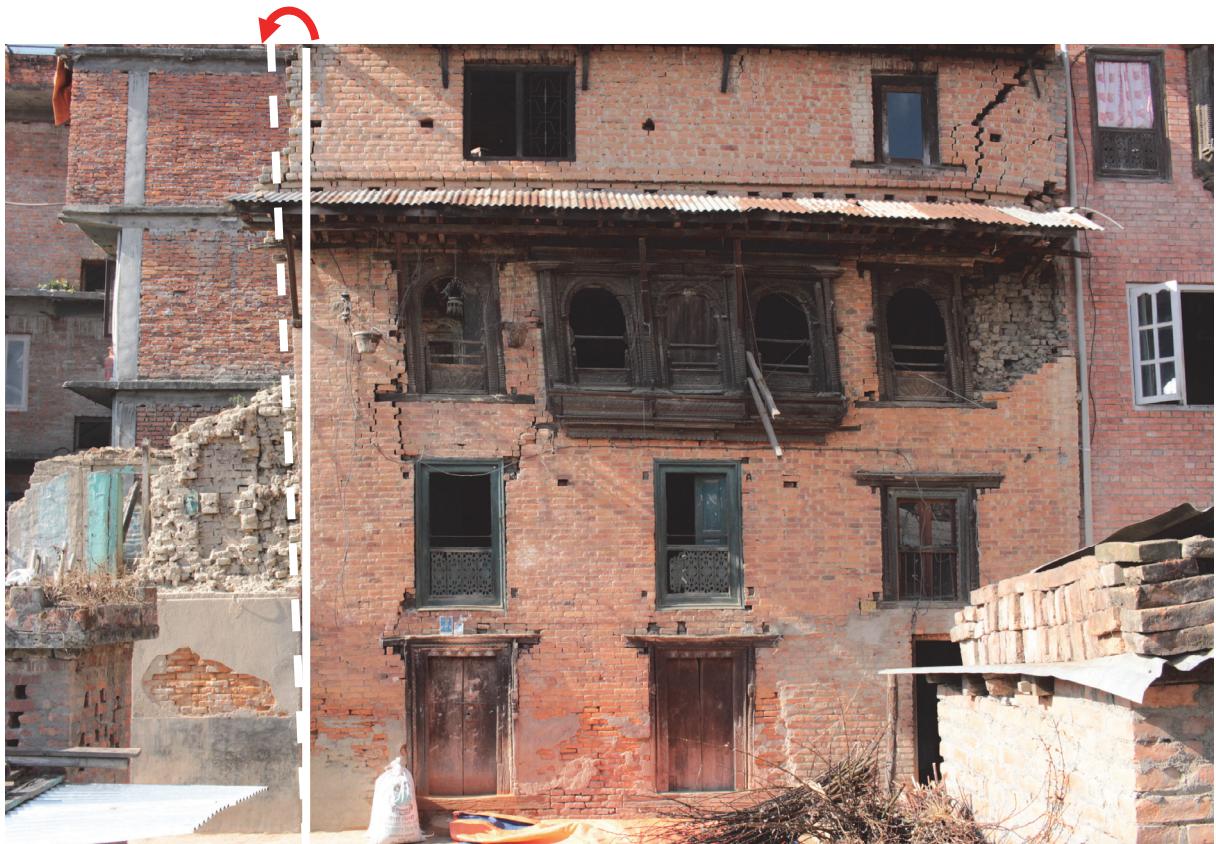
**Figure 11** Traditional structures caused residual deformations and defective corners of the building related to the 2015 Gorkha Earthquake in Khokana (photo by T. Ohsumi after the 2015 Earthquake).

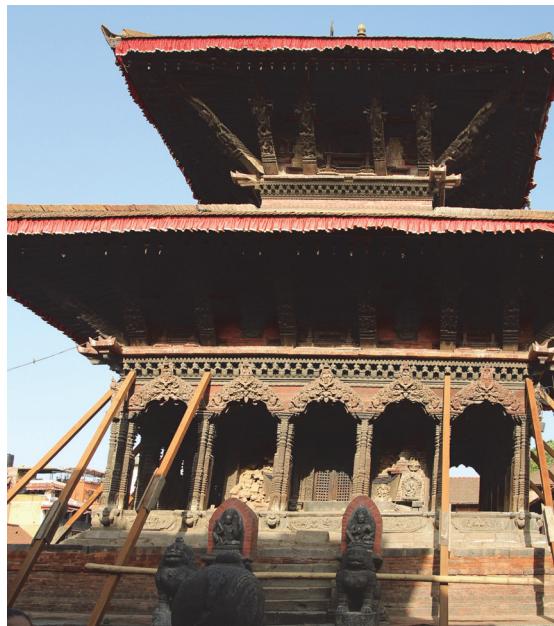
**Figure 12** Temple caused residual deformations and defective corners of the temple related to the 2015 Gorkha Earthquake in Patan (photo by T.Ohsumi after the 2015 Earthquake).

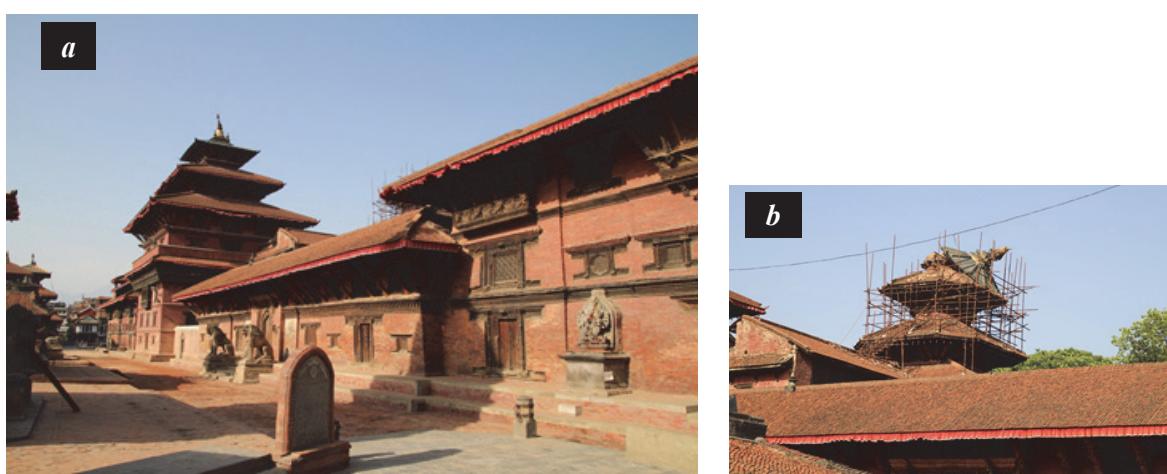
**Figure 15** In Patan, after the earthquake, this place (a) had partial damage at top of structure parts (Gajur and Baymvah) (b)  
(photo by T. Ohsumi).

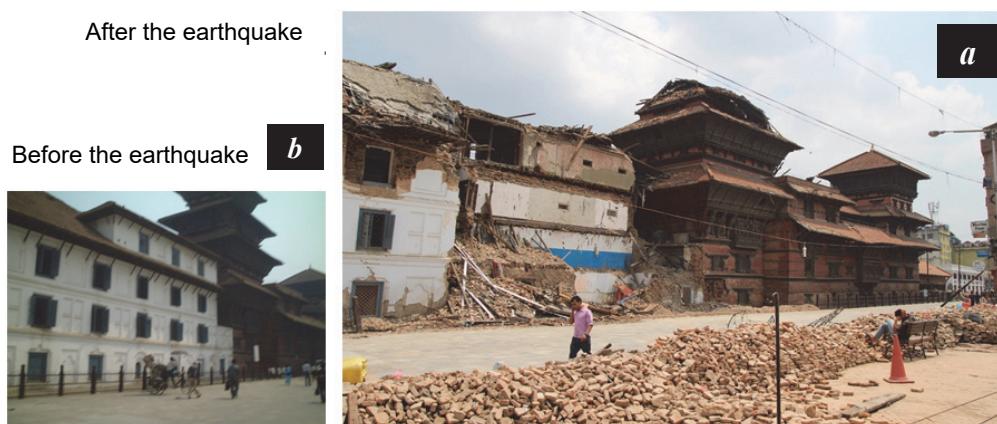
**Figure 16** Kathmandu Durbar Square after the earthquake (a), before the earthquake (b)

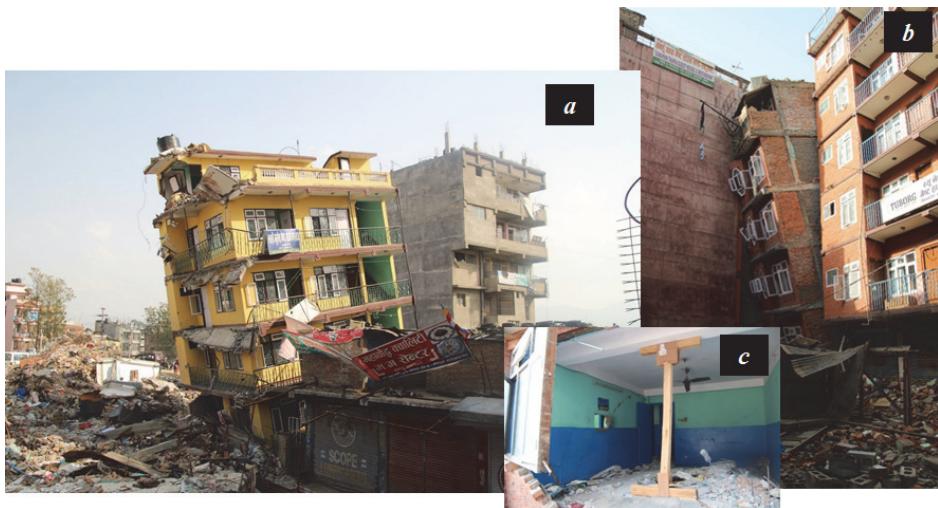
At places along the Kathmandu Ring Road, reinforced concrete (RC) frame buildings were damaged by tilting; however, most of the building damage in the city occurred in masonry buildings. At Gongabu, northwest of the Ring Road, many RC buildings were damaged; most of these were four to seven story structures. The damage was sometimes greater at locations with soft ground such as deltaic deposit near river branches (**Figure 17**); however, some damage was also likely to have been caused by inappropriate construction methods. At Sitapaila, west of the Ring Road, some RC building collapsed at locations where the ground conditions on terraces were a bit stiff. At Balkhu, southwest of the Ring Road, RC frame buildings were tilted. This is near the confluence of the Bagmati and Balkhu rivers, where collapsed buildings fell onto and destroyed a neighboring building (**Figure 18**). The ground conditions in Balkhu were soft because of the presence of riverbed sediments.

**Figure 17** At Gongabu, RC frame buildings were tilted (a,b). A shear crack in the first flower (c)

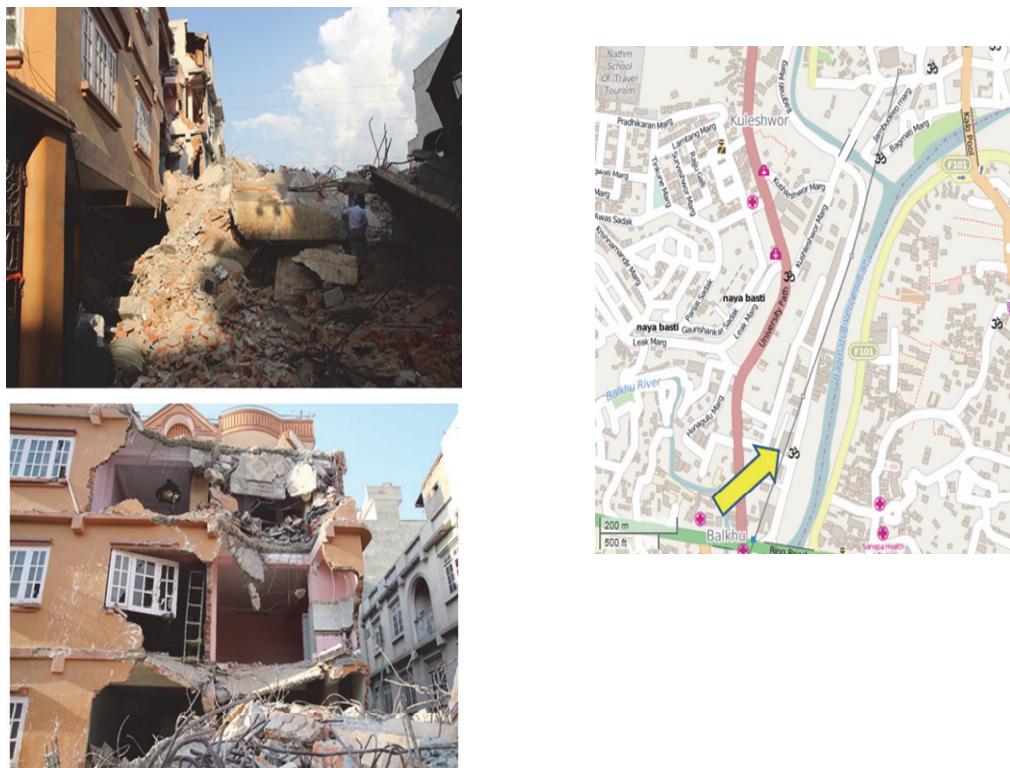
**Figure 18** At the branch point of the Bagmati River and the Transformor River, collapsed building fell onto and destroyed the next building (photo by T. Ohsumi).

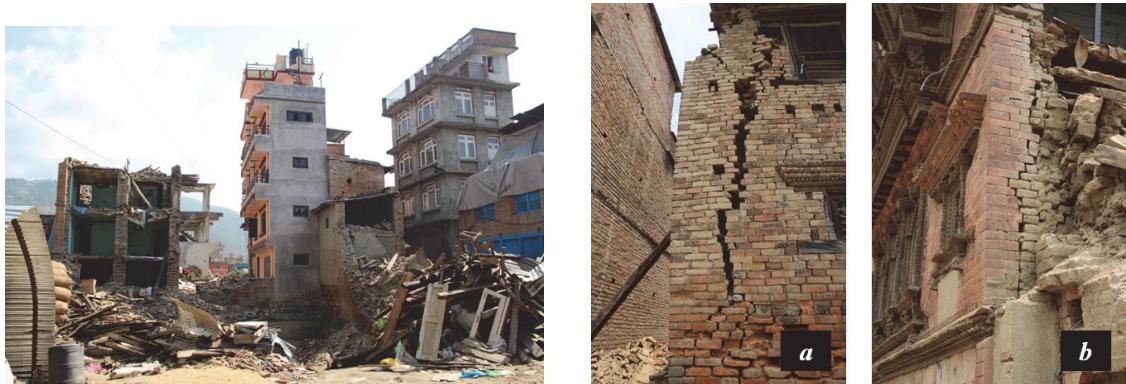
**Figure 20** The damage to RC structures was generally minor. These structures were mainly five to six story buildings. Many of the non-engineered masonry structures that experienced complete collapse or partial damage were two to four story buildings in Sankhu (*left*). Damage in non-engineered masonry structures was initiated by vertical cracks in the corners of the buildings (*a*), which contained no RC columns (*b*). (photo by T. Ohsumi).

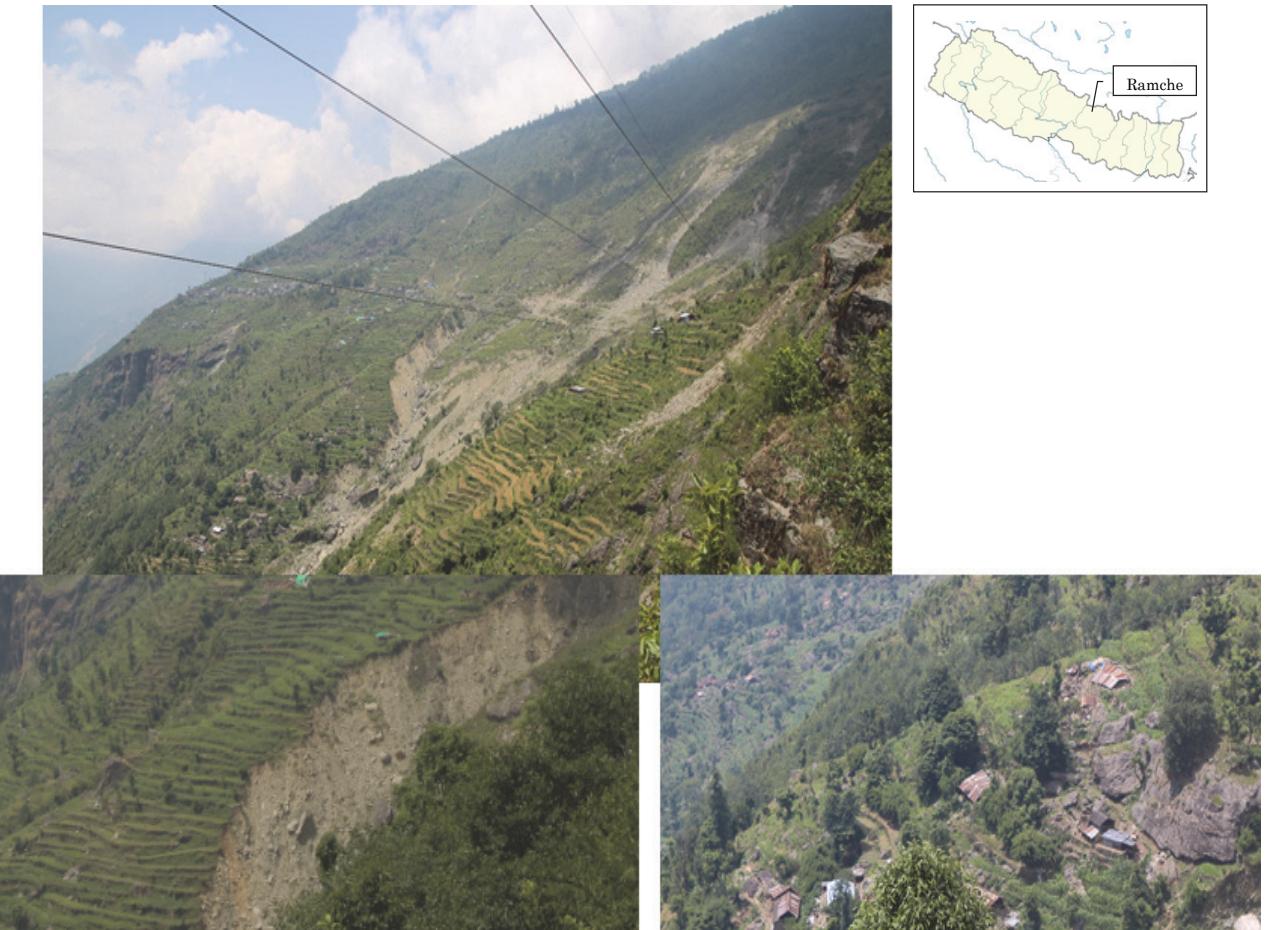
**Figure 22** Thick talus is deposited in the landslide area in Ramche. (photo by T. Ohsumi)

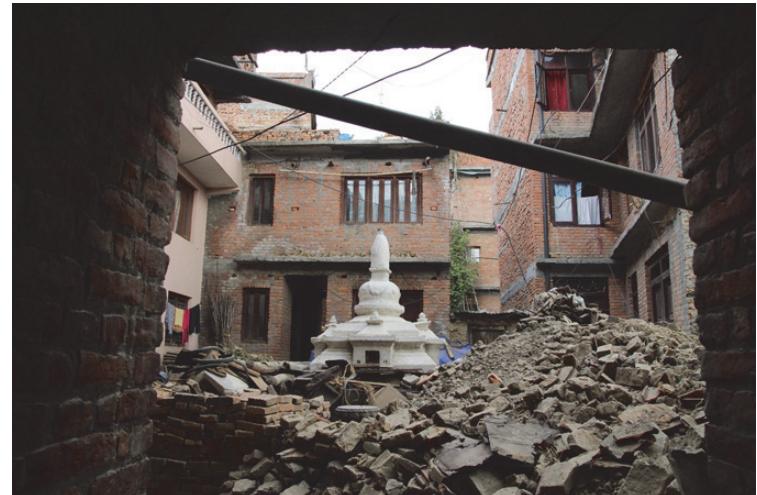
**Figure 26** Damaged buildings with the *Chowk*, in Sankhu.  
This *Chowk* was changed by rebuilt.  
(photo by T. Ohsumi, taken after earthquake in Sankhu)

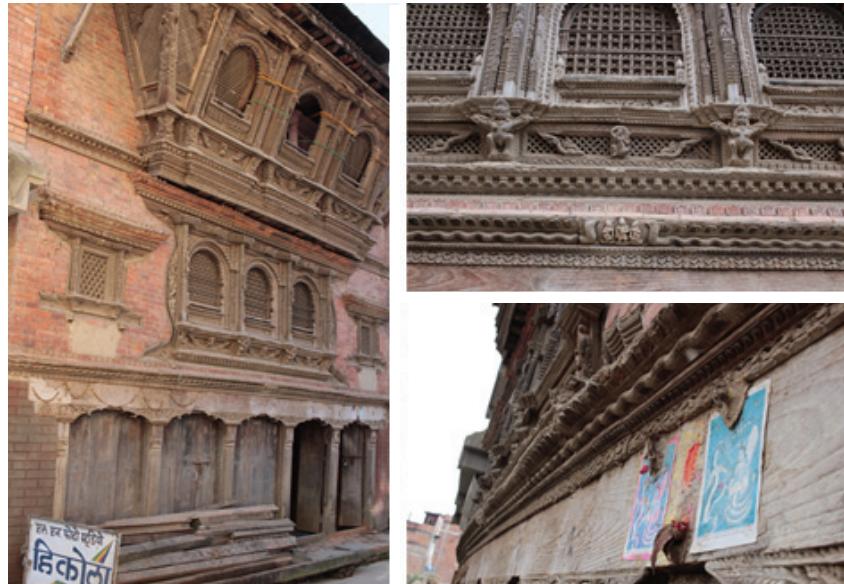
**Figure1** Building constructed over 100 years ago that was slightly damaged by the Gorkha earthquake. The building has a snake (Naga) band surrounding it between the first and second floors.  
(photo by T. Ohsumi, taken after the Gorkha Earthquake in Sankhu)

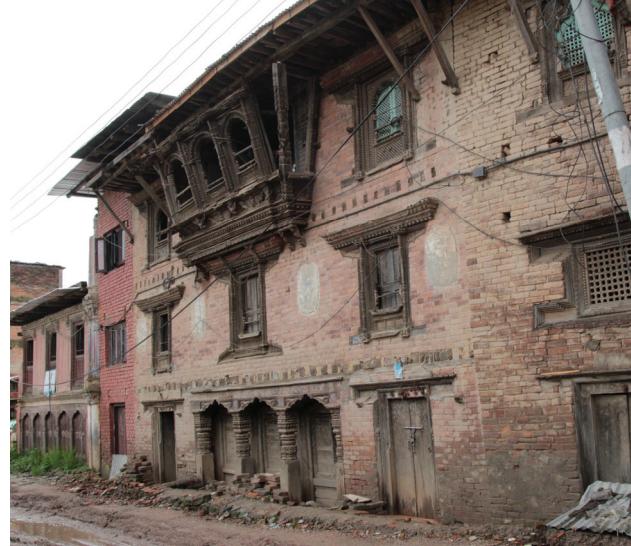
**Figure 2** Building that was over 100 years old, showing little damage. (photo by T. Ohsumi, taken after the Gorkha Earthquake in Sankhu)

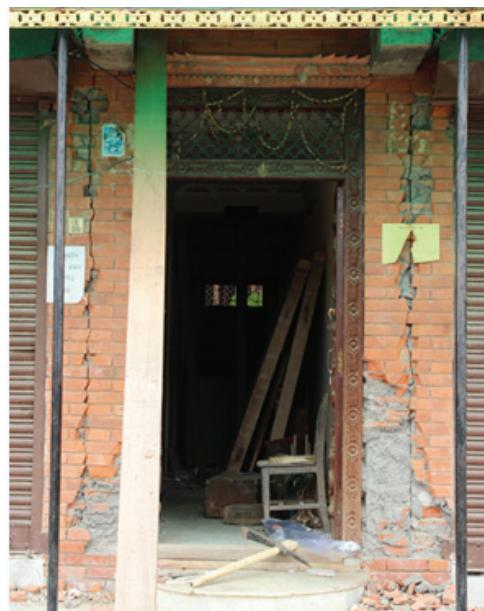
**Figure 7** Entrance damage, damage level  
was deemed to be “yellow”.  
(photo by T. Ohsumi)

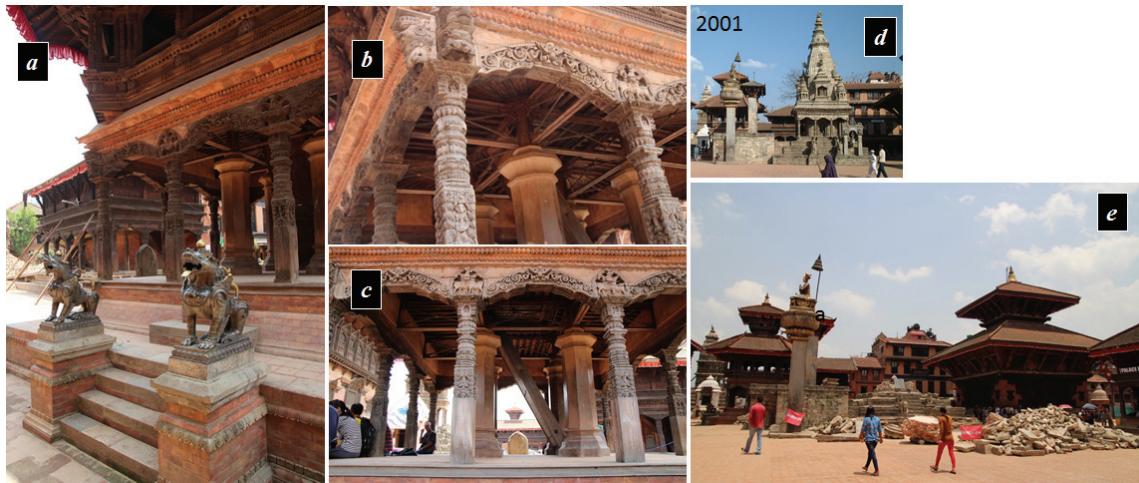
**Figure 10** Steel frame reinforced Chayslin Dega Temple (*a, b, c*), Vatsala Temple (*d* and *e*: before the earthquake) was destroyed and Yaksheshvara Temple (*e*) survived (photo by T. Ohsumi).
