# Impella inlet area adjacent to mitral valve leaflets potentially leads to mitral chordal rupture

European Heart Journal : Case Reports,6(12):ytac451

2022-12

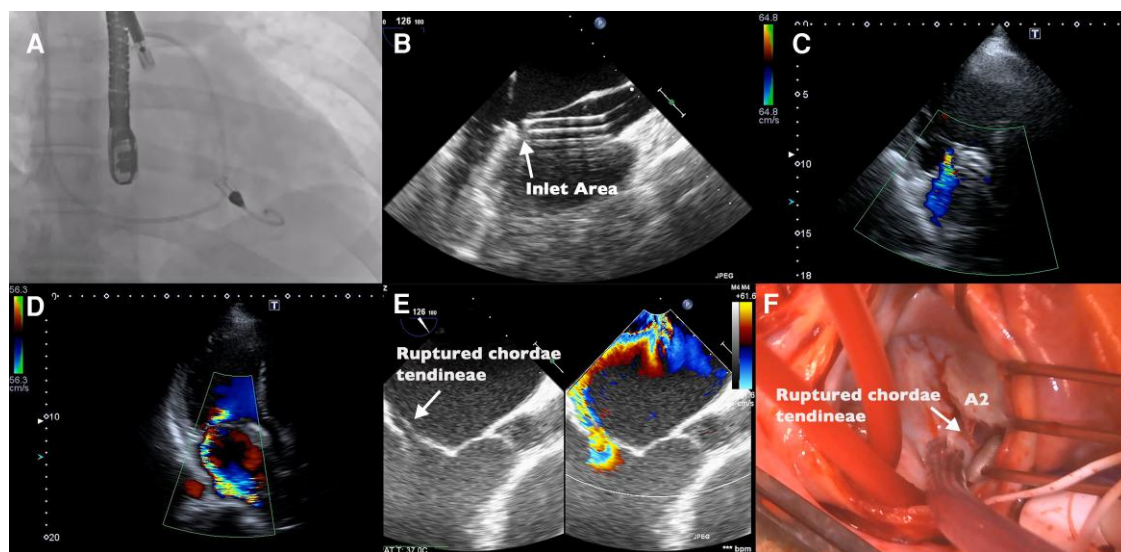
A 42-year-old man with acute heart failure due to dilated cardiomyopathy was admitted to our institution. Transthoracic echocardiography (TTE) showed severe left ventricular (LV) dysfunction and moderate mitral regurgitation (MR). As his condition was not well-controlled with intra-aortic balloon pumping and dobutamine infusion, Impella 5.0 was inserted via the right subclavian artery. Although we attempted to advance this device towards the LV apex and away from mitral valve apparatus, it was forced into the position adjacent to the anterior mitral valve leaflet (Panels A and B). Transoesophageal echocardiography (TEE) confirmed no change of the mitral valve apparatus motion and no entanglement in the sub-mitral apparatus during the procedure.

We performed TTE each day because the Impella positioning was sub-optimal and then confirmed no change of the position of Impella catheter and MR grade (Panel C); however, 3 days after the implantation, MR worsened to severe with an eccentric jet impinging on the left atrial posterior wall (Panel D). TEE showed chordal rupture of the anterior mitral valve leaflet (Panel E). Consequently, he underwent mitral valve repair in addition to implantation of the HeartMate3 for bridge to transplantation (Panel F). Only a few reports have described mitral chordal rupture during Impella support. In these cases, as in the present case, the inlet area was adjacent to the mitral valve leaflet (see [Supplementary material](#) online, [Video S1](#)). This finding suggests that persistent mechanical damage by
