Quantitative Deterioration Evaluation of Heavy-Duty Anticorrosion Coating by Near-Infrared Spectral Characteristics

Engineering Proceedings, 8(1):26

Quantitative Deterioration Evaluation of Heavy-Duty Anticorrosion Coating by Near-Infrared Spectral Characteristics [†]

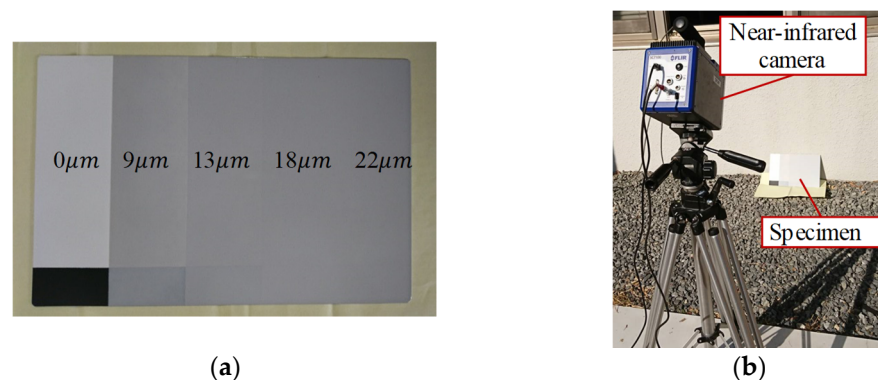
Figure 3. (a) Specimen simulated heavy-duty anticorrosion coating, (b) Experimental setup of the specimen.

Figure 3a shows the specimen having various thicknesses of top coat used in this study. The specimen consists of an intermediate coat of epoxy resin on the steel surface and a top coat of fluoropolymer resin on the intermediate coat. The top coat was painted in five different thicknesses. The thickness values of the top coat are indicated in the figure, and each value is the average of five measurements obtained by using a paint-cutter type coating thickness gauge. The leftmost specimen was not painted with the top coat, exposing the intermediate coat. This study used the near-infrared camera with InGaAs array detector and spectral response of 900–1700 nm. Figure 3b shows the experimental setup with the near-infrared camera and specimen. Infrared measurements were conducted under continuous sunlight on the specimen. The temperature change due to the sunlight exposure did not cause any effect on the short wave infrared reflection measurement.
