Centrifuge modelling of small earth dams subjected to the combined effects of rainfall and earthquakes

Soil Dynamics and Earthquake Engineering, 151:106963

Centrifuge Modelling of Small Earth Dams Subjected to the Combined Effects of Rainfall and Earthquakes

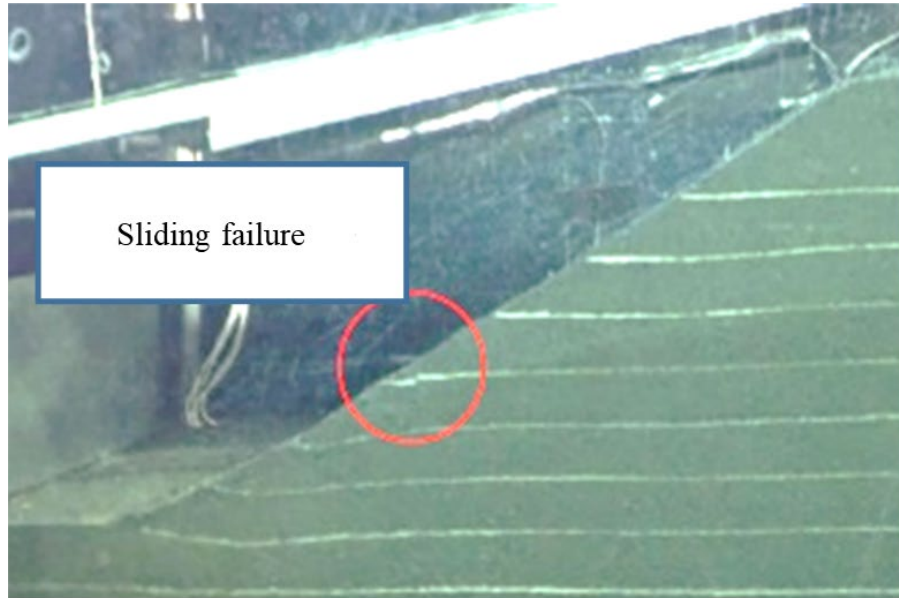
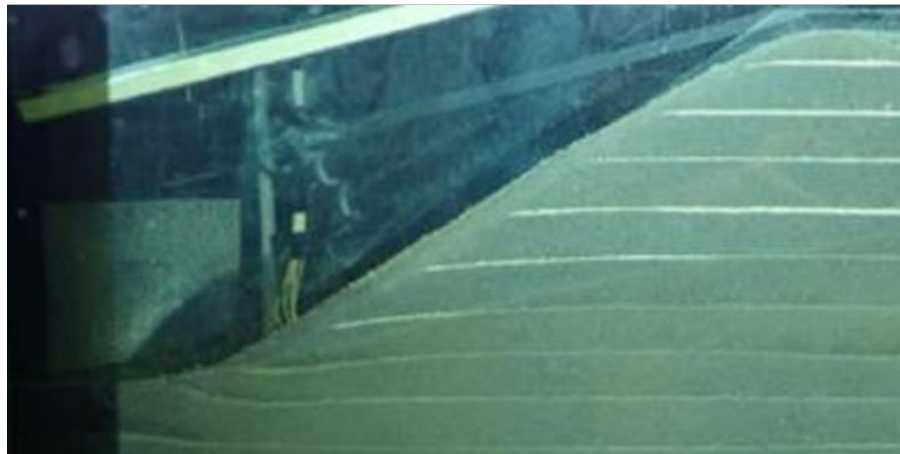
Fig. 8. Status of downstream embankment slope after shaking: (a) Case 1 (rainfall, then shaking); (b) Case 2 (shaking only). Red circle in (a) indicates sliding failure.

This subsection describes the difference in the after-shaking embankment shape because of prior rainfall. Fig. 8 shows the state of the embankment, as observed from the front end of the soil container, for Cases 1 and 2 after shaking. Although sliding failure was observable at a height of approximately 1.2 m near the toe of the embankment on the downstream side in Case 1, no such sliding failure occurred in Case 2.

Fig. 9 shows the results of LDM measurements of the embankment shape after shaking for Cases 1 and 2. The magnitude of deformation near the embankment toe on the downstream side was greater for Case 1. The position of this deformation roughly agrees with the position of the sliding observed in Fig. 8.

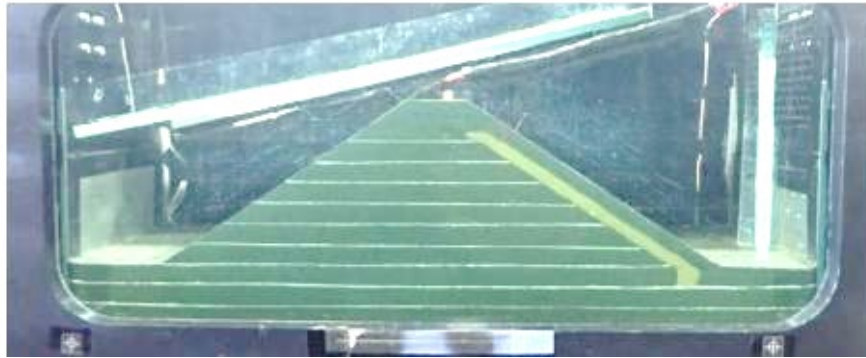
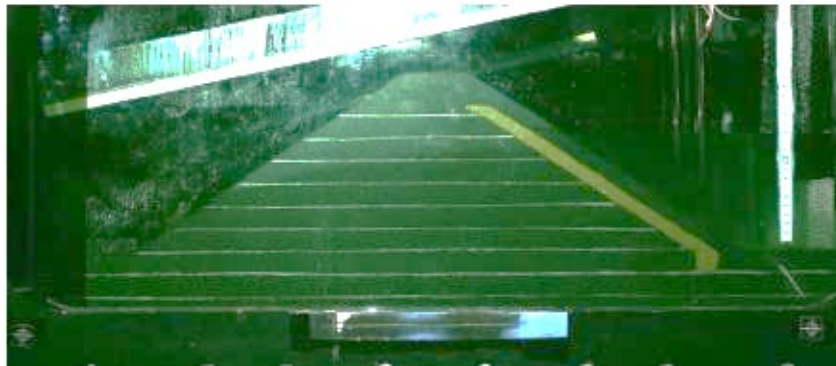
Fig. 13. Embankment status (a) before and (b) after rainfall in Case 1 (rain, then shaking). There was almost no deformation.

Fig. 13 shows the status of the embankment before and after it was subjected to rainfall in Case 1; it can be seen that there was no change in the embankment shape. Fig. 14 shows the results of the LDM measurements for Cases 2 and 3. (Note that the measurement results shown here correspond to a position 20 cm from the front end of the soil container.) For Case 2, there was almost no change in the shape of the slope on the upstream side after shaking and rainfall, but on the downstream side the deformation generated by shaking was exacerbated by the rainfall that followed. It is likely that this was because the shaking caused minute damage to the downstream-slope surface of the embankment, and the surface soil at these damaged points was washed away by the subsequent rainfall. Similarly, in Case 3, although there was no significant change in the shape of the upstream-slope surface after the shaking and rainfall, the

deformation of the downstream slope caused by the shaking was increased by the subsequent rainfall. Based on the results shown in Figs. 13 and 14, even rainfall not sufficient to cause any change in an undamaged embankment can have large effects on an embankment damaged by a prior earthquake.
