# Full scale investigation of GCL damage mechanisms in small earth dam retrofit applications under earthquake loading

Geotextiles and Geomembranes, 47(4):502-513

**KEY WORDS:** Earth dam; Full-scale shaking table test; Geosynthetic clay liner

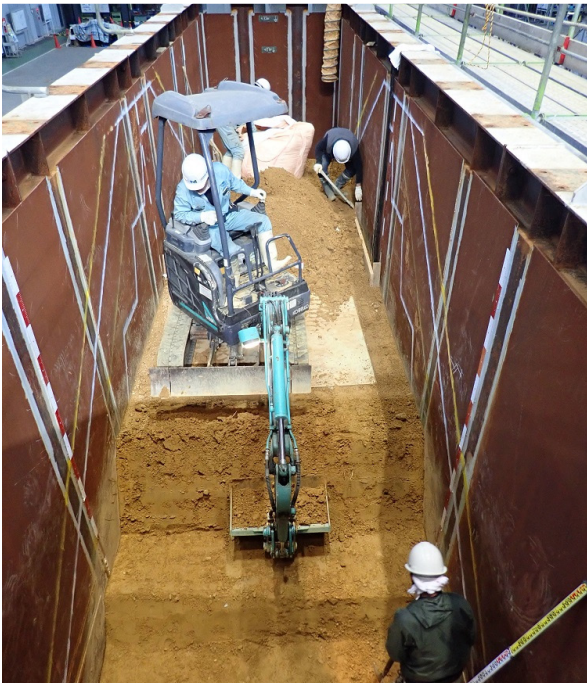
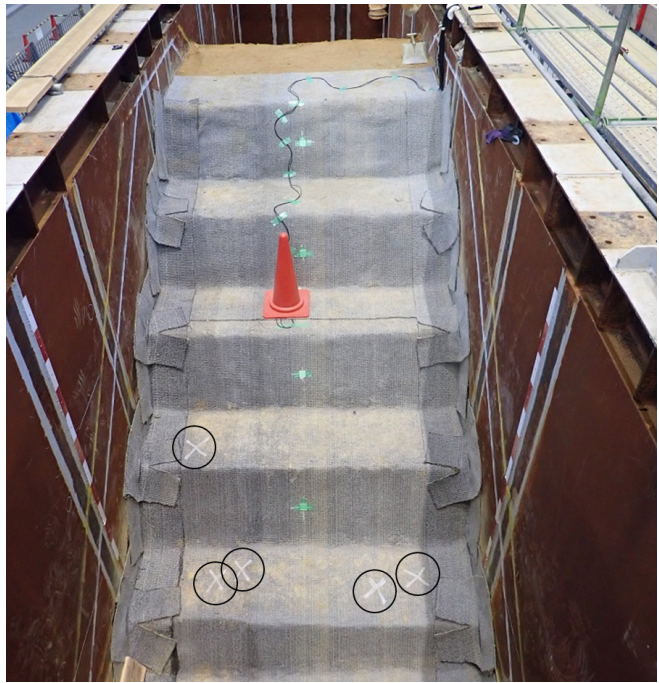
Figure 2. Full scale shaking table experiments contrasting seismic performance of 3 m high earth dams retrofitted with a) a continuous GCL (modified from Sawada et al., 2016), and b) GCL barriers subject to possible damage at locations of overlapped joints and gravel particles at the GCL-foundation soil interface

The objectives of the study will be met through two separate full scale experiments. Firstly, the experiment of Sawada et al (2018) in which a 3 m high dam retrofitted with a continuous GCL (Figure 2a) will be replicated with two notable differences – the inclusion of a downslope lapped joint and the intentional placement of gravel particles at the surface of the GCL – foundation soil interface. Secondly, a compaction test plot will be conducted in which an uncovered GCL will be exposed to prescribed durations of rainfall and subsequent varying degrees of compaction of an overlying cover layer to observe the GCL properties upon exhumation of the lapped GCL core.

The geometry of the baseline experiment of Sawada et al., (2018) is presented in Figure 2a. With a height of 3 m, and a crest width of 1.5 m, the base of the dam was designed to a length of 10.5 m following Japanese guidelines of 1:1.5 side slopes (Ministry of Agriculture, Forestry and Fisheries, 2015a). The earth dam material was placed into 1000 kg capacity bags and hoisted into the strong box using a crane. A miniature excavator was then used within the strong box to place the material, before each 0.23 m thickness lift was finished by hand using rakes and densified with a vibrating roller and plate compactor resulting in a 0.2 m lift thickness of compacted material. The miniature excavator was then used to cut five 600 mm wide benches into the upstream slope of the earth dam (Figure 3a) to provide an average inclination of the benches of 1:1.5. As shown in Figure 2a, a bench rise of 0.3 m to

The new earth dam test geometry, illustrated in Figure 2b, is nominally identical to the earth dam retrofitted with the continuous GCL of Figure 2a with two notable exceptions. Firstly, a 350 mm width lapped joint was included on the third bench. With the lower elevation GCL placed first, and the upper elevation GCL placed second, the top surface of the upper GCL of the overlap is intended to be tension should the cover soil experience shear displacement at the GCL – cover soil boundary. To ensure adequate hydraulic performance of the overlap, supplemental granular bentonite was applied with a target dry mass per unit area application rate of  $8.9 \text{ kg/m}^2$  within the central 250 mm of the 350 mm overlap width. The second difference in the present study is the intentional inclusion five approximately 30 to 50 mm diameter gravel particles at the top surface of the bench. As illustrated in Figure 2b, these

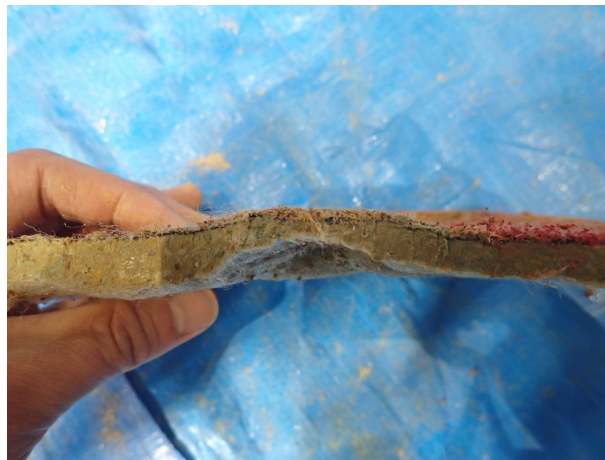
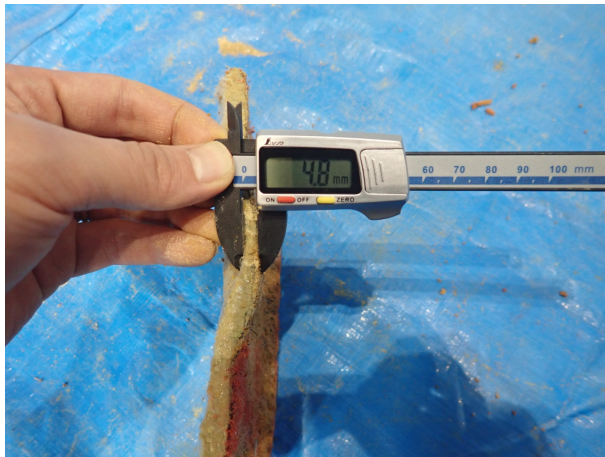
Figure 14. GCL samples of approximate dimensions of 200 x 200 mm, flipped to view underside of GCL to illustrate shape of gravel indentation and lack of evidence of relative motion between GCL and underlying gravel particle.

The position of five gravel particles that were not removed from the surface of the lower two benches of the earth dam are identified in Figure 3 with an "x". At the completion of the measurements of GCL panel overlap, the remainder of the upstream face of the dam was carefully removed to expose the GCL at these locations and approximately 200 x 200 mm samples of the GCL were cut from the GCL panel. These samples were then turned over to expose the underside of the GCL, and the gravel particle protruding from the top surface of the embankment dam soil to illustrate the nature of the gravel indentation. These photographs, presented in Figure 14, illustrate that a significant amount of indentation has occurred and that the magnitude of the thickness reduction should be expected to vary considerably based on the geometry and size of the gravel particle protruding from the foundation soil. However, the shape of the indentation matches the shape of the gravel indenter, indicative of no

significant shear displacement having occurred between the underlying gravel particle and the GCL.
