Experimental Investigation for Monitoring Corrosion Using Plastic Optical Fiber Sensors

Keywords: corrosion detection; color change; plastic optical fiber sensor; graphic image analysis

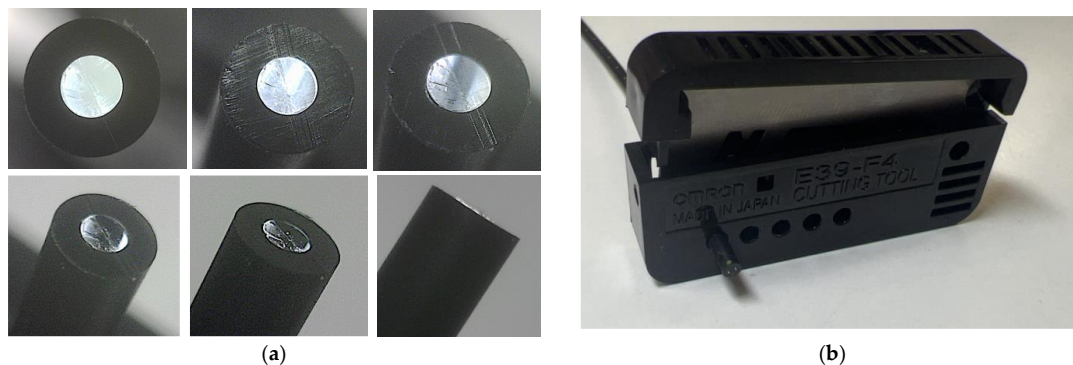
Figure 1. Cross section of a POF cable and a POF cutter: (a) Cross section of a POF cable taken from various angles; (b) A compact POF cutter (Model E39-F4 produced by OMRON). After inserting a POF cable into a hole, the blade can be pressed down to cut it.

either introducing light into the end face or recording the light emitted from it. While it was feasible to polish the cut surface to achieve complete flatness, this incurred excessive time and cost, impeding the technology's widespread societal adoption. In Figure 1a, surface photos taken from various angles of a POF cable are shown. To make this cut surface, the POF cutter shown in Figure 1b was used. These surfaces were mostly perpendicular to the POF axis, yet they retained microscopic irregularities. As these irregularities varied slightly between POFs, fabricating multiple sensors of the same type introduced some variance in measured values. Nonetheless, this divergence in sensor characteristics isn't critical. The stability and variability of data from their respective initial values offered insight into the occurrence and progression of corrosion conditions.

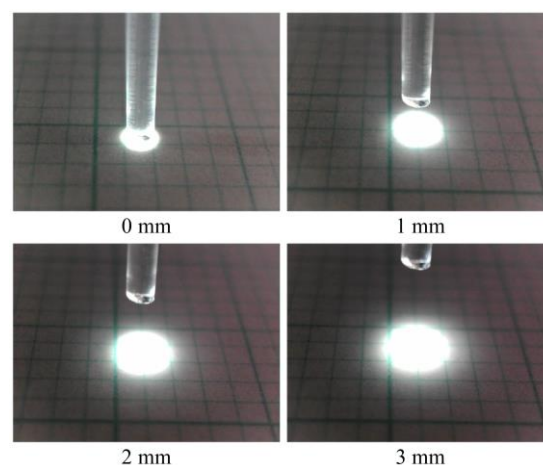
Figure 2. Size comparison of illuminated zones with respect to the vertical distance between the scale sheet and the tip of POF with a length of 1.5 m.

When light entered the POF, it underwent multiple reflections owing to the contrast in the refractive indices of the core and cladding. Consequently, the light emitted from the POF tip exhibited marginal dispersion. A POF tip that was positioned at a distance of 3 mm from the grid paper revealed a light spot with a diameter of approximately 2.5–3 mm, as shown in Figure 2.

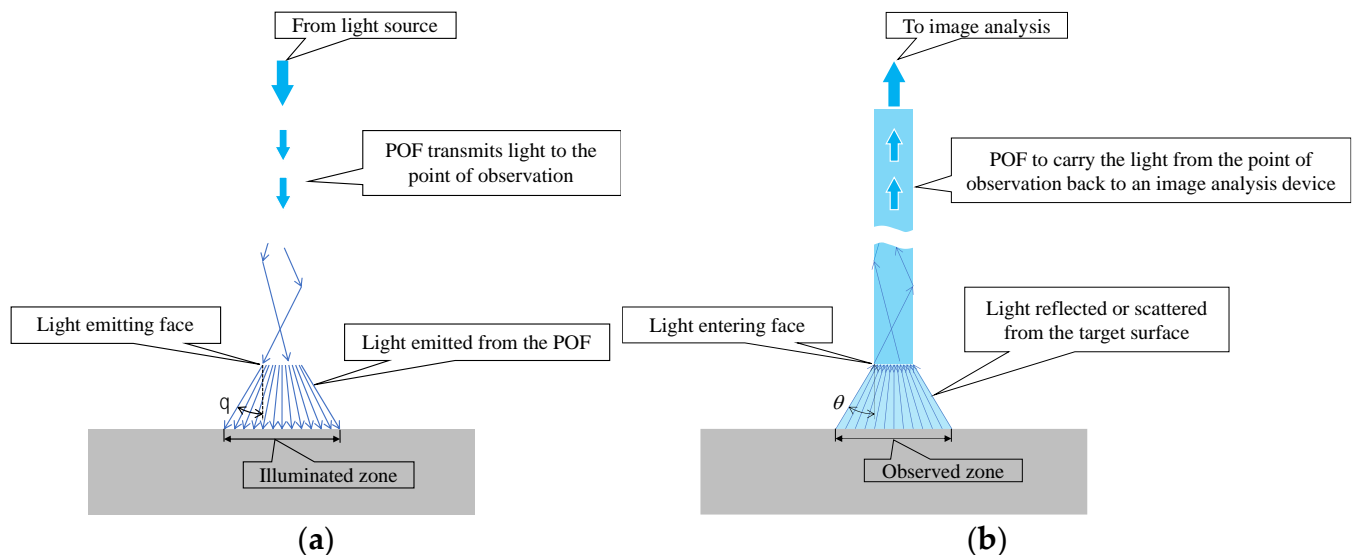
Figure 3. Identification of the illuminated and observed zones with respect to paths of light: (a) Paths of light exiting the POF; (b) Paths of light entering the POF.

Figure 3 illustrates the path of light. Light within the POF was propagated and emitted from the POF tip, spreading to a maximum angle of approximately 30° (with a marginal variation depending on the flatness of the end face), as shown in Figure 3a. It illuminated the surface of the object under examination. Conversely, when the light was reflected or scattered from the object's surface and traveled in random directions, a part of reflected or scattered light followed the path shown in Figure 3b and entered the POF. This light reflected the color of the observed area, which spread with a maximum angle of 30° from the tip of the POF.

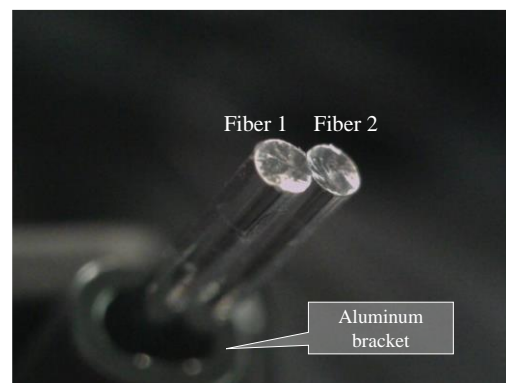
Figure 4. R2 sensor comprising two POF cables with a length of 1.5 m.

Based on the observed light behavior at the POF tip, an introductory experiment employing two POF cables to show a basic and important ability to recognize change in the appearance or color of the observed spots prepared on the surface of the metal plate, was performed. Initially, two POF cables, namely Fibers 1 and 2, were prepared, and their tips were placed adjacent to each other after stripping approximately 20 mm of the insulation (as illustrated in Figure 4). This sensor, comprising two POF cables, was denoted as an R2 sensor. The name arose from its capacity to detect alterations in the condition of an arbitrary object based on the reflection of light from the surface in front of the sensor. As illustrated in Figure 5, circular vinyl tape segments (5 mm in diameter) in black, red, green, and blue colors were fixed to a steel plate (15 mm wide, 38 mm long, and 3 mm thick). Light reflected from the surface of the steel plate (without tape), positioned approximately 3 mm in front of the R2 sensor, was directed onto Fiber 2, establishing an initial state that could be examined from the opposite end of the POF. Subsequently, the steel plate was incrementally shifted to the left, and the reflected light was recorded by Fiber 2 at each stage as the R2 sensor tip passed above the tapes of distinct colors, as shown in Figure 6. The changes in the optical conditions in the area in front of the R2 sensor, primarily related to color changes, were recorded. This suggested that the R2 sensor can identify variations in the optical conditions attributed to metal corrosion.

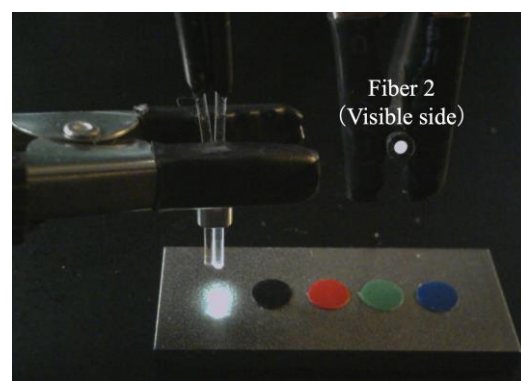
Figure 5. R2 sensor and a steel plate with vinyl tapes of different colors.

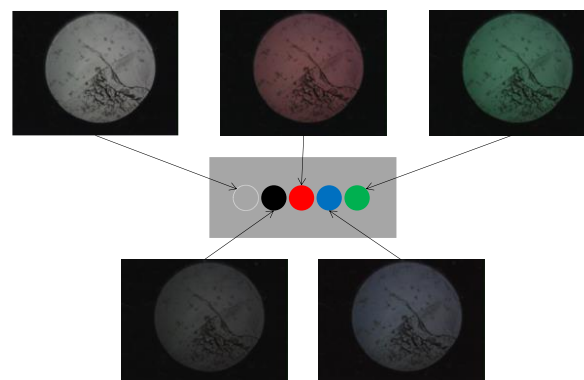
Figure 6. Images of light captured by Fiber 2.

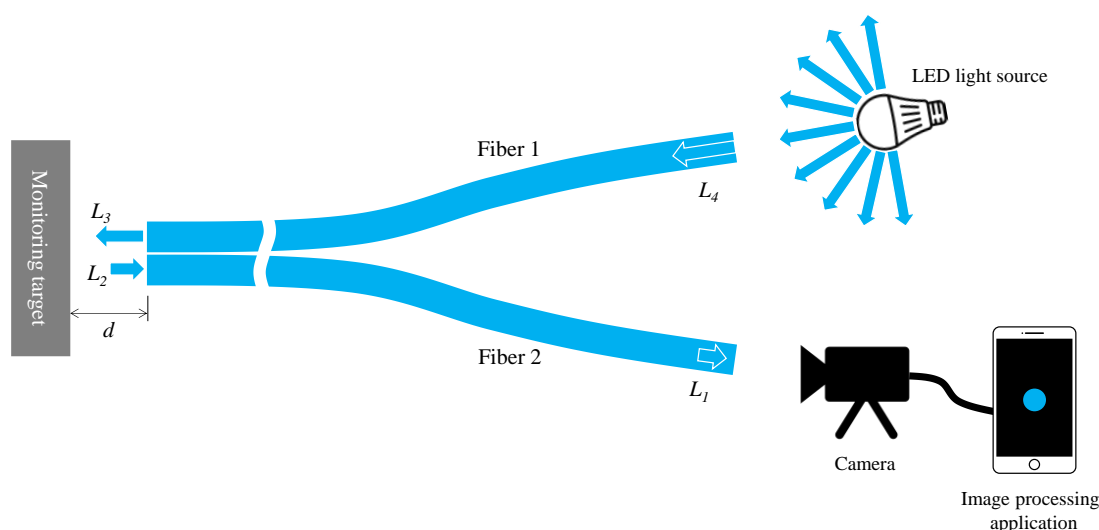
Figure 8. A typical layout of an experimental setup for corrosion monitoring by R2 sensor.

Considering the fundamental components explained earlier, the experimental setup's basic layout for corrosion detection using the proposed R2 sensor is depicted in Figure 8. We first denoted L_4 as the initial light intensity when a segment of emitted light from an arbitrary LED source entered Fiber 1. As this light traversed Fiber 1, reaching the observation point at its opposite end, the light intensity diminished to L_3 (lesser than L_4) due to inherent distance attenuation within the POF's polymer material. Upon reflecting from the object's surface and entering Fiber 2 as L_2 , a fraction of this light contained corrosion-related information. Subsequently, it traveled through Fiber 2, reaching its termination, labeled as L_1 (lesser than L_2) due to identical distance attenuation. This light, captured by a camera, underwent image data recognition via an image processing application on a smartphone. The final light intensity, denoted as L , was calculated following the method detailed in Section 2.5. Drawing from our experimentally-based expertise from the recent study [34], favorable outcomes typically arise when the smartphone records a final light intensity of approximately half or less than the maximum value (around 441). Consequently, during the corrosion detection experiment, adjustments encompassing the light source's brightness, distance from the light source to Fiber 1, POF length, and distance from Fiber 2's right end to the camera were made holistically. This ensured that the final measured light intensity L remained around half or less of its maximum value.

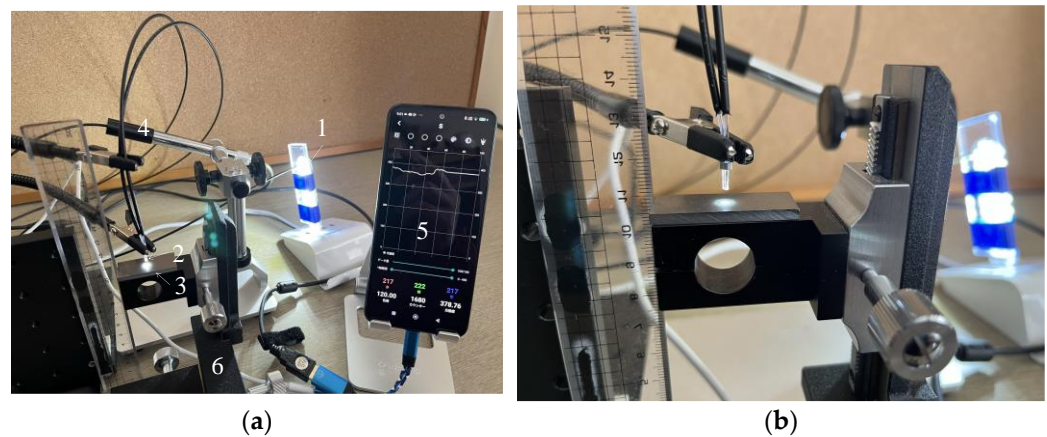
Figure 9. Experimental apparatus used to examine the optimal distance from the R2 sensor to a steel plate: (a) Experimental layout: (1) Light-emitting diode (LED) light. (2) R2 sensor. (3) Steel plate. (4) USB camera (AS ONE Corporation, USB Digital Microscope SDM200). (5) Smartphone with the graphic application software. (6) Three-dimensional stage; (b) Enhanced view of the R2 sensor and the steel plate.

The separation distance, denoted as d , between the R2 sensor and the object must be determined to allow proper observation of a target surface. Ensuring adequate illumination of the observed surface, particularly the area in front of Fiber 2, was crucial for achieving optimal light reflection into Fiber 2. If Fiber 1's tip was positioned too close to the object's surface, the illuminated area would be limited, resulting in reduced light entering Fiber 2. Conversely, placing Fiber 1 too far from the object's surface will diminish both incident and reflected light. Consequently, we have chosen to experimentally determine the optimal distance for Fiber 2 to capture an adequate level of light. Figure 9 shows the experimental scheme used in this investigation, which was based on the concept shown in Figure 8. In this figure, the light emitted from the tip of the R2 sensor (2) was reflected by the surface of the steel plate (3) before entering Fiber 2. Subsequently, the light from the opposite end of Fiber 2 reached the image processing application (5) through a Universal Serial Bus (USB) camera (4). A three-dimensional stage (6) was used to lower the steel strip, while the separation distance, d , was altered from 0 to 6 mm.

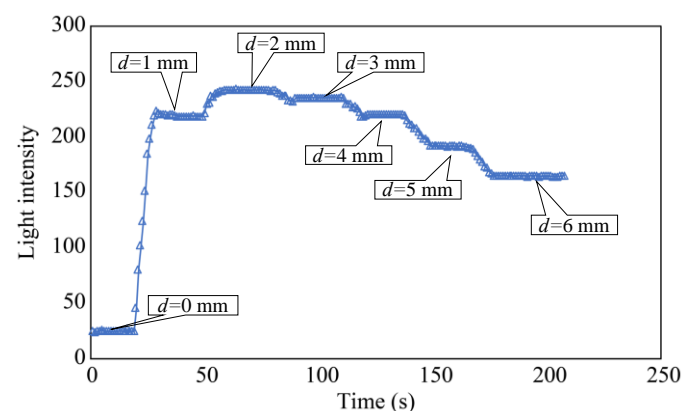
Figure 10. Light intensity recorded as the distance d was varied.

In the initial phase of the plate-lowering experiment, the separation distance, d , was set to zero and maintained for approximately 20 s. Subsequently, d was incrementally increased by 1 mm every 10 s and maintained for approximately 20 s. When d reached 6 mm, it was maintained at this value for approximately 30 s to complete the experiment. Figure 10 shows the light intensity L of the R2 sensor at this point, revealing that L was significantly higher within the range of $d = 2\text{--}3$ mm. Based on this trend, the standard separation distance, d , was determined to be 3 mm. This decision considered the convenience of the fixture used to create a more advanced sensor for subsequent experiments.

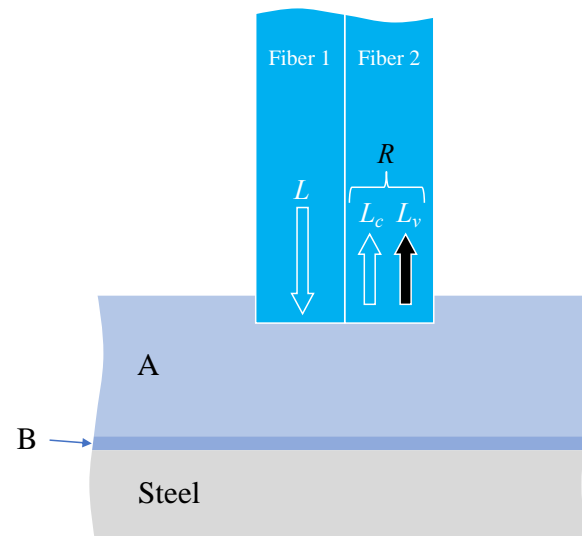
Figure 12. Various light paths associated with corrosion monitoring through two layers of adhesive materials.

The factors considered when attempting to observe corrosion on the surface of a steel plate through two adhesive layers, as illustrated in Figure 12, were explained subsequently. The light was reflected or scattered from the boundary surfaces between adhesive layers A and B, between adhesive B and the steel plate (steel), and from the actual surface of the

Here, L_c denotes the sum of the light scattered from the edge of Fiber 1, and the light reflected and scattered from the boundary between adhesives A and B, which is unrelated to the corrosion of the steel plate. In principle, this value remains constant. Conversely, L_v signifies the light influenced by the corrosion of the steel plate and exhibits variability. Hence, when scrutinizing the light R captured by the image processing application, the state of steel corrosion must be assessed by considering the overall trend of R variation while acknowledging that some light encompasses aspects unrelated to steel corrosion.

The light intensity at the end of the experiment fluctuated within a range of 60–120. Provided that a part of the observed light, described as L_c in Figure 12, remained unaltered throughout the experiment, we can deduce that corrosion byproducts exhibiting subtle variations in hues were consistently present within the observation regions of Fibers 1–6 as the corrosion process neared completion.

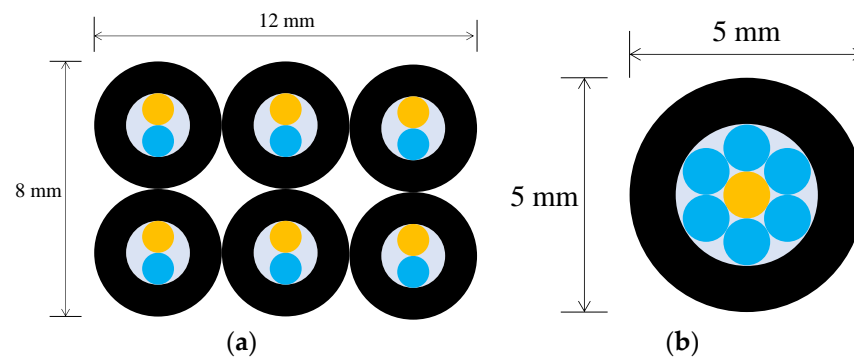
Figure 13. A comparison of two different strategies in the use of light emitting POF depicted by an orange color: (a) A strategy of having a light emitting POF in each R2 sensor; (b) A strategy for sharing a light emitting POF by multiple POFs.

The secondary checkpoint involved closely monitoring the progression of corrosion in the vicinity of each of the sensor installation points within the steel plate. To realize this, employing the previously described R2 sensor would entail utilizing two 1 mm-diameter POF cables within one sensor unit. If the pipes accommodating these POF cables had an inner diameter of 2 mm and an outer diameter of 4 mm, observing 6 locations would necessitate an 8 mm by 12 mm rectangular area (Figure 13a). In this case, the actual observation points would be spaced apart by a few millimeters. By implementing the concept of sharing a single POF illuminating multiple observation points, the arrangement depicted in Figure 13b enabled densely positioning six observation POFs within a circle approximately 5 mm in diameter (corresponding to the outer pipe diameter holding the POFs). This configuration facilitated the acquisition of detailed insights into corrosion progression at multiple contiguous locations in front of a single sensor unit.

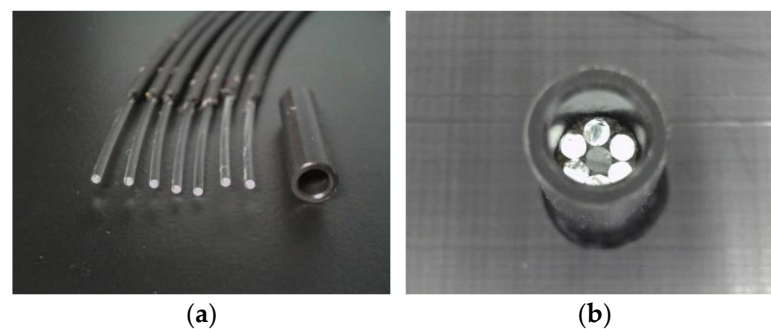
Figure 14. Structure of the R7 sensor: (a) Seven POF cables with a length of 2.5 m and a plastic pipe; (b) Assembled form before injecting adhesive A.

Figure 14 illustrates the preparation of seven POFs placed within a plastic pipe (inner diameter: 3 mm; outer diameter: 5 mm; length: 20 mm). Adhesive A (BD-SKCJ produced by BONDIC), which solidifies under ultraviolet (UV) irradiation, was introduced into the pipe up to a distance of 3 mm from the POF tips. The sensor is denoted as R7, signifying its construction with seven POFs.

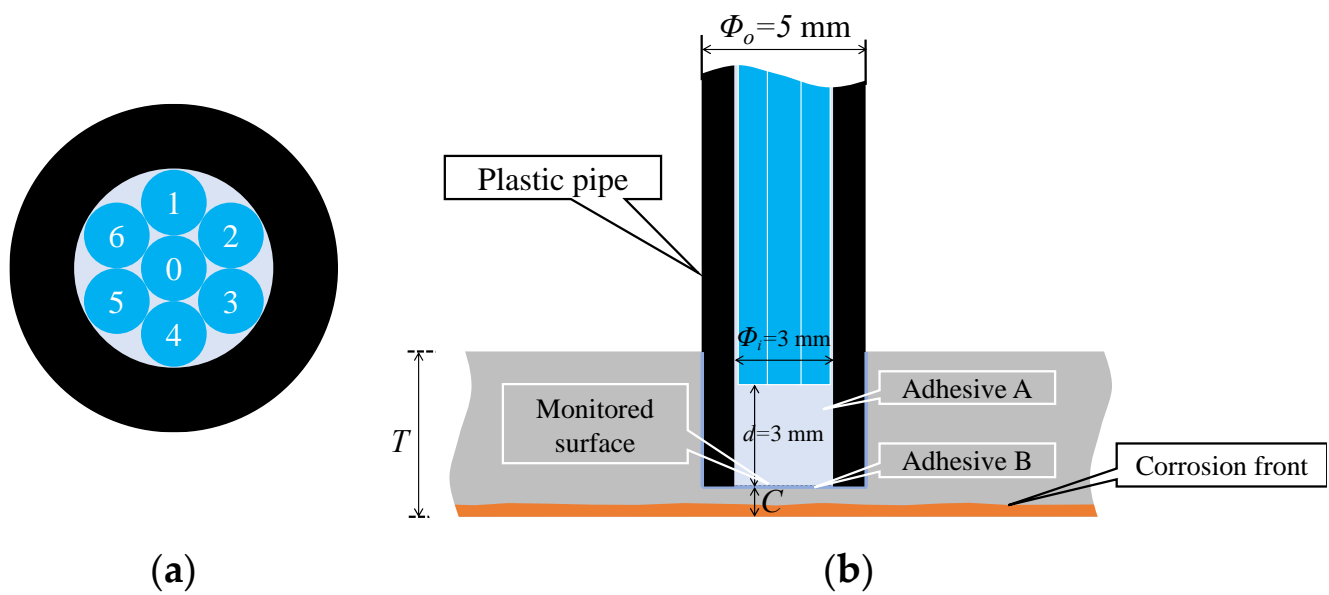
Figure 15. Structure and installation image of the R7 sensor: (a) Cross section; (b) Vertical cross section of the R7 sensor.

Figure 15 shows a detailed perspective of the R7 sensor. The seven POFs were tightly fitted within a plastic pipe with a 3 mm inner diameter, facilitated by the 1 mm diameter of each POF. The centrally positioned Fiber 0 was the light emitter, whereas the surrounding six fibers (Fibers 1–6) captured the light that was reflected and scattered from marginally varied points ahead of the sensor. Using a small quantity of general-purpose instant adhesive B, the R7 sensor was affixed into a 5 mm-diameter hole on the upper surface of a steel plate with thickness T . The R7 sensor facilitated the monitoring of a 3 mm diameter observation area (corresponding to a corrosion depth labeled as C , measured from the underside) to track the state and progression of the upward-propagating corrosion area initiated from the underside of the steel plate.

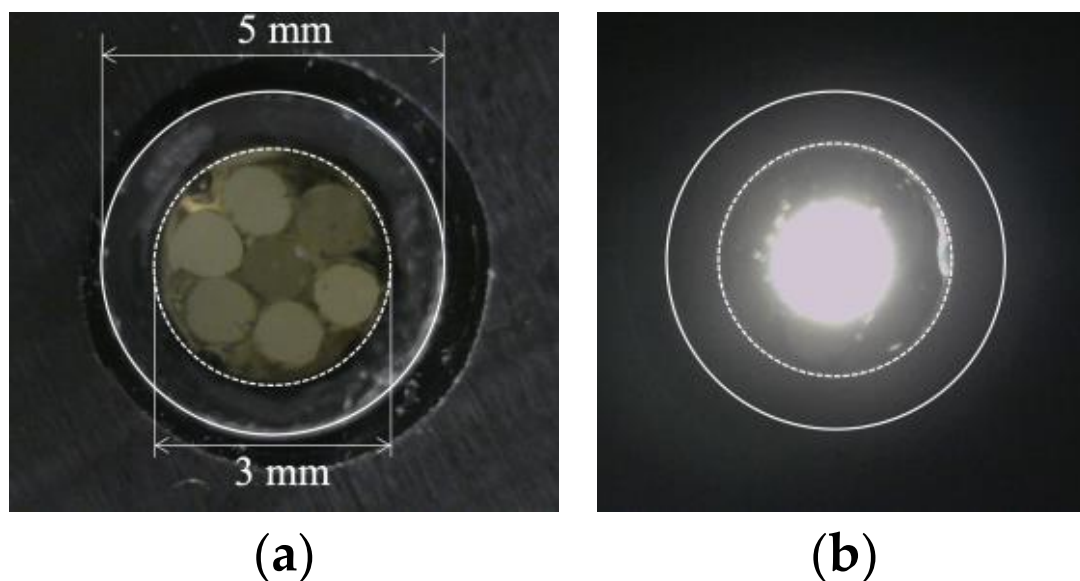
Figure 16. R7 sensor before and after transmitting light through Fiber 0: (a) R7 sensor before sending light into Fiber 0; (b) Zone illuminated by Fiber 0.

Figure 16 shows a frontal close-up of the R7 sensor (Figure 16a) and the state of the R7 sensor when the light was applied only to Fiber 0 (Figure 16b).

Evidently, the light emitted from Fiber 0 evenly illuminated the entire peripheral surface (with a diameter of 3 mm) of adhesive A, with a particular emphasis on a region approximately 2 mm in diameter (referred to as “Area 0”). Figure 17 shows the scenario where each of the surrounding POFs was illuminated, from Fibers 1 to 6. For example, the region designated as “Area 1”, illuminated by the light from Fiber 1, was not perfectly circular. This non-uniformity might be attributed to some of the light emitted by Fiber 1 being reflected by the inner surface of the plastic pipe before reaching the end of adhesive A.

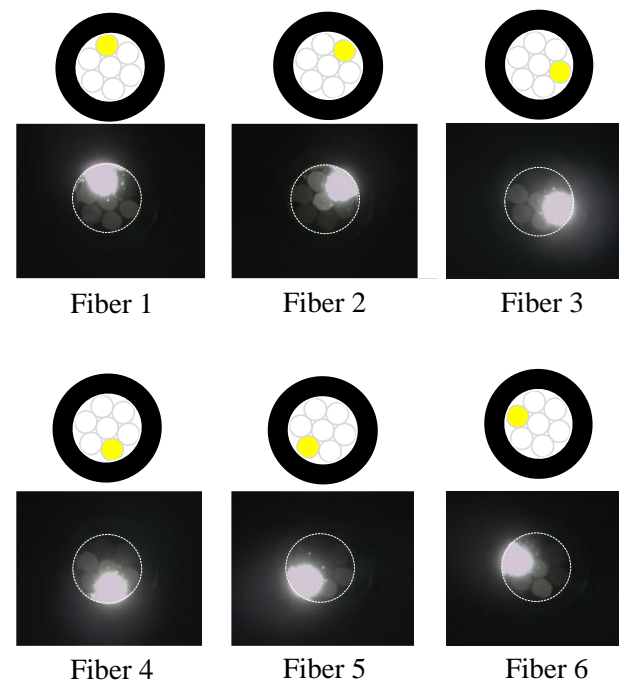
Figure 17. Zones illuminated by Fibers 1 to 6.

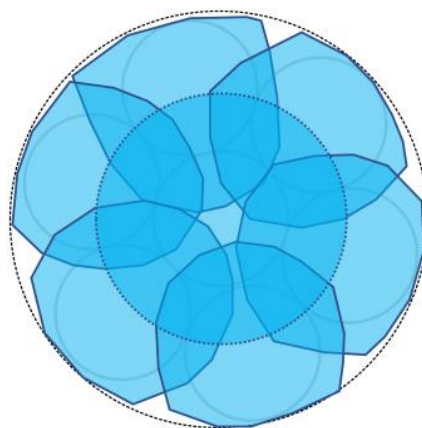
Figure 18. Observation zones for Fibers 1 to 6.

We considered a reverse approach in this context. When the light from Fiber 0 reached Area 0 on the adhesive surface A, some light was reflected or scattered. Among this reflected or scattered light, only the portion directed toward Fiber 1 and overlapping with Area 1 enters Fiber 1. In essence, Area 1 served as both the region where light entered Fiber 1 when it was irradiated and the region from which light in the surrounding areas entered Fiber 1 after being scattered or reflected. Thus, it became the “observed region perceived by Fiber 1”. Similarly, the respective observation areas of Fibers 2–6 could also be defined, as illustrated in Figure 18. This figure illustrates that the light emitted from Fiber 0 at the center could be employed to monitor the entire three-millimeter-diameter observation surface, with some overlap between the observation areas of Fibers 1–6.

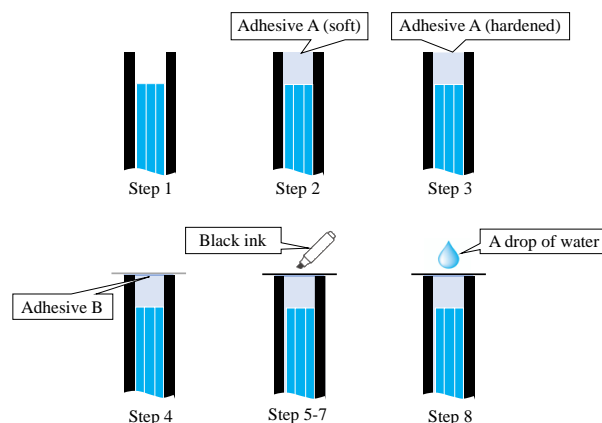
Figure 19. Sequence of actions performed to check the fundamental performance of the R7 sensor.

A simple experiment was conducted in a dark room to verify the functionality of the proposed R7 sensor before conducting the actual steel plate corrosion experiment. This experiment involved nine sequential steps (Steps 0–8) to assess the performance of the R7 sensor at each stage, as shown in Figure 19.

Step 0: Initially, the R7 sensor was incomplete, with only seven POFs inserted into the plastic pipe. The measurement commenced with no obstruction in front of the sensor, and this condition was maintained for approximately 20 s.

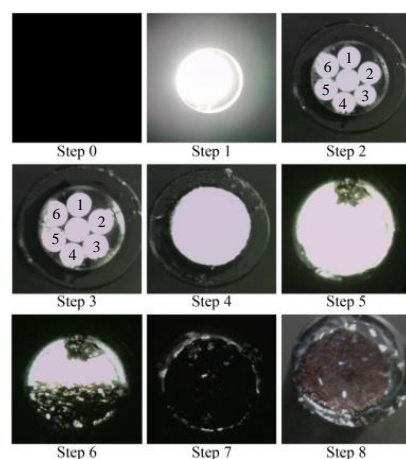
Figure 20. Photographic images of the fundamental experiment.

A detailed record of this process is illustrated in Figure 20. Note that the room lighting was switched on in certain instances, permitting a controlled amount of light to enter the POF within the sensor as needed. This was performed to facilitate the assessment of the sensor tip under specific conditions.

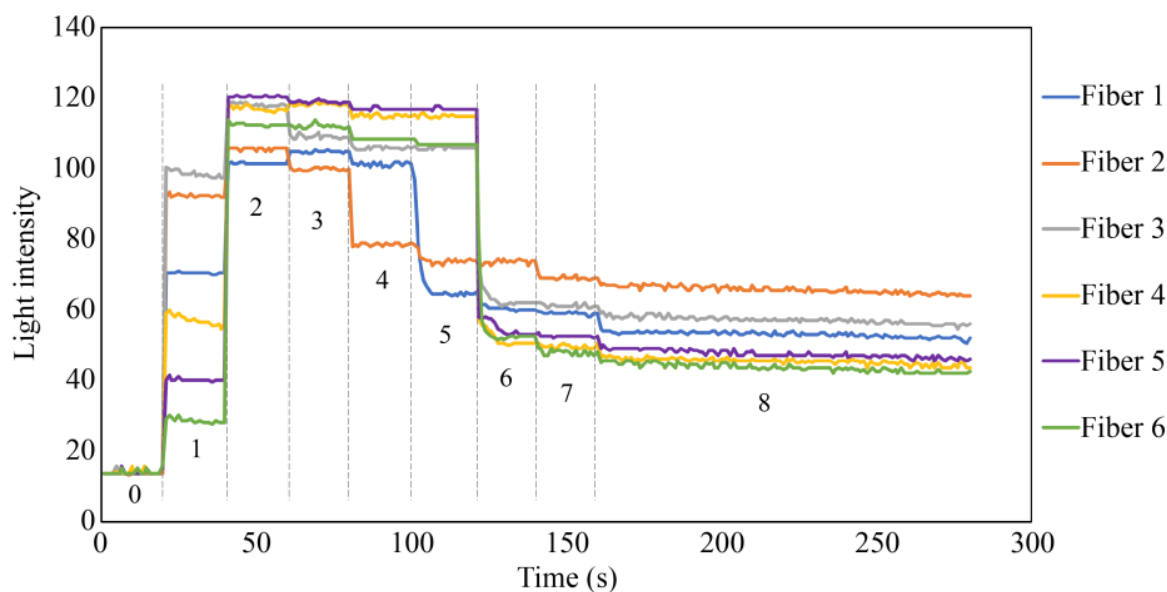
Figure 21. Light intensities recorded by Fibers 1 to 6 in the fundamental experiment.

Figure 21 shows the results of the simulated experiment. In Step 1, the diffused reflected light due to the micro-unevenness in the POF cross section and the plastic inner wall entered Fibers 1 to 6. The considerable variance in light intensity captured by Fiber 1 through Fiber 6 could be attributed to the imperfect flatness of the end faces of the seven POFs. The minor differences in the vertical positioning of the POFs' end faces might also result in each POF surrounding Fiber 0 receiving diffused reflected light of slightly different intensities. In Step 2, the UV-curable adhesive (adhesive A) was applied to the tips of the seven POFs at a depth of approximately 3 mm. Consequently, light was reflected from their surfaces, significantly increasing the light intensity in Fibers 1–6. Subsequently, UV irradiation (the light intensity during irradiation was omitted from the graph because of the significant disturbance) solidified adhesive A, and a subtle change in the refractive index of the light was observed in Step 3.

In Step 4, a small quantity of commercially available instant adhesive B was applied to the upper surface of the solidified adhesive A. On top of this, a piece of paper with a gray underside was positioned. This procedure marginally reduced the light detected by Fibers 1–6 compared to that in Step 3. The initial state following the conclusion of Step 4 was analogous to the initial state in an actual corrosion experiment involving steel plates. The significant reduction in light intensity captured by Fiber 2 at this stage could have occurred due to the imperfectly flat edge surface of adhesive A and the boundary surface between adhesive B and the paper, attributed to the sensor's handmade nature. Additionally, microscopic unevenness of the paper surface may potentially complicate light reflection and dispersion, resulting in varied light intensity levels received by Fibers 1 to 6, not necessarily equating in intensity.

In Step 5, a tiny dot was marked near the observation area of Fiber 1 using a black oil-based marker pen. In Step 6, approximately one-half of the area opposite the black dot corresponding to the space covered by Fibers 3–5 was filled in with the ink of the marker pen. In Step 7, the remaining areas were covered by the black ink, making the entire underside of the paper black. Throughout Steps 5–7, the light intensity in Fibers 1–6 decreased, corresponding to the blackened areas. Finally, to assess the impact of moisture, a water droplet was applied to the paper, allowing it to permeate through the paper. The light intensity in Fibers 1–6 was marginally reduced owing to this effect, confirming that the light intensity exhibited minor fluctuations owing to moisture, even when the color in front of the sensor remained constant.

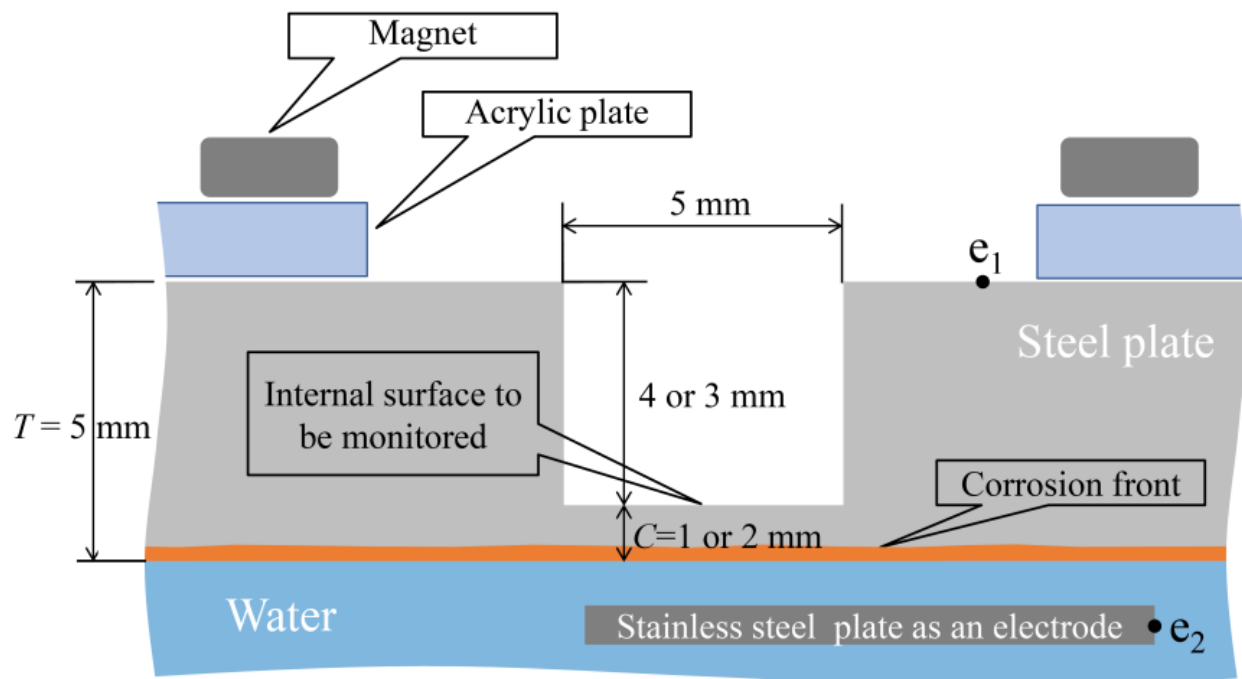
Figure 22. Fundamental strategy for the corrosion test.

In the corrosion experiment involving an aqueous solution system, a 5 mm-thick SS400 steel plate whose lower surface was submerged in water was utilized, as shown in Figure 22. The corrosion initiation on the lower side of the plate could be observed using this setup; thus, the upward propagation of corrosion could be tracked till a designated corrosion thickness (1 or 2 mm) was attained. Multiple observation holes with diameters of 5 mm and depths of 3 or 4 mm were incorporated into the upper surface of the steel plate to facilitate this. Some holes were equipped with R7 sensors, whereas others were left without a sensor to enable direct visual observation from above. Under these conditions, points e_1 and e_2 , as shown in the figure, were linked to a DC electric circuit to conduct the electric corrosion test. The setup involved the preparation of an acrylic jig, onto which a neodymium magnet was affixed. This magnet secured the steel plate to a predetermined height.

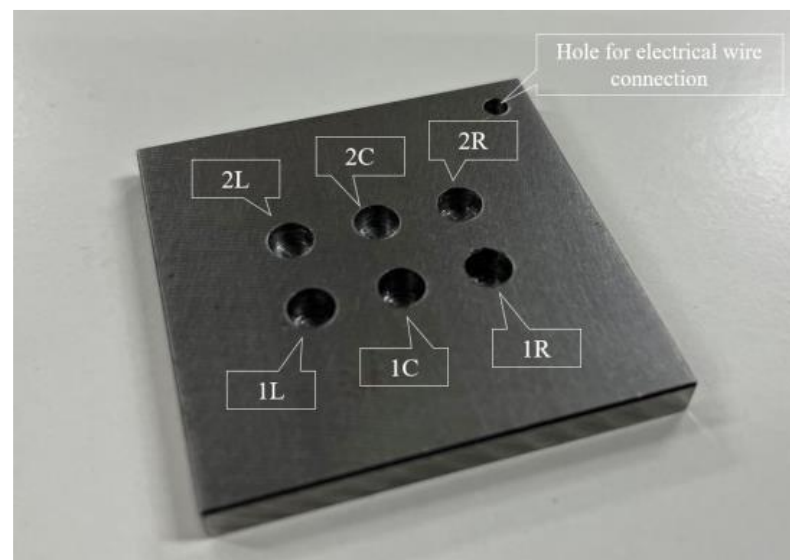
Figure 23. Steel plate used for the corrosion test with 6 holes for either POF sensor installation or direct visual observation. The depths of holes 1L, 1C, 1R are 4 mm; therefore, the remaining thickness of steel to be corroded is 1 mm. The depths of holes 2L, 2C, 2R are 3 mm; therefore, the remaining thickness of steel to be corroded is 2 mm. To make these holes, a drill bit with flat end was used.

Figure 23 shows a steel plate measuring 50 mm × 50 mm × 5 mm composed of observation holes with unique notations. In each notation, the number denoted the thickness (in mm) of the steel plate remaining below the holes, while the letter signifies the location, where “L”, “C”, and “R” represented the left, center, and right sides, respectively. The thicknesses of the remaining steel plates, where the R7 sensor was installed, were deliberately set at 1 mm and 2 mm, respectively. This setup aimed to enable accurate detection of the corrosion depth precisely as it reached these individual thicknesses with a certain corrosion rate determined by a given set of experimental environments. The R7 sensors were positioned at 1R, 1L, 2R, and 2L among the six observation holes. In contrast, 1C and 2C were left open because these holes were designated for visual observation and image recording. The positions and cross-sectional views of the observation holes are shown in Figure 24.

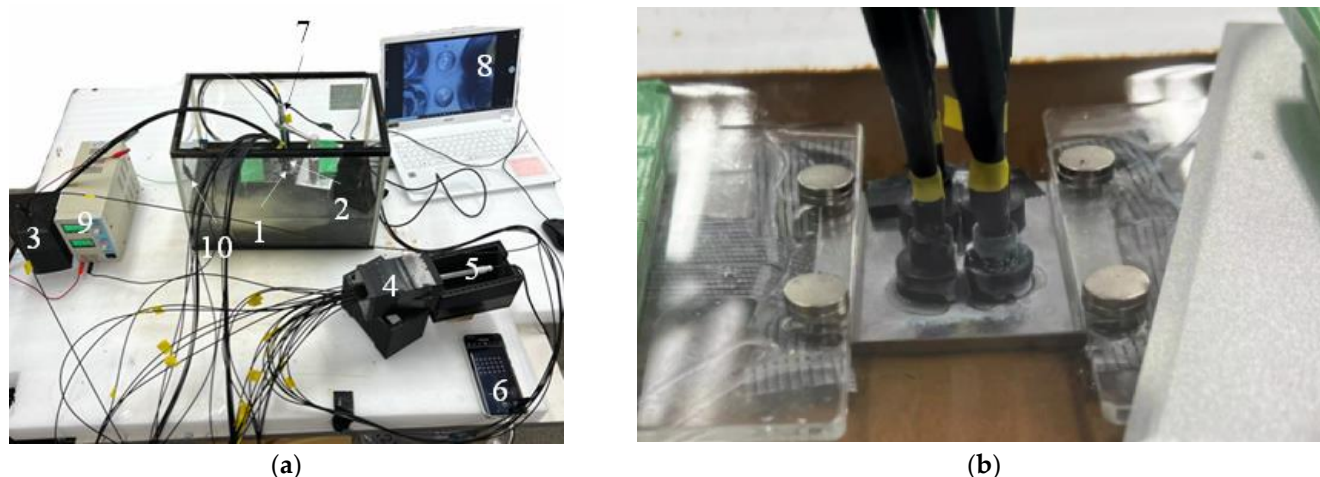
Figure 25. Overall layout of the plate corrosion test and a closer view of the plate: (a) Experimental configuration for the plate corrosion test: (1) Steel plate to be corroded. (2) R7 sensors. (3) Box containing an LED light source. (4) Box containing POE cables from the R7 sensors. (5) USB camera to capture images of the POE cables. (6) Mobile phone for graphic image analysis. (7) USB camera to observe the open holes. (8) PC for confirming and recording images of the open holes. (9) Direct current control unit. (10) Stainless steel plate; (b) Closer view of the sensor installation on the plate.

Figure 25 shows an overview of the complete experimental setup, featuring the steel plate with the R7 sensor installation. A 600 mm-wide, 300 mm-deep, and 400 mm-high glass container was filled with a 5% saline solution. Approximately half of the 5 mm-thick steel plate (1 in Figure 25a) was submerged in the saline solution. The R7 sensors were affixed to the top surface of the steel plate over observation holes 1R, 1L, 2R, and 2L using adhesive B. Light was transmitted from a white LED light source (3) to Fiber 0, which was positioned at the center of each R7 sensor. The light captured by the remaining six fibers was directed into a light-tight enclosure (4) that was designed to block external light and record internal light. Simultaneously, a USB camera (5) captured the images, which were then transmitted to a smartphone (6) equipped with the image processing application.

Another USB camera (7) was positioned above the observation holes 1C and 2C, which were left uncovered for visual observation to monitor the bottom of each hole. The resultant images were recorded on a PC (8). Moreover, a device designed to deliver DC for the electrolytic corrosion test (9) was configured. An electrical circuit was established by connecting the electrodes from this device to the steel plate, and the stainless steel plate (10) was immersed in the saline solution.

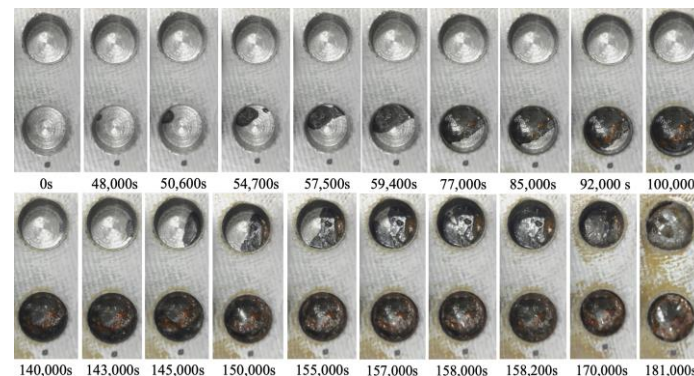
Figure 26. Images recorded at the open holes showing the progress of corrosion.

After the initial preparation, the electrolytic corrosion test was conducted at 30 V. It was concluded after approximately 50 h and 39 min (182,320 s) when satisfactory corrosion was confirmed in observation hole 2C, with a corrosion depth of 2 mm. Figure 26 shows the images captured at various stages of the corrosion experiment in observation holes 1C and 2C, which were designated for visual observation. The lower and upper photographs show 1C (thickness: 1 mm) and 2C (thickness: 2 mm), respectively. Approximately 48,000 s into the experiment, a black area appeared on the upper left shoulder of 1C, signifying the onset of a part of the corrosion front originating from the underside of the steel plate at a corrosion thickness of 1 mm. The corrosion area expanded and connected with a black area that surfaced on the upper right side. At 59,400 s, approximately half of the bottom of the hole was corroded. At 77,000 s, a brown area emerged within the corroded region and grew alongside the black area. At 100,000 s, the entire bottom of the borehole was corroded. Borehole C1 exhibited continuous development of black and brown corrosion products, reflecting the actual progression of the aqueous solution-based corrosion experiment.

Conversely, at 140,000 s, a corrosion zone emerged on the right side of 2C. The space occupied by the black and brown corrosion products increased, ultimately enveloping the entire area of 2C at 158,200 s. This indicated an ongoing escalation of corrosion products until the final stage.

Based on these visual observations, the times required to identify the initial corroded area in boreholes 1C and 2C with corrosion thicknesses of 1 and 2 mm were 48,000 and 140,000 s, respectively, indicating different corrosion thicknesses. Subsequently, the time taken for the corrosion zone to encompass the entire area, following its initial observation at the base of the borehole, was 52,000 and 18,200 s at 1C and 2C, respectively. These findings confirmed the fundamental corrosion initiation and propagation patterns observed in this

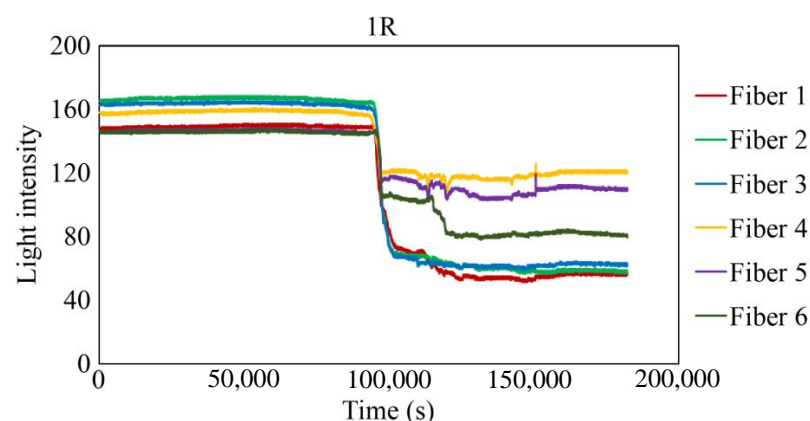
Figure 27. Light intensities recorded for the R7 sensor installed in 1R.

The behavior recorded by the R7 sensor in observation hole 1R is shown in Figure 27. Immediately after the commencement of the experiment, a consistent level of light was captured by Fibers 1–6. The light emitted from Fiber 0 penetrated the two adhesive layers and was reflected from the steel surface at the base of the observation hole 1R, providing stable measurements. Subsequently, within a specific timeframe preceding 100,000 s, the light intensities in Fibers 1–6 exhibited diminishing trends, albeit to varying degrees, and then remained somewhat unstable until approximately 150,000 s. Throughout this interval, the light intensities of Fibers 1 and 6 were unstable, particularly that of Fiber 6. This period is presumably influenced by corrosion byproducts, indicated by a blend of black, brown, and other hues, and possibly water, generated by the ongoing corrosion process. Moreover, the light intensities generally stabilized beyond 150,000 s, signifying that the conditions in front of Fibers 1–6 became steady and independent of the progression of corrosion.

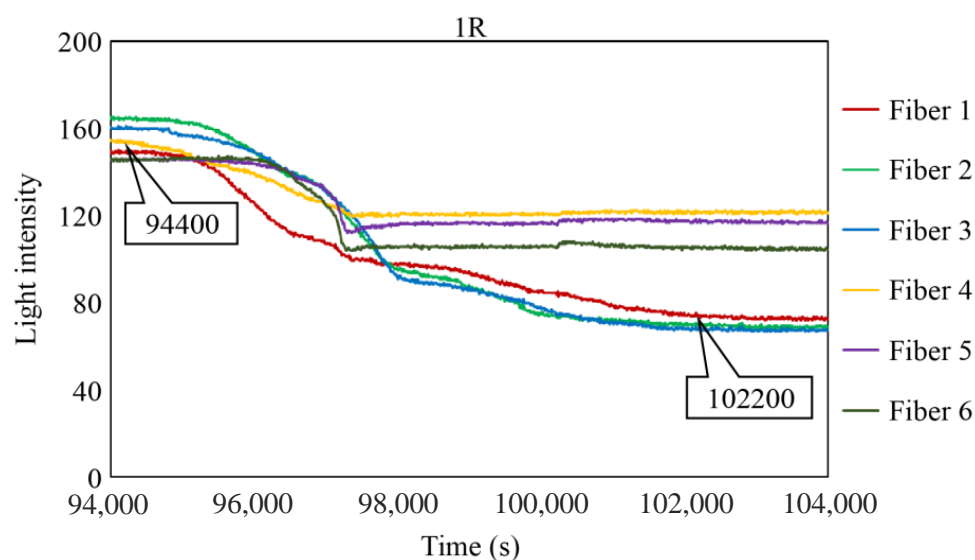
Figure 28. Light intensities recorded by the R7 sensor installed in 1R from 94,000 to 100,000 s.

To scrutinize the precise timeframe when the corrosion front reached the base of borehole 1R, the interval from 94,000 to 104,000 s was meticulously examined, and the results are shown in Figure 28. The figure illustrates scenarios in which the reduction in light intensity occurred at varying paces; for example, Fibers 1 and 4 experienced a relatively gradual decrease, whereas Fibers 5 and 6 exhibited a swift decline. Among the six fibers, Fiber 4 exhibited the earliest decrease in light intensity with an estimated elapsed time of approximately 94,400 s, denoted as C_i , signifying the earliest corrosion area coverage in this observation hole. The decline in light intensity progressed within each observation fiber, and the point at which the diminishing trend was presumed to have mostly halted was labeled as C_f , occurring at approximately 102,200 s in Fiber 1. Consequently, the concurrent reduction in light intensity was construed as a progression wherein the corrosion front initially reached a specific point on the borehole bottom in 1R and then subsequently spread across the entire borehole bottom within a timeframe of ΔT_c ($= C_f - C_i$), which was approximately 7800 s in the case of 1R. Notably, this duration was significantly shorter than the corresponding periods in boreholes 1C ($\Delta T_c = 52,000$ s) and 2C ($\Delta T_c = 18,200$ s), suggesting the formation of a relatively uniform corrosion front within the circular area of 3 mm diameter that was monitored by the R7 sensor installed in 1R.

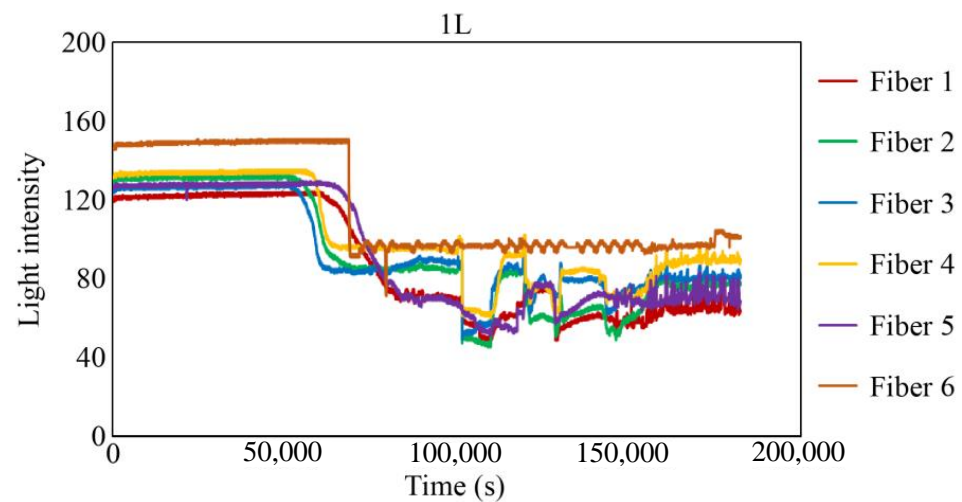
Figure 29. Light intensities recorded by the R7 sensor installed in 1L.

Figures 29–31 show the light intensity results recorded in additional observation holes, namely, 1L, 2R, and 2L. In 1L, the light intensity in certain fibers decreased considerably earlier than in 1R despite having the same corrosion thickness. Subsequently, the light intensity exhibited irregular fluctuations during the simultaneous decrease and in the subsequent period, where it fluctuated but remained stable. This suggests that the generation of corrosion products near observation hole 1L was highly intricate. The irregular light intensity fluctuations persisted until just before the experiment concluded. In boreholes 2R and 2L, where the corrosion thickness measured 2 mm, a simultaneous decrease in light intensity occurred around 150,000 s, followed by stabilization. Figures 32–34 provide magnified images of the period during which the simultaneous light intensity reduction occurred in 1L, 2R, and 2L. These boreholes exhibited corrosion areas appearing at marginally different times in various locations, indicating the recording of the corrosion development process.

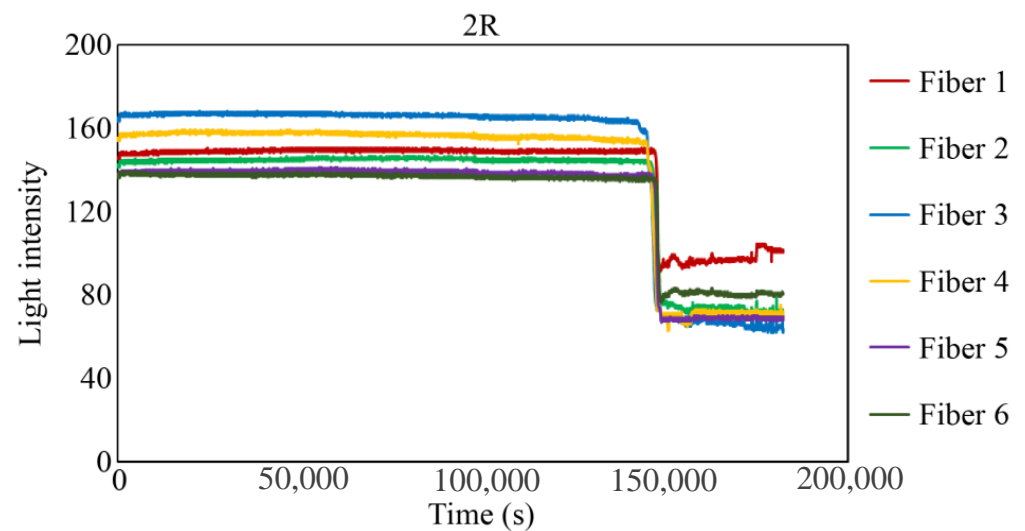
Figure 30. Light intensities recorded by the R7 sensor installed in 2R.

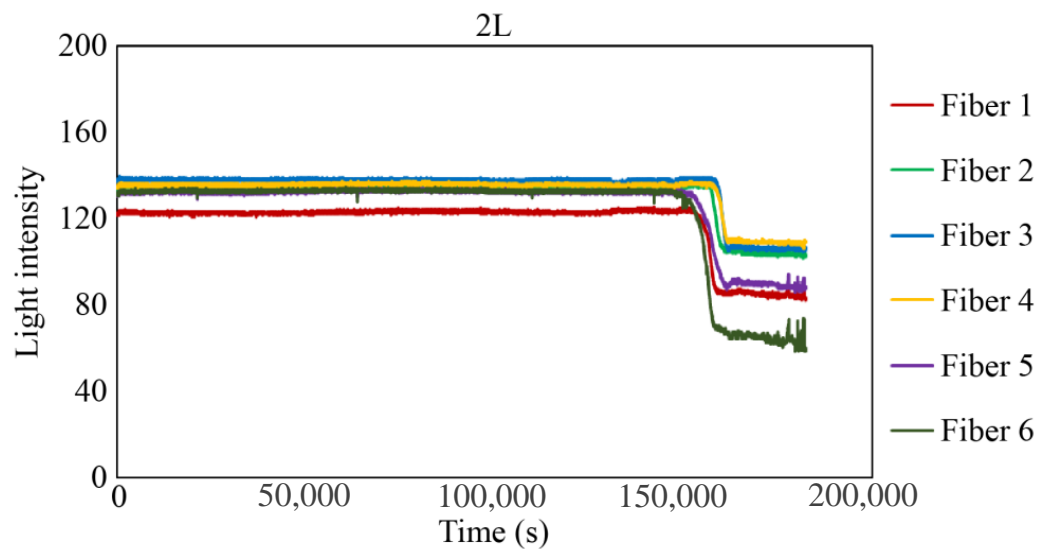
Figure 31. Light intensities recorded by the R7 sensor installed in 2L.

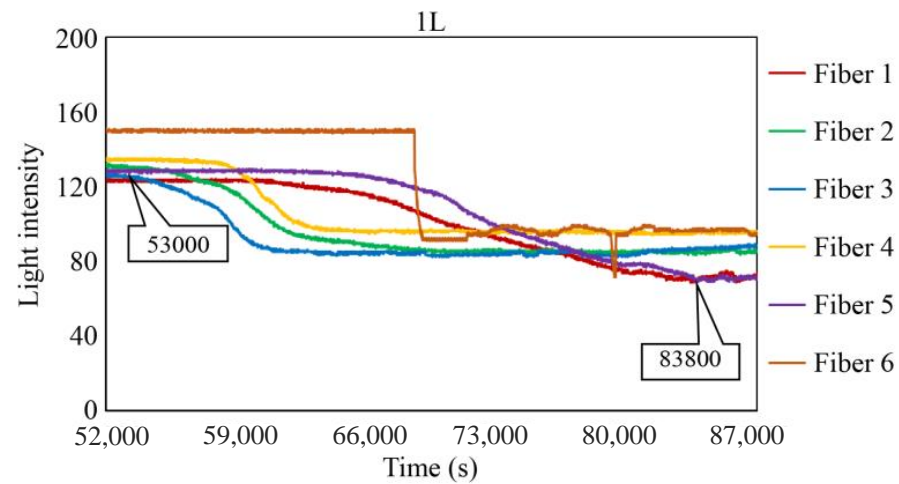
Figure 32. Light intensities recorded by the R7 sensor installed in 1L from 50,000 to 78,000 s.

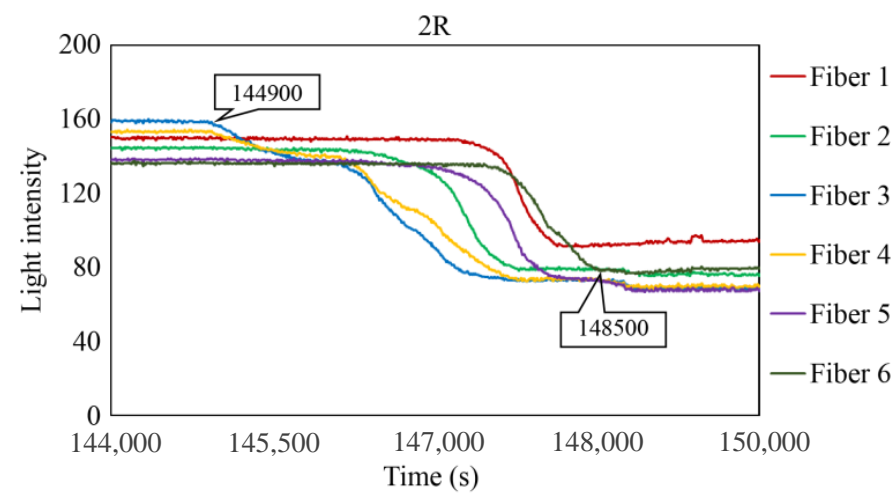
Figure 33. Light intensities recorded by the R7 sensor installed in 2R from 144,000 to 149,000 s.

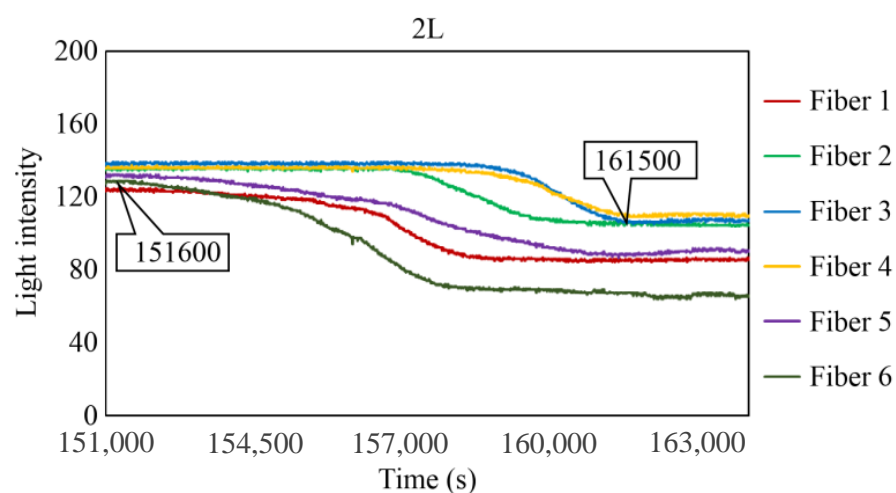
Figure 34. Light intensities recorded by the R7 sensor installed in 2L from 152,000 to 164,000 s.

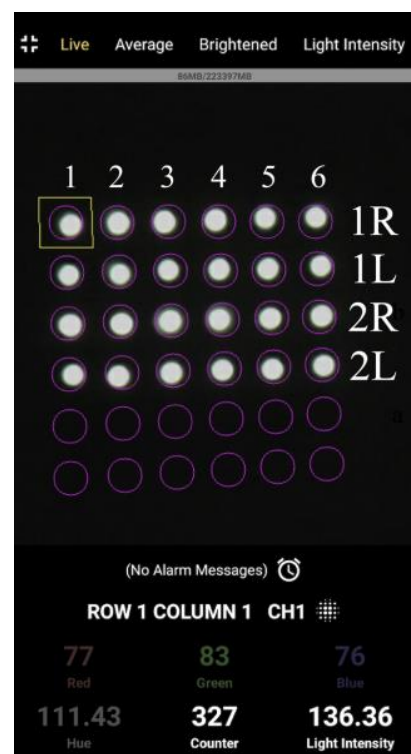
**Figure 35.** Screenshot image of the light observed for R7 sensors at the beginning of the test.

The focus of the analysis up to this point had been the light intensity captured by the R7 sensor. However, this section described the image processing application utilized, which could capture screenshots (Figure 35) showing the conditions of the POFs during monitoring. In this screenshot, the top row shows six lights representing Fibers 1 (leftmost) to 6 (rightmost) of the R7 sensor installed at observation hole 1R. In contrast, the second, third, and fourth rows correspond to observation holes 1L, 2R, and 2L, respectively.
