Experimental Investigation for Monitoring Corrosion Using Plastic Optical Fiber Sensors

Keywords: corrosion detection; color change; plastic optical fiber sensor; graphic image analysis

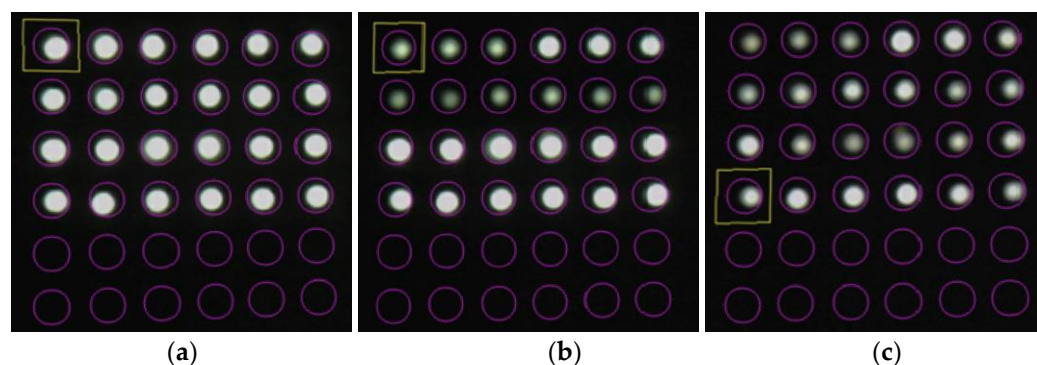
Figure 36. Screenshot images of the light observed for R7 sensors during the test: (a) 0 s; (b) 107,000 s; (c) 181,000 s.

Figure 36 shows screenshot images recorded at the start of the experiment (elapsed time: 0 s), when the corrosion thickness was believed to have surpassed 1 mm (elapsed time: 107,000 s), and after the experiment (elapsed time: 181,000 s).

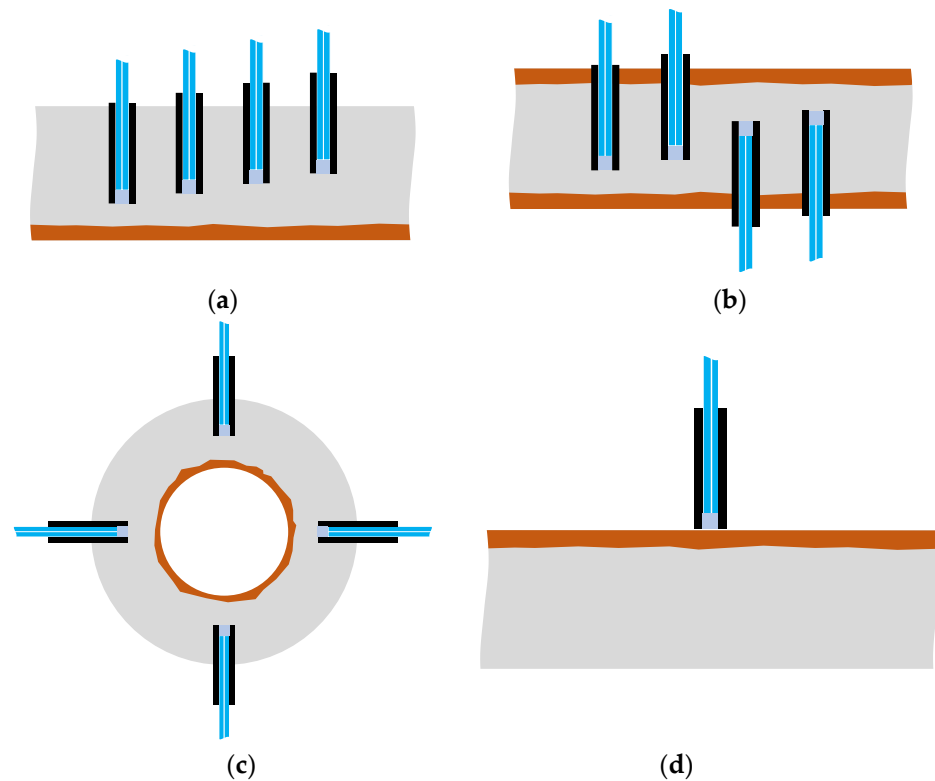
Figure 37. Various configurations for corrosion monitoring using POF sensors: (a) R2 sensors for monitoring the progress of corrosion at multiple depths; (b) R2 sensors for monitoring the progress of corrosion from two directions; (c) R2 sensors for monitoring the progress of corrosion in pipes; (d) R2 sensor to be used for corrosion detection on the surface of a plate.

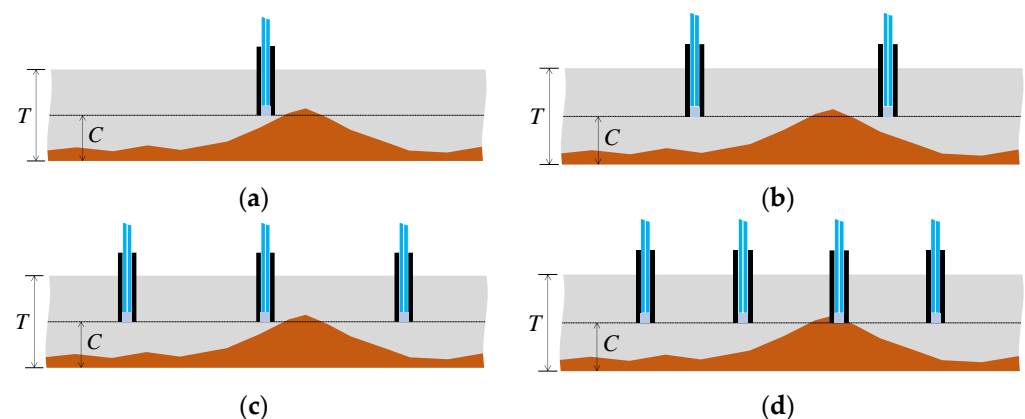
Figure 38. Monitoring strategy comparison with uneven progress of the corroded region: (a) Monitoring with 1 sensor; (b) Monitoring with 2 sensors; (c) Monitoring with 3 sensors; (d) Monitoring with 4 sensors.
