# Effect of Degraded Characteristics of Corroded PC Steel Strands on Prestressed Concrete Beams under Static and Fatigue Loads

# Doctoral Dissertation

Graduate school of Engineering  
Kobe University

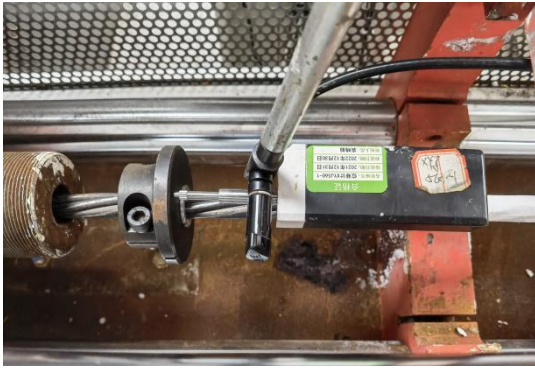
Fig. 2.4 Steel plate and displacement sensor

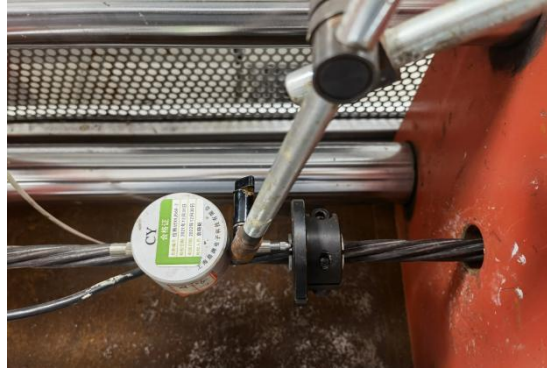
Fig. 2.5 Anchor device

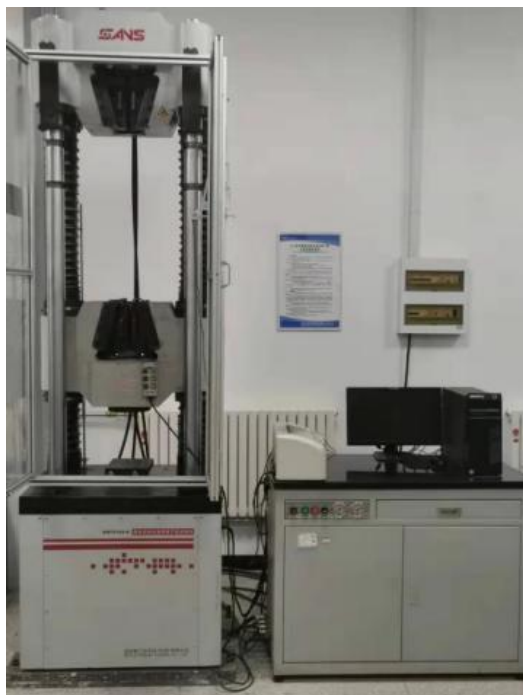
Fig. 2.6 SHT4106G microcomputer control electro-hydraulic servo universal testing machine

A tensile loading test was carried out on 9 steel strands which showed without fracture during the previous corrosion test. The electric hydraulic servo universal testing machine as shown in **Fig. 2.6** was used to tension the steel strand. To facilitate the tensile test, the test strands were cut to 1000 mm (including the corroded section) and protected at both ends with clamps. In the tensile test, two end sides of the strand are held by the grip. If the grip wedge contacts, the surface of a strand directly, crack can be propagated from the wedge earlier than the tensile strength of the wire due to stress concentration. For this reason, Kim et al. (2014) suggested to wrap the end parts with a silica-coated aluminum sheet to protect the end parts. This method was adopted in this study. The loading speed was controlled by displacement, and was set at a rate of 1 mm/min. The load data was automatically read by the tension tester.

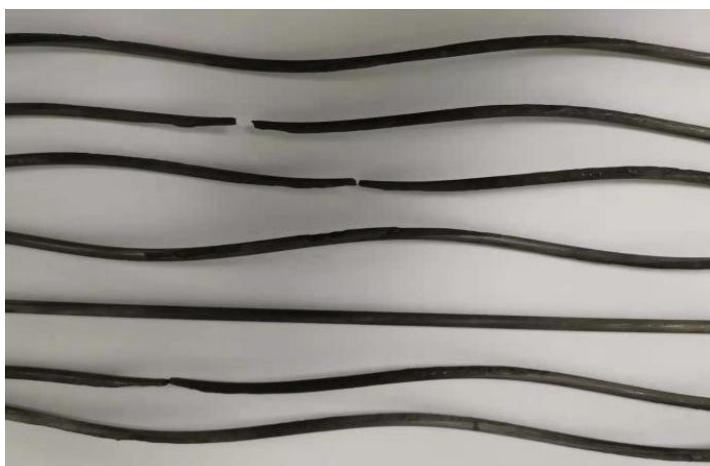
Fig. 2.7 Disassembled corroded steel wires

Strand was considered to reach the ultimate tensile force once the steel wire was reputed as stipulated in the Chinese Standard (China GB/T 5224-2014 2014). The failure modes of specimens with different corrosion degree were compared to investigate the fracture mode of steel wire under different corrosion losses. The relationship between the ultimate tensile strength and corrosion degree curve was drawn to summarize the effect of corrosion on the tensile capacity of the strand. For the steel strand failed in tension test, the corroded section was re-intercepted after test, cleaned with 12% hydrochloric acid, and measured the weight to calculate the mass loss of the corroded steel wires. The tested wires in the PC strand are shown in **Fig. 2.7** as a sample.

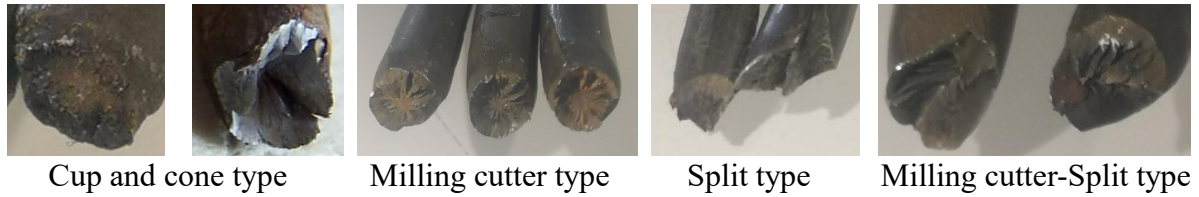
Fig. 2.10 Fracture type of corroded steel wires

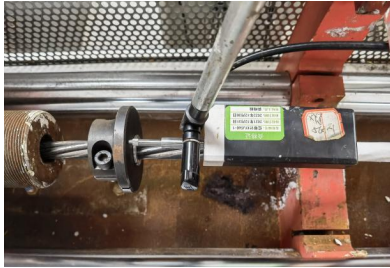
Fig. 2.21 Steel plate and displacement transducer

tank were sealing and the non-corroded section of the strand was wrapped with adhesive tape to prevent the solution from flowing out along the pores inside the strand. The strand on both sides of the corroded part was fixed steel plates and displacement transducers were set to measure the change in elongation of the strand during corrosion, as shown in **Fig. 2.21**. The initial distance of the displacement transducers was set as 1000 mm. The distance between the two anchor points before tension was 1300 mm, and the anchorage device was shown in **Fig. 2.22**. Before corrosion test started, the outer ring wires of the strand were marked and numbered as No.1 to No.6, and strain gauges were pasted on the uncorroded section of the outer ring wire between the displacement transducers, as shown in **Fig. 2.23**. Six gages on the right and three gages on the left as a supplement was set to measure the strain change in each wire of the outer ring during corrosion.

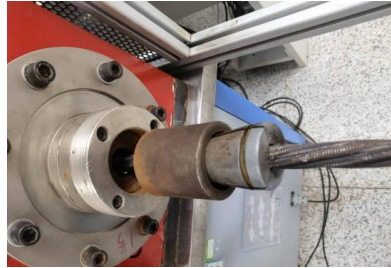
Fig. 2.22 Anchorage device

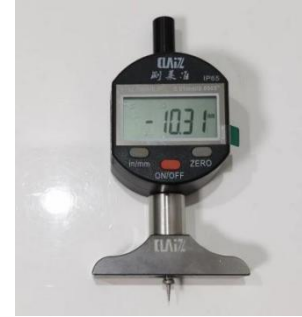
Fig. 2.25 Depth measuring instrument

The mass loss and maximum cross-sectional loss of a strand or a wire are generally the two main parameters to reflect the corrosion level. The mass loss can be directly weighed and calculated, while the maximum cross-sectional area loss was measured and calculated by using the method of Jeon et al.<sup>[18]</sup>. The method calculates the cross-sectional area loss of the strand by measuring the corrosion depth, and divides three types of corrosion pitting as shown in Fig. 2.24. Vecch<sup>[22]</sup> used 3D scanning technology to verify this method, and found that the calculated results are very close to the size of the actual cross-sectional area loss. The depth of the strand corrosion pitting was measured by means of an instrument shown in Fig. 2.25. The loss of sectional area can be calculated through Eqs. (2.8) to (2.13).

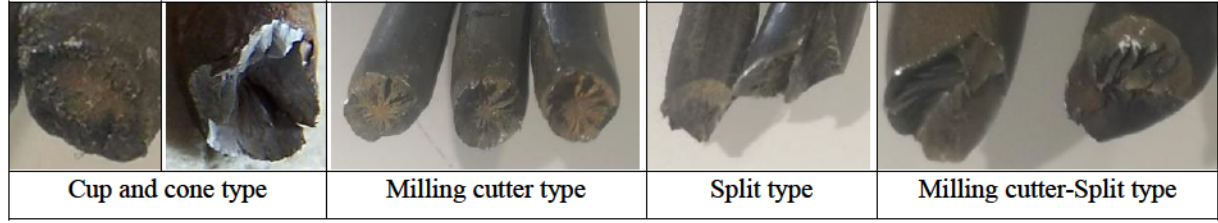
Fig. 2.27 Fracture type of corroded steel wires<sup>[47]</sup>

The failure modes of the ruptured steel strand during the corrosion test are analyzed. The fracture of wires is a sign of failure of PC strands, the conditions of the 9 fractured wires in the 6 corroded strands are summarized in **Table 2.9**. All the fracture types can be divided into three basic fracture types: cup and cone type, milling cutter type, split type, and their combination. Macroscopic photos of various fracture type are shown in **Fig. 2.27**, and those pictures were taken in previous study<sup>[47]</sup>. The necking phenomenon appeared near both the cup and cone fracture type and the milling cutter fracture type (the necking degree of the cup and cone type is relatively light), which shows ductile failure. There is no obvious necking phenomenon near the split type and split-milling cutter type, which shows brittle failure. It can be found from Table 4 that the fracture types of 50-10-1, 50-10-2, and 50-10-5 are all the milling cutter type, with a more obvious necking phenomenon belonging to ductile failure.

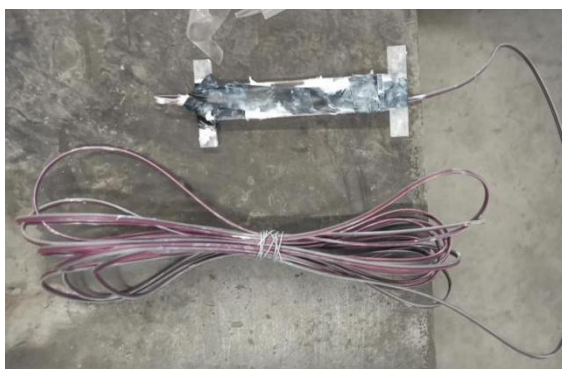
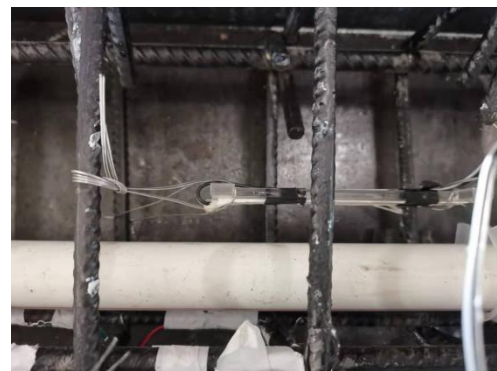
(a) 'I' plastic plate with concrete strain gage

(b) Install in reinforcement cage

Fig 3.2 Embedded concrete strain gage

The reinforcement cage was tied. To prevent corrosion of the longitudinal bars and hoop reinforcement during the test, anti-corrosion paint was applied to the surface of the cage after tying as shown in Fig 3.3. To measure the internal strain in the concrete, 100aa strain gauges were attached to the plastic 'I'-plates and the surface was covered with waterproof structural adhesive to prevent damage to the gauges during casting as show in Fig 3.2. After the pour was completed, the 'I' plastic plate was embedded in the concrete and deformed as the concrete deformed. The corrugated pipe was not buried inside the test beam to prevent the strand from being difficult to corrode. After the tied cage was formed, a 2.5m long, 32mm diameter pvc pipe was fixed to the position of the strand and then casted. After the concrete had first set, the pvc pipe was pulled out to form the prestressing strand aperture. Tension is applied at one end and the age of the concrete exceeds 28 days at the time of tensioning. The tensioning end and the anchoring end are simultaneously pre-buried with a steel mat to withstand the local pressure. Strain gauges affixed to the outer ring of the strand were attached to the strand before tensioning and tested for strain changes during the tensioning process. The tensile prestress  $\sigma$  was taken to be 915 MPa for all test beams, which is approximately 50% of the yield stress. Finally, grouting was carried out and the results are shown in Fig. 3.4

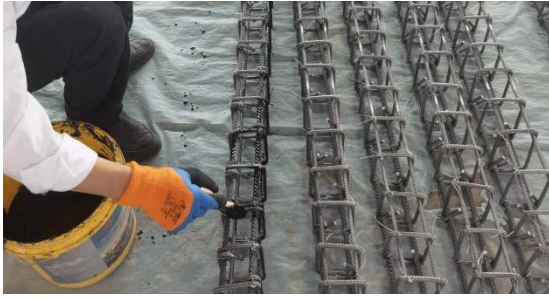
Fig. 3.3 Anti-corrosion paint is applied

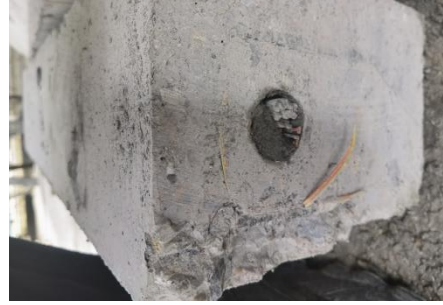
Fig.3.4 Grouting condition

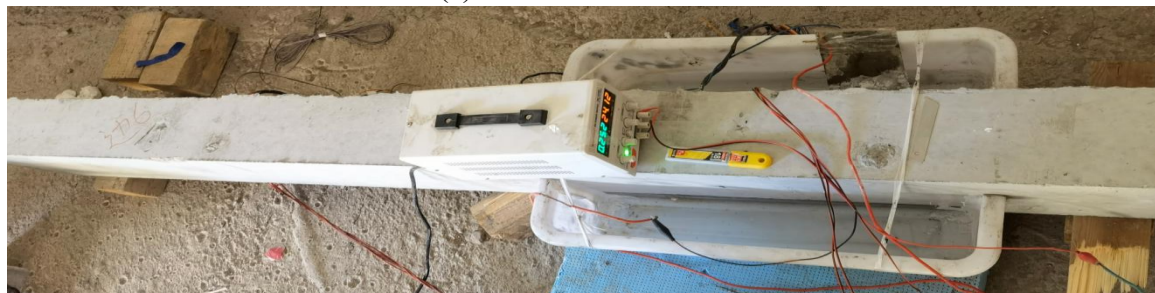
(b) Corrode at side

Fig. 3.7 Corrosion picture

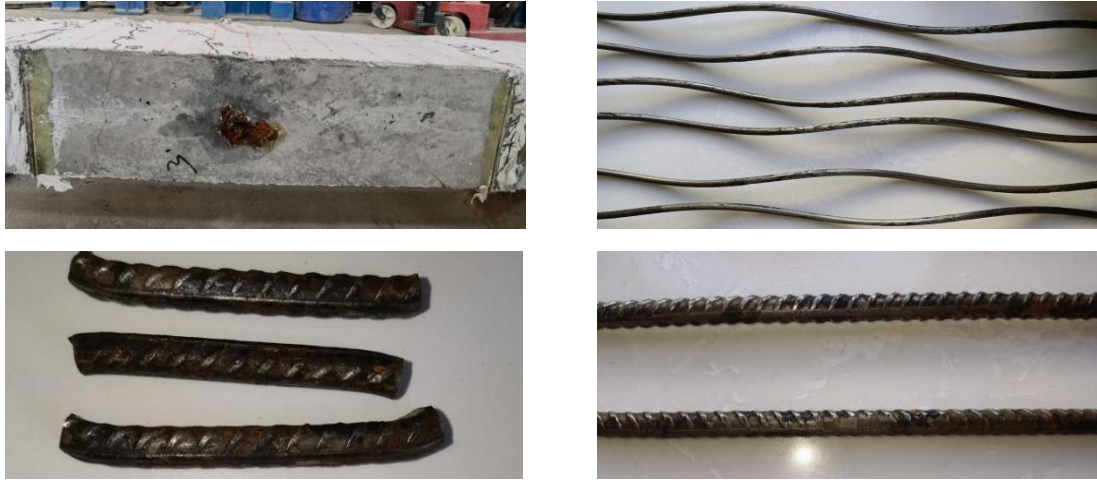
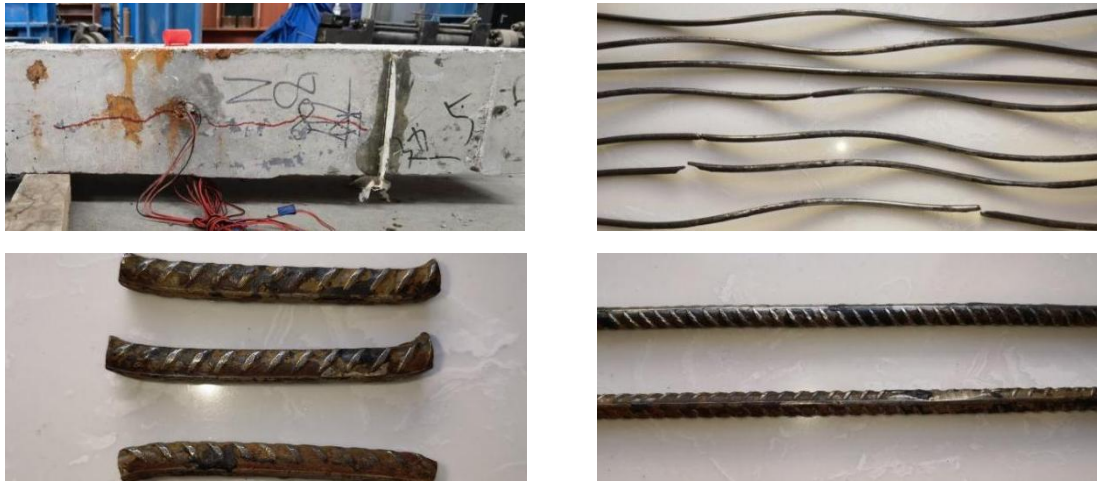
**Figure 3.8** shows the corrosion condition of S-B-6 and S-B-12 in bottom of beam, PC strands, stirrups and longitudinal steel bars. It can be found that due to the anti-corrosion paint applied to the stirrups and longitudinal bars, the surfaces of the stirrups and longitudinal bars are almost free from corrosion regardless of whether the corrosion level of the strands is high or low. Observing the corrosion zone at the bottom

of the specimen, it can be found that when the corrosion degree is high, longitudinal cracks will appear at the bottom of the specimen.

Fig 3.8 Corrosion condition of PC strands, reinforce bars and stirrups

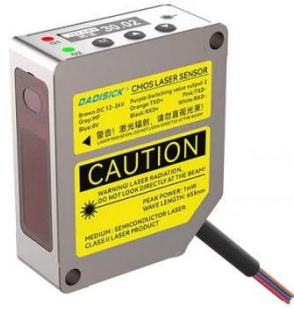
Fig 5.3 Laser displacement sensor GFL-Z200N

S-A-M-H-2 was loaded in the same load range as the other specimens for the first 150,000 loadings, followed by a fatigue load range of 20%-60% for the next 150,000 loadings to measure the performance of the specimen under different loadings, with the specific test groupings shown in **Table 5.1**. Previous tests have shown that the effect of frequency on the mechanical properties of the member is negligible when the test beam in air is loaded at a frequency of less than 5Hz. The loading frequency for this test was 2Hz, and the test beam was loaded in an equal amplitude cycle using load control, with a sine wave load waveform. Due to the high loading evaluation rate ordinary displacement sensors are difficult to measure the displacement change accurately, laser displacement sensor is used to measure the deflection change in the mid-span and below the two loading points, and it was fixed with two magnetic blocks. The laser displacement sensor is shown in **Fig.5.3**. Before the fatigue test, three static load tests

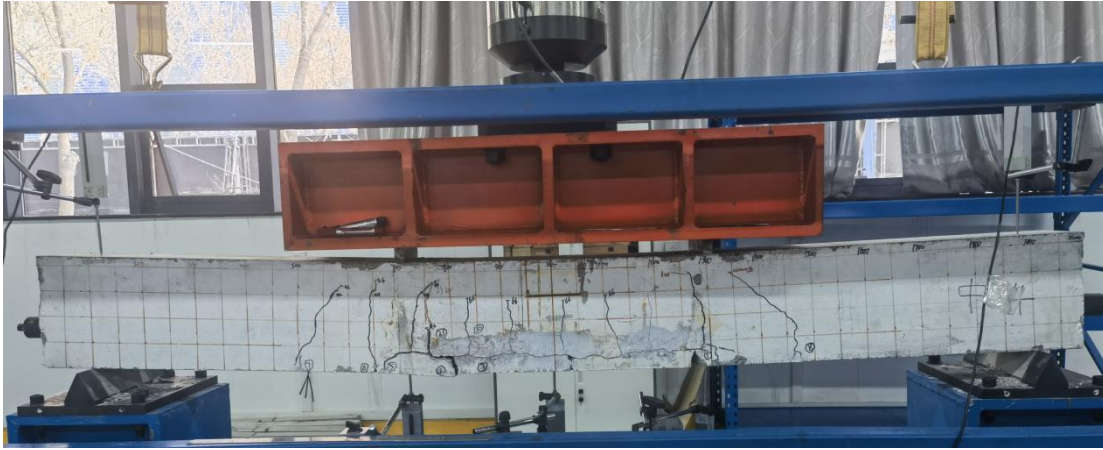
Fig. 6.2 Static loading test

The test loading apparatus is the same as the loading apparatus in Chapter 4, and the displacement meter measurement position, and strain gauge arrangement position are also the same, as shown in Fig. 6.1 and Fig. 6.2. The test mainly measured the deflection at the bottom of the specimen, the longitudinal bar strain, the crack width, the ultimate bearing capacity and so on. The loading process is also divided into two stages, the first stage loading method adopts force control method until the peak load is reached. The second stage loading method adopts displacement control method for loading until the bearing capacity decreases to 80% of the peak load or the physical deterioration of the beam is obvious, then the loading test is stopped. Due to the low mechanical properties of the specimens after fatigue action, the force control method was loaded at a rate of 2kN/min and the displacement control method was loaded at a rate of 1mm/min, with 2mm per loading. As the specimens were already cracked, the initial cracks did not need to be measured, and testing of the width of the major cracks was started when the load reached 40 or 50kN. In order to make a distinction from fatigue cracks, the development of cracks at different loads was depicted with a black pen during the loading process.
