# Survey of the effects of Hurricane Katrina on the Gulf Coast : October 17-19, 2005

# Survey of the effects of Hurricane Katrina on the Gulf Coast

October 17-19, 2005

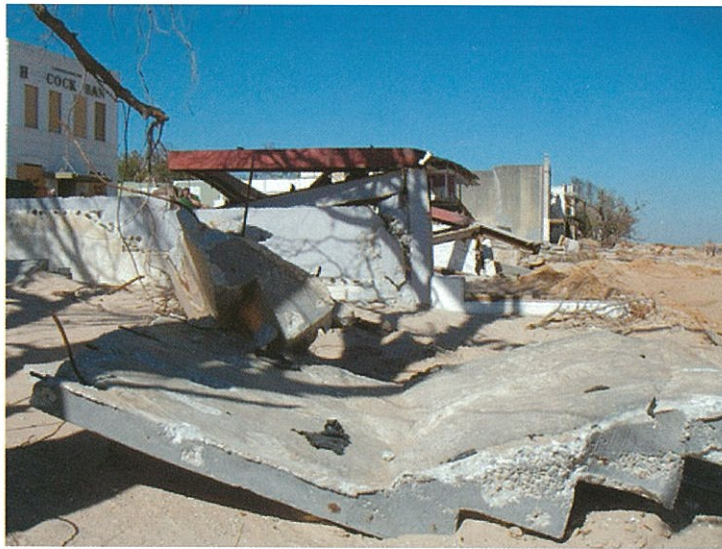
Photo #16. Bay St. Louis, MS. Steel-frame and reinforced-concrete restaurant on the beach, destroyed by the surge.

the momentum of tidal currents due to the surge, or the impact of large debris carried by the surge.
