CHALLENGES AFTER EARTHQUAKES: LESSONS LEARNT FROM THE 2015 NEPAL EARTHQUAKE

Abstract: Concurrent rebuilding situation of Nepal after 2015 earthquake was analyzed on the basis of information obtained from field visits, hearings with responsible officers engaged in emergency support and reconstruction activities, and referring the published government reports. Finally, measures to be taken in order to solve the post-disaster rehabilitation difficulties and being prepared for future such disaster in Nepal are discussed.

Key words: 2015 Nepal Earthquake, emergency relief, rehabilitation, reconstruction

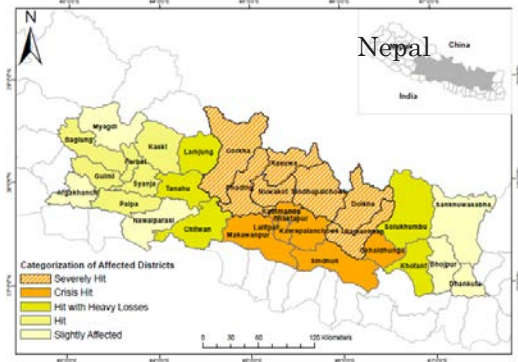
Fig. 2. Earthquake damage scenario (PDNA)

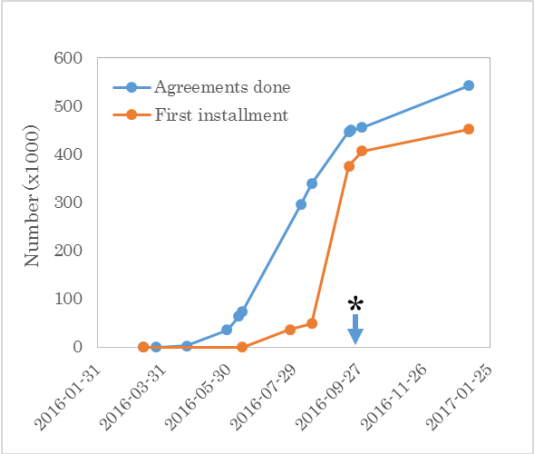
Regarding the NRA housing grant distribution rules aimed at private owners, the following documents are to be submitted by beneficiaries to receive the grant allowance for rebuilding their houses; 1) citizenship certificate, 2) landownership certificate, and 3) the paper given by the surveyor while categorizing the damage. Most of the adults already have citizenship certificate at their hand. If anyone has land, landownership certificate is also not a problem. A copy of both 1) and 2) can be obtained if the originals are lost. There is an alternative for No. 3 if the person has lost original paper but if he/she is listed as beneficiary. In brief, the paper requirements are not so complex. Delay in NRA formation has delayed the reconstruction activities during initial days but NRA outputs are gaining momentum along with the experience. The number of agreements made and first installment of NRs. 50,000 transferred to beneficiaries' bank provide some hints on this trend (Fig. 4).

Fig. 4. Reconstruction progress of private housing (Source: NRA press notices) (*: NRA decision to increase grant allowance for earthquake victims to NRs. 300,000

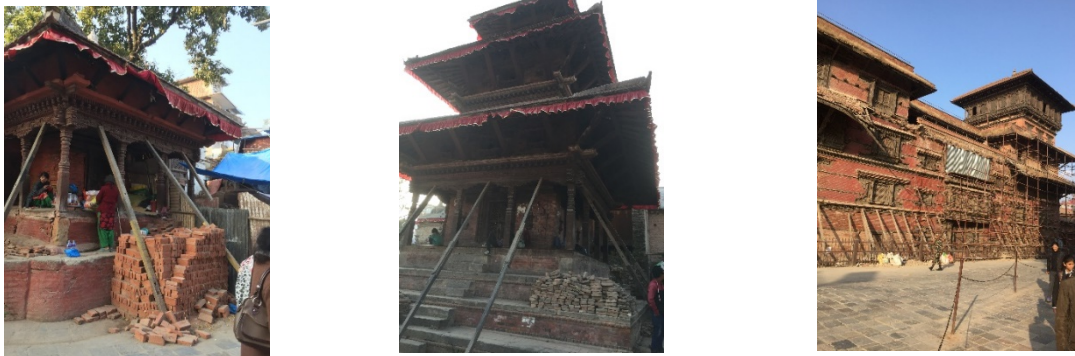
Photo. 1. Two temples and Durbar Square in Basantapur area under temporary supports (Photo taken on Feb. 2017)

Photo 1 shows the Basantapur Durbar Square and other two other adjacent temples, one of the most famous tourist attractions in Kathmandu city, under temporary supports. Photo 2 is the same Durbar Square, photographed at various dates and these well state that many archeological monuments are yet to get government attention until recently. Similarly, other places, such as, Gorkha Durbar in Gorkha, temples in Patan and Bhaktapur were also found untouched until September 2016. In a country, where tourism constitutes a large share of GDP, keeping them without renovating is costing a lot economically. The NRA progress report published on December, 2016 shows the work progress of archeological monument restoration as; completed- 15, undergoing-69. As PDRF plan for reconstruction of monuments is also 4 to 5 years, long waiting time for full recovery is expected.

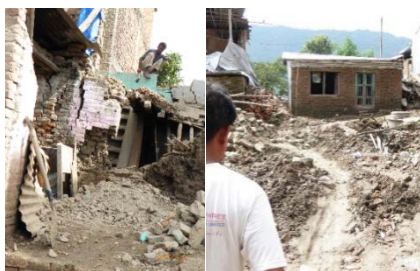
In Sankhu, where the building damage was as high as 90%, the streets were filled with debris and there were so many walls or even whole buildings in ready to fall condition in September 2015. However, the roads were mostly cleared and building construction cases were rising in the next visit done after a year of earthquake as symbolically shown by the photograph (Photo 3, 4 and 5) taken at different dates.

Photo. 3. Ready to fall buildings and streets still to be cleared even after six months (Sept, 2015)

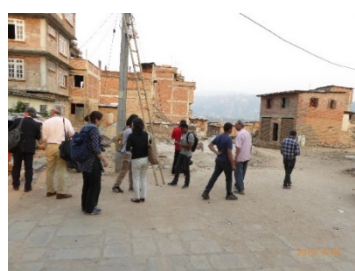
Photo. 4. Streets rubbish partly cleared and a few new buildings coming up (April, 2016)

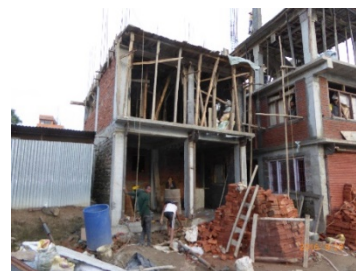
Photo. 5. New buildings on private funding coming up (Sept, 2016)

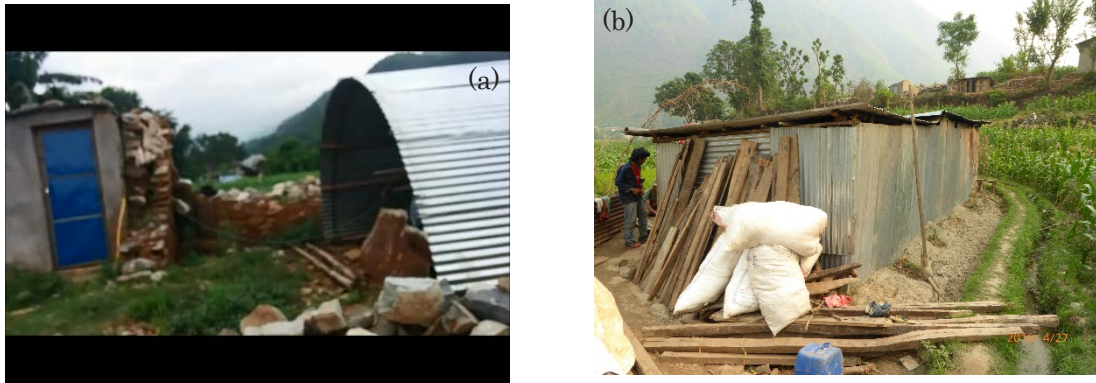
With the visits of Keureni, Tupche and Charghare villages in Nuwakot district and in the vicinity of Gorkha bazaar, families having agricultural plots around their original residence were found living on their own land by preparing shelter with government provided CGI sheets (Photos 6a) and had built WASH facilities themselves. In Photo 6b, a family from Rasuwa district having 9 family members were living in some other's land temporarily by supporting the owner's farming. While having difficulties of residence, they could produce vegetables and other agricultural products for living.

Photo. 6. Typical private temporary shelter houses made of CGI sheets (a) Keureni, and (b) Tupche in Nuwakot (Photo taken in September, 2015)

- 2) Government help in providing transitional shelters was almost limited in providing CGI sheets. Many of the shelters were found unsafe and unhygienic. Although settlements in group got some assistance from NGOs/INGOs to install water supply, sanitary and hygiene (WASH) but not the individual ones. So, technical help in constructing temporary shelters (design, skilled manpower) including WASH aspects in a set shall be considered in future.

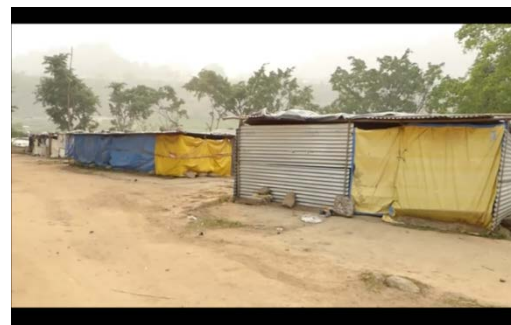
Betrabati Shelter Camp (Fig.6, Photo 7), which was just a few minutes' drive from district headquarter at Bidur was visited in September, 2015. Representatives informed that total of 304 families, about 1375 persons, were living there. Peoples from Haku VDC of Rasuwa district (adjacent to Nuwakot district at the north) came in mass after about a month of earthquake and were living in temporary camps there because their original village was destroyed by landslide. It was understood that almost 90% were from Rasuwa district. There are 36 families from Bhalche VDC of Nuwakot as well. Some NGOs had built water supply system, lavatory and were also helping with food items. They were sending their kids to nearby school, about 15-20 minutes walking distance from there and this is not so far as compared to adjacent villages. The difficult part of living was that the space allotted to each family was very small, the expected time of stay was quite long and they did not have any agricultural land in the vicinity to produce anything for survival.

The condition was almost unchanged during the second visit made on April 2016. There seems to be some unseen conflict of interest among various parties involved. The NRA has the policy to settle the affected peoples near their original place but many residents of that camp opt to settle there because of its proximity to Nuwakot district headquarter and having better chance of getting job. Besides, the land belonged to Bidur municipality and might have commercial interest in it and, like to see the central government or the Rasuwa district to settle its residents.

Photo. 7. Betrabati shelter camp, Nuwakot (April, 2016)
