# Sirolimus-eluting stent fracture with thrombus, visualization by optical coherence tomography

European Heart Journal, 27(12):1389-1389

Junya Shite, MD; Daisuke Matsumoto, MD; Mitsuhiro Yokayama, MD

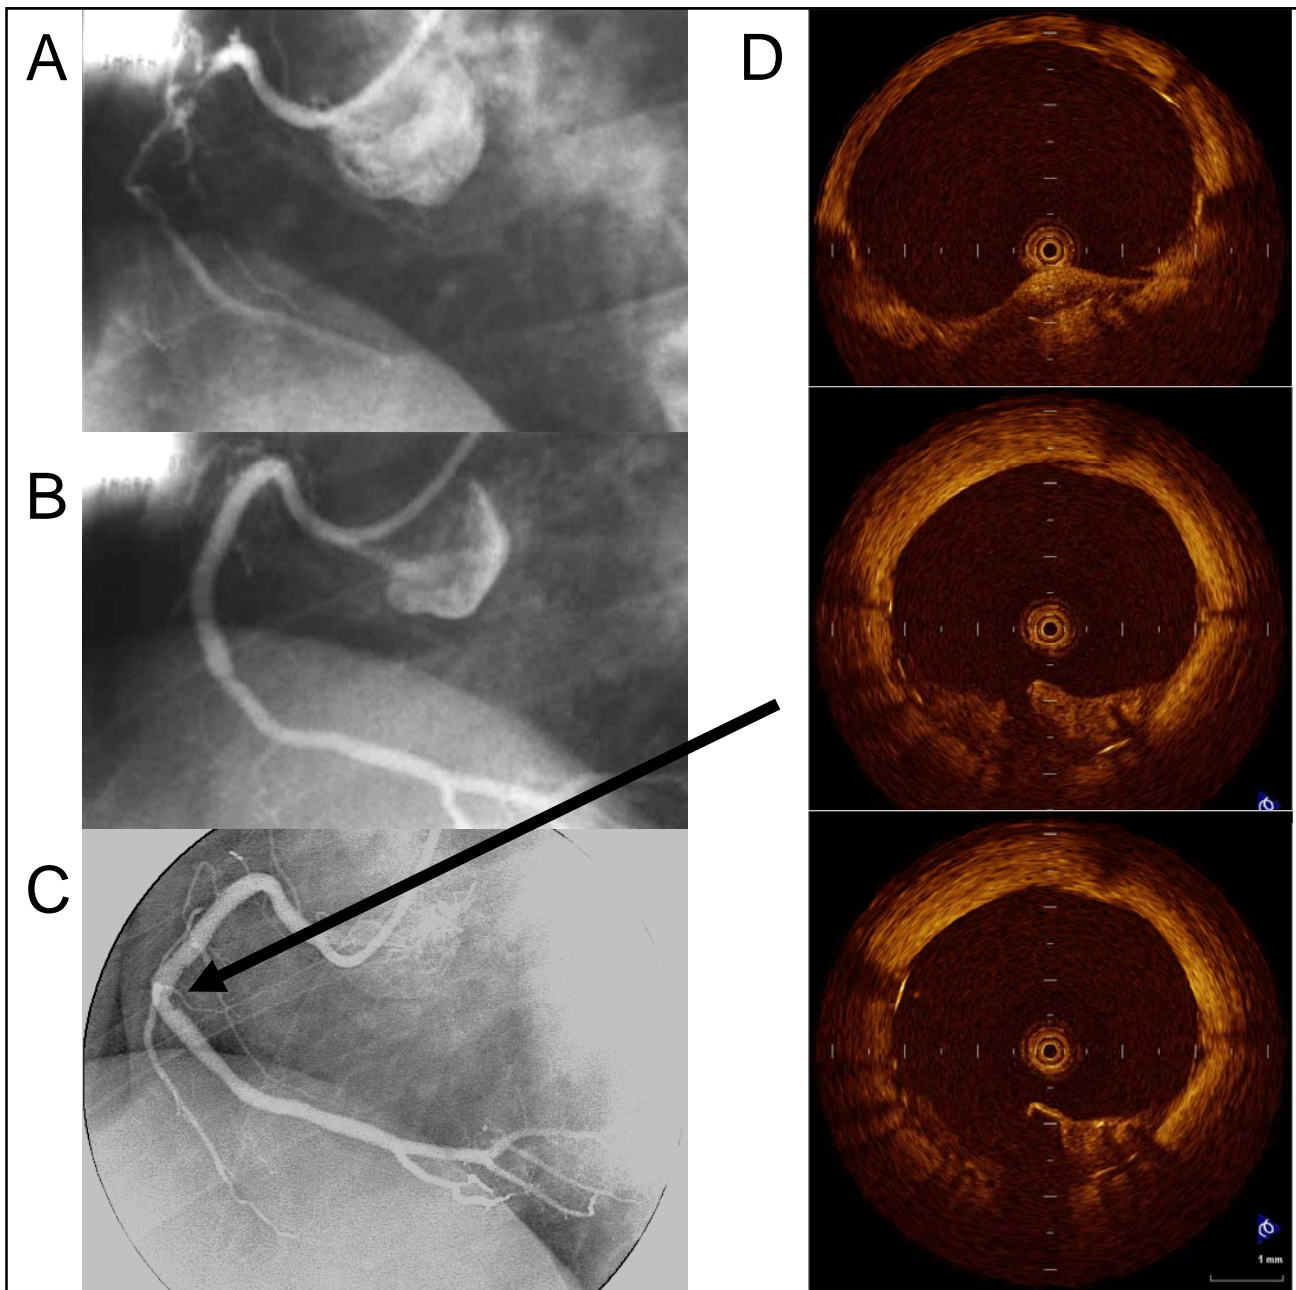
### Figure legend

Coronary angiographies before (A) and after (B) sirolimus-eluting stent implantation. A well-dilated and straightened coronary was achieved by stenting. Six-month follow-up angiogram (C) showed a re-angulated coronary with contrast filling defect (arrow). Optical coherence tomography images at angulated coronary site show a fractured stent with attached thrombus (D).

A 72-year-old man, with a history of old myocardial infarction, was admitted for angiography. The angiogram showed a 99% angulated stenosis in the right coronary artery (Panel A). Following implantation of two sirolimus-eluting stents (SES) (Cypher<sup>TM</sup> 3.5x23 mm, 3.5x18 mm) at the culprit lesion and dilatation with a 4 mm balloon at 20 atm, the angulated segment of the artery straightened (Panel B). Intravascular ultrasound demonstrated the well-apposed SES with no stent fracture nor plaque protrusion at the angulated site. Three months after cessation of ticlopidine with continued use of aspirin, an angiogram at 6-month follow-up showed a re-angulated coronary artery with contrast filling defect (Panel C). At this site, optical coherence tomography (LightLab<sup>TM</sup>) revealed the fractured stent at six o'clock with thrombus adhesion (Panel D).
