Proceedings of SPIE – Thermosense: Thermal Infrared Applications XL, 10661:106610T-106610T

Application of infrared camera for steel bridge maintenance

Takahide Sakagami ^a, Yoshiaki Mizokami ^b, Daiki Shiozawa ^a,
Masahiro Hayashi ^b, Masahiro Takeguchi ^b

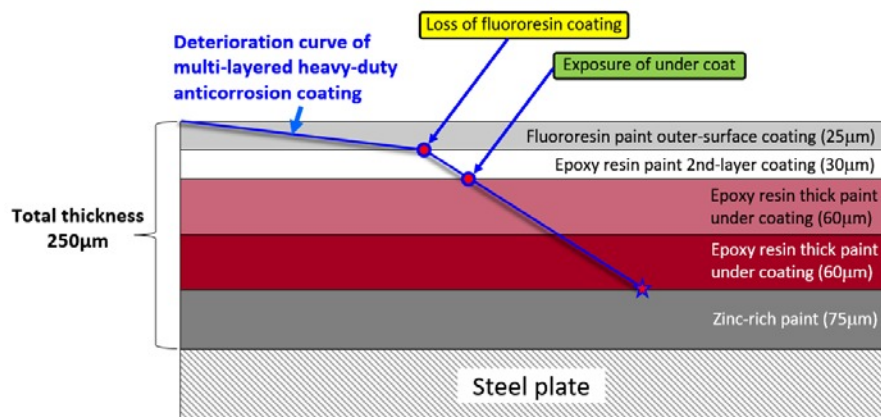
Fig. 1 Illustration of structure and deterioration curve of heavy-duty anticorrosion coating.

As shown in the figure, zinc-rich paint expecting electric anticorrosion effect is applied on steel surface. Epoxy resin layers for protecting the zinc-rich paint are painted next. Finally fluororesin coating with excellent weather resistance is applied

on the outer surface. This kind of multi-layered coating is worn from surface year by year due to aging deterioration. The wear rate of the outer surface fluororesin coating is relatively small, however the wear rate of the epoxy resin paint is accelerated after the loss of the fluororesin coating. In the maintenance program of the heavy-duty anticorrosion coating, protection of the zinc-rich paint is very important since on-site fabrication of the zinc-rich paint coating is almost impossible. Therefore the appropriate timing for repainting maintenance should be set when the surface fluororesin coating is lost. However it is difficult to detect the loss of the surface coating by visual inspection, because the similar color paint is chosen for the second-layer epoxy resin paint for better appearance. Nondestructive testing technique that is suitable for early global inspection of wear of surface fluororesin coating has not been developed yet. In this study a new nondestructive evaluation technique that enables us to easily detect the loss of surface fluororesin coating layer is developed based on the difference in spectral absorbance between the surface fluororesin coating and the second-layered epoxy resin.

A steel plate specimen with multiple-layered heavy-duty anticorrosion coating employed in this study is shown in Fig. 3. This specimen has the same coating structure shown in Fig. 1. The infrared spectral absorptance was measured by the FT-IR instrument and the result was shown in Fig. 2. The SWIR camera with InGaAs array detector was employed in this experimental study. Specifications of the SWIR camera are shown in Table 1. According to the infrared spectral absorptance obtained for fluororesin coating and epoxy resin coating, a sharp cut filter transmitting infrared light with a wavelength of 1400nm or over as well as a sharp cut filter transmitting infrared light with a wavelength of 1450nm or below were prepared. Measurements were conducted using the SWIR camera and the two filters under the conditions shown in Table 2. Sun light in fine weather and halogen lamps were employed as infrared illuminations.

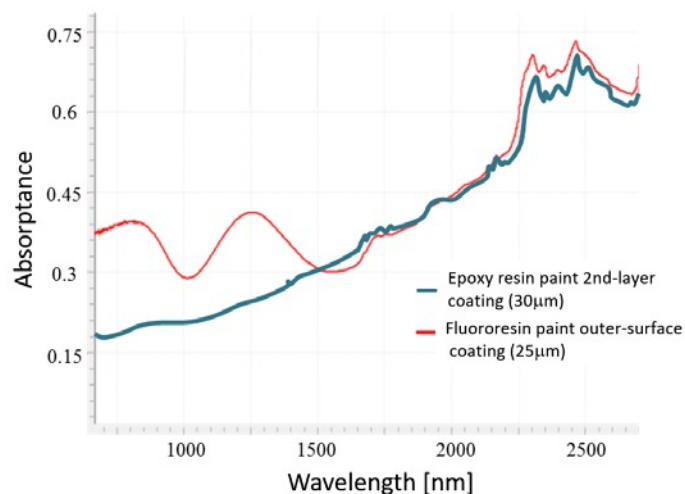
Spectral infrared absorbance of materials shows characteristic distribution influenced by the material's molecular structure, and this enables identification of materials and analysis of chemical structures. As an example, spectral infrared absorbance measured for outer surface fluororesin coating and second-layer epoxy resin coating of the multi-layered heavy-duty anticorrosion coating is shown in Fig. 2. It is found from the figure that fluororesin coating and epoxy resin coating show almost same spectral infrared absorbance in the range of wavelength of 1500nm or over. In contrast, the fluororesin coating shows higher infrared absorption rate than that of epoxy resin coating in the range of wavelength of 1500nm or below.

Fig. 2 Infrared spectral absorbance measured for fluororesin coating and epoxy resin coating.

When surfaces of fluororesin coating and epoxy resin coating are observed by the SW infrared camera under broad band infrared illumination covering detectable wavelength of the camera, luminosities are almost same for fluororesin coating and epoxy resin coating over the wavelength of 1500nm; in contrast luminosity for fluororesin coating is lower than that for epoxy resin coating below the wavelength of 1500nm. This kind of infrared spectral luminosity change detected by the infrared camera with sharp-cut wavelength filtering can be utilized for the detection of exposure of the 2nd layer epoxy resin coating due to the wear of outer surface fluororesin coating.

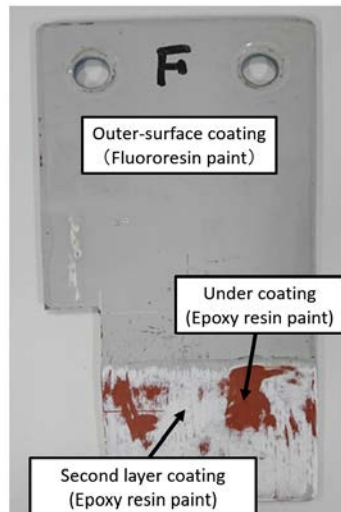
Fig. 3 Steel plate specimen with multiple layered heavy-duty anticorrosion coating employed in this study.

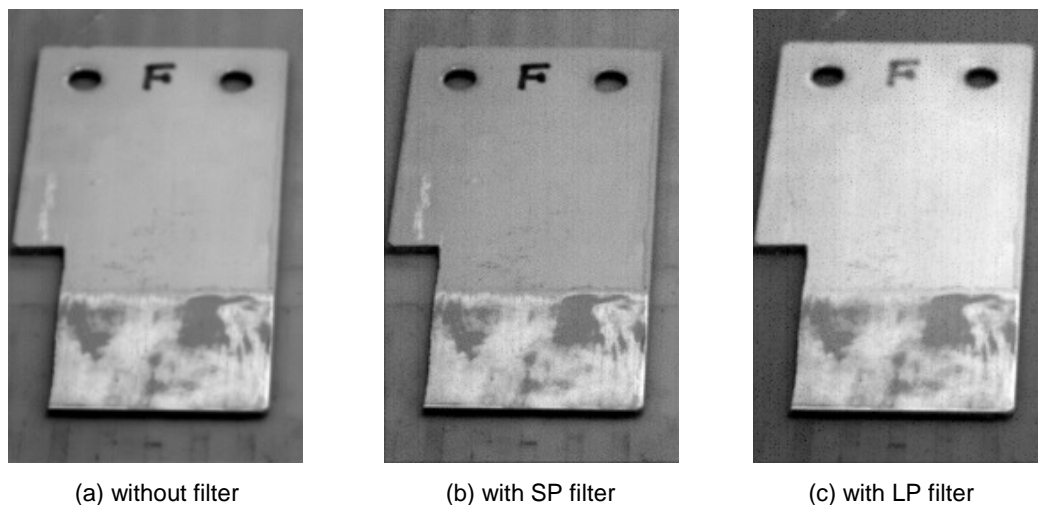
The heavy-duty coating specimen and SWIR camera were set on the sunny day so that direct sun light was incident on the specimen surface. Infrared images taken under the three filtering conditions are shown in Fig. 4. It is found from the figure that infrared image with LP filter measured in the wavelength range from 1400nm to 1700nm shows similar luminosities for fluororesin coating and epoxy resin coating. In contrast infrared image with SP filter measured in the wavelength range from 900nm to 1450nm shows distinctively low luminosity on the region where the outer surface fluororesin coating is remaining.

Fig. 4 Infrared images taken under sun light illumination for three filtering conditions for heavy-duty coating specimen.

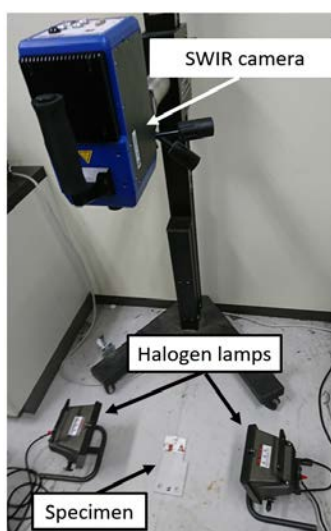
Infrared measurements under artificial illumination using halogen lamps were conducted assuming night time inspections or inspections of bridge members when enough sun light illumination is not expected. Experimental set up with commercially available halogen light projectors and SWIR camera is shown in Fig. 5. Infrared images taken under the three filtering conditions are shown in Fig. 6. It is found from the figures that experimental results show the same tendency as those for sun light illumination measurement: infrared image with LP filter shows similar luminosities for fluororesin coating and epoxy resin coating; in contrast infrared image with SP filter shows low luminosity on the region where the outer surface fluororesin coating is remaining. For the both cases, the loss of the surface fluororesin coating can be clearly identified using SWIR camera with spectral transmittance filtering.

Fig. 5 Experimental set up for halogen lamp illumination.

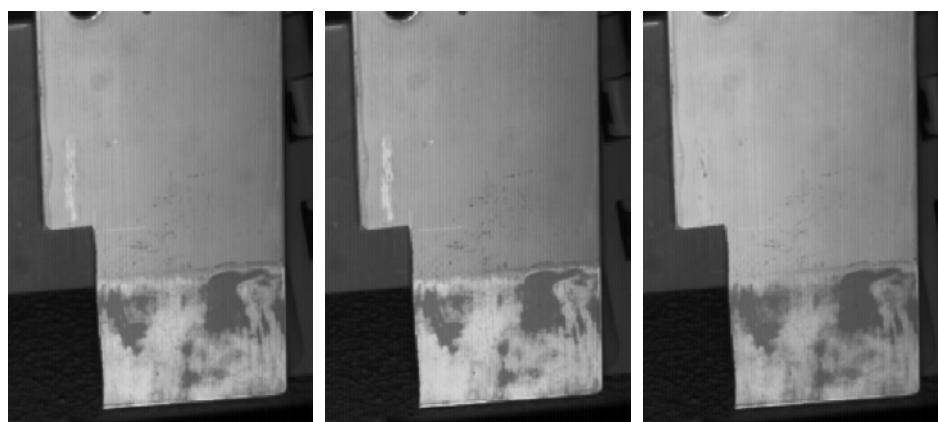
(a) without filter (b) with SP filter (c) with LP filter

Fig. 6 Infrared images taken under halogen light illumination for three filtering conditions for heavy-duty coating specimen.

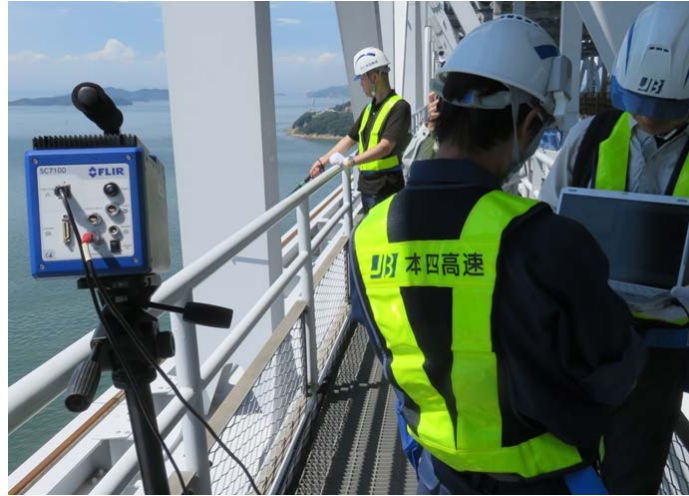
Figure 7 is a photograph showing the situation of infrared measurement on the bridge. Visible image and infrared images taken under the three filtering conditions are shown in Fig. 8. The rectangular red and blue marks on the images indicate outer surface fluororesin coating and inner epoxy resin coating, respectively. The pixel values obtained in red and blue marks under the three filtering conditions are shown in Fig. 9.

Fig. 7 Photograph showing the situation of infrared measurement on the bridge.

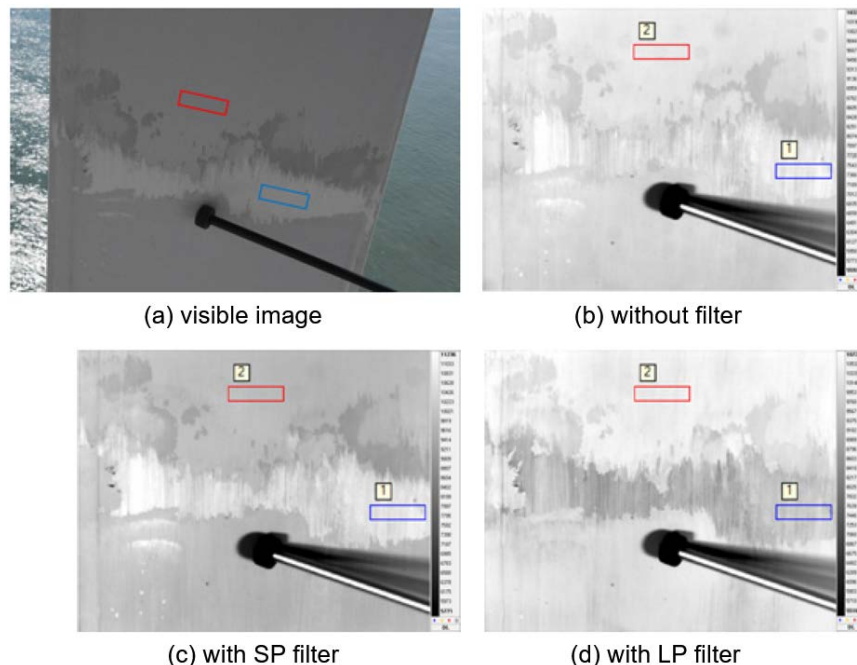
Fig. 8 Visible image and infrared images taken under three filtering conditions.

It is found from figures that the tendency of the infrared pixel values is partially different from that of the plate specimen shown in the foregoing paragraph. Figs. 8(b) and 9 show that measured infrared pixel values show similar values for fluororesin coating and epoxy resin coating in the case of without filtering. Figs. 8(c), 8(d) and 9 show that the infrared luminosity shows higher values in the inner layer epoxy coating with SP filter; on the other hand the infrared luminosity shows higher values in the outer surface fluororesin coating with LP filter. It can be estimated that the spectrum absorptance of the anticorrosion coatings fabricated on this bridge is partially different from that shown in Fig. 2; that is to say the tendency of spectrum absorptance of the outer surface fluororesin coating and the inner epoxy resin coating is reversed below and over the wavelength of 1500nm.

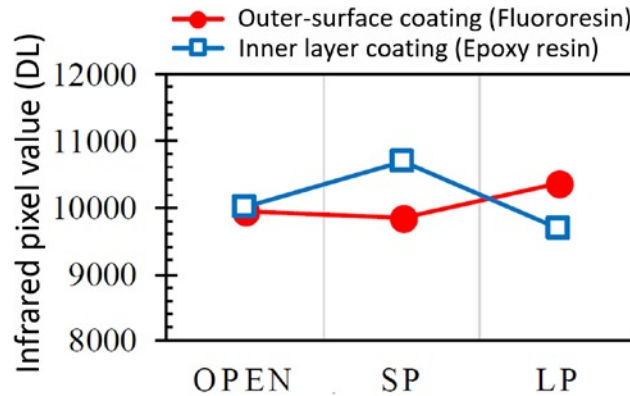
Fig. 9 Pixel values obtained for fluororesin coating and epoxy resin coating under three filtering conditions.
