**Reconstruction and Transformation of Living Space  
: Focused on Tsunami Affected Coastal Housing Settlements in Sri Lanka**

**January 2009**

**Graduate School of Science and Technology  
Kobe University**

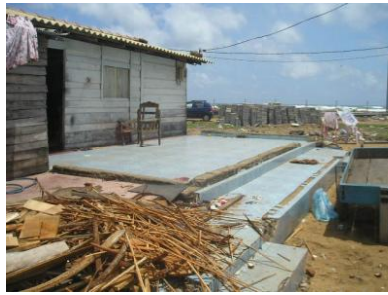
⑩

Fully Damaged Permanent House-  
Temporarily Repaired-2006

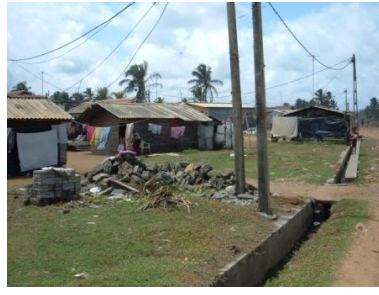
⑪

Fully Damaged Permanent  
Houses-Temporarily Repaired-  
2007

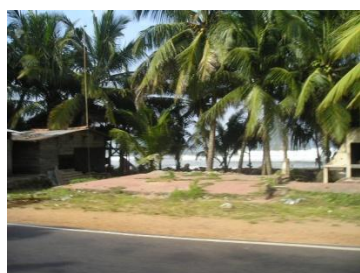
①  
Totally damaged permanent house at Hikkaduwa-2006

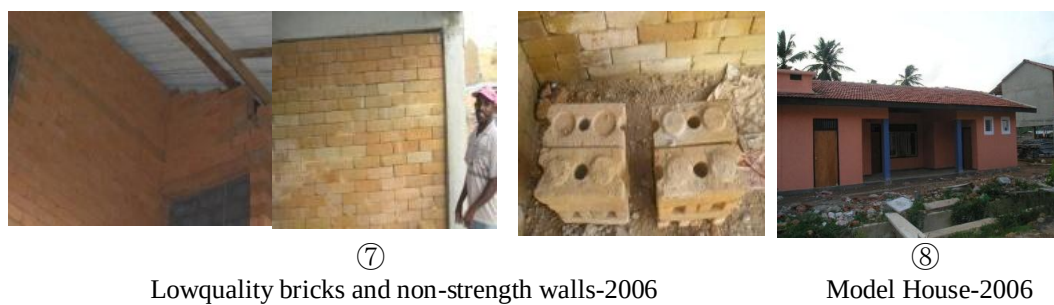
Fig.3.35: Construction Failures and Experimental Model House on 2006

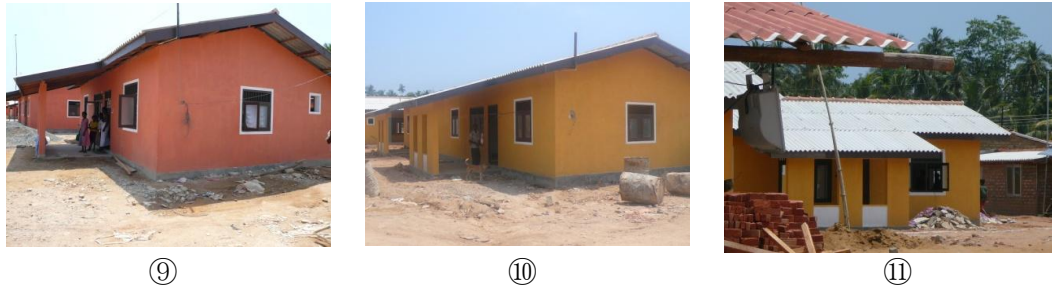
Fig.3.36: Mirihanawatta Permanent Housing Scheme – under construction 2007

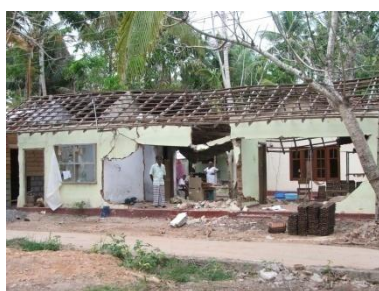
Partially damage (unusable) permanent house

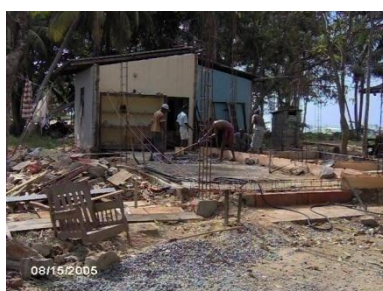
Reconstruction of a partially damage house
