Seismic vulnerability of a water-supply pipeline based on the damage analysis of two earthquakes during the Great East Japan earthquake

SEISMIC VULNERABILITY OF A WATER-SUPPLY PIPELINE BASED ON THE DAMAGE ANALYSIS OF TWO EARTHQUAKES DURING THE GREAT EAST JAPAN EARTHQUAKE

Yasuko KUWATA[1], Keisuke SATO[2], and Soji KATO[3]

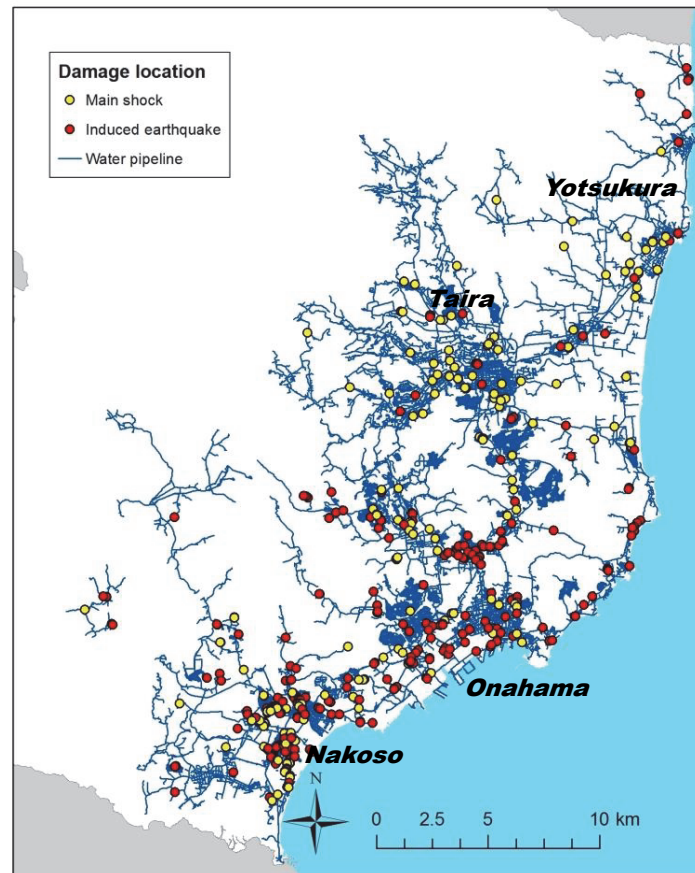
Fig. 1 Locations of damage to the water-supply pipeline (215 locations after the MS and 268 locations after the IE)

When the location of the damaged pipeline in Fig. 1 and the engineering geomorphological classifications in Fig. 2 are compared, the damage caused during the MS is concentrated in locations of back marshes, sand bars, and coastal lowlands in the areas of Taira and Yotsukura located in the northern part of Iwaki. The damage during the IE is concentrated in the delta and coastal lowland of Nakoso and Onahama areas in the south.

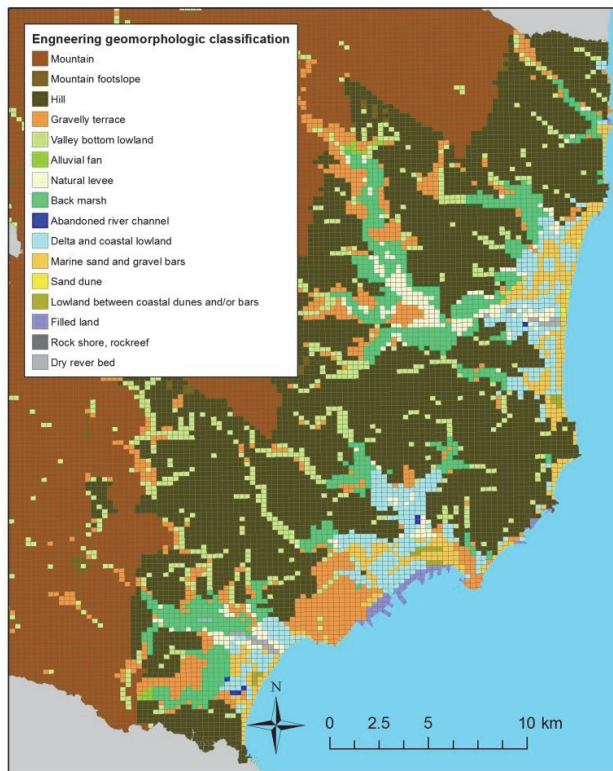
Fig. 2 Engineering geomorphological classification[14]

In order to clarify the geological condition at the location of pipeline damage, the 250 m-by-250 m mesh that is one-fourth size of standard regional was used. Each grid square is given an engineering geomorphological classification that was proposed by Wakamatsu et al.[16] Fig. 2 shows the city map as classified by the engineering geomorphological classification, and Fig. 3 shows the ratio of pipeline lengths according to the engineering geomorphological classification. The pipeline is installed in a range of different areas classified as hills, gravelly terraces, back marshes, and coastal lowlands, although the majority of the city of Iwaki is in the mountains or hills.

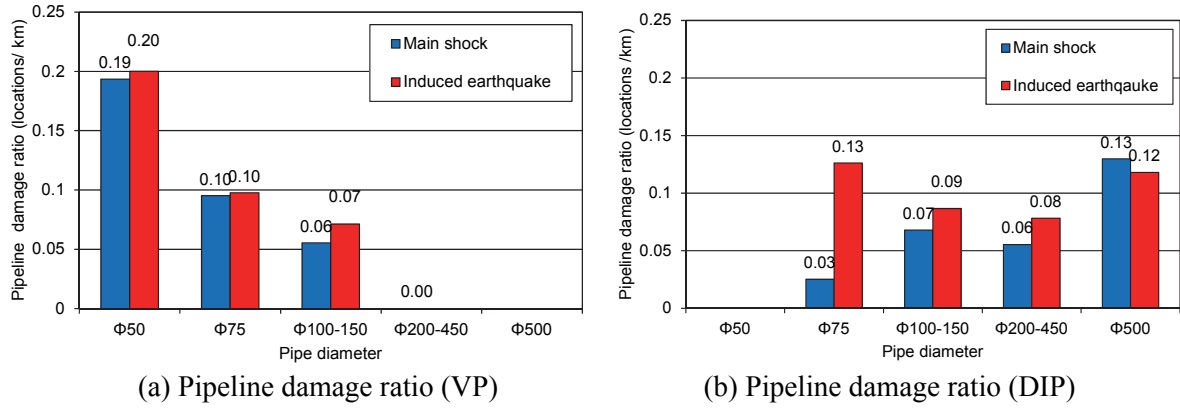
Fig. 4 Pipeline damage ratios of the MS and IE in terms of the diameter of VP and DIP

(a) Pipeline damage ratio (VP)　　　　　　(b) Pipeline damage ratio (DIP)

and more than ϕ 500 of DIPs may be overestimated or underestimated, as the installation lengths are shorter than the others. In addition, when comparing the pipeline damage ratio of VPs and DIPs at ϕ 100–150, those of DIPs were somewhat high regardless of which earthquake caused the damage.

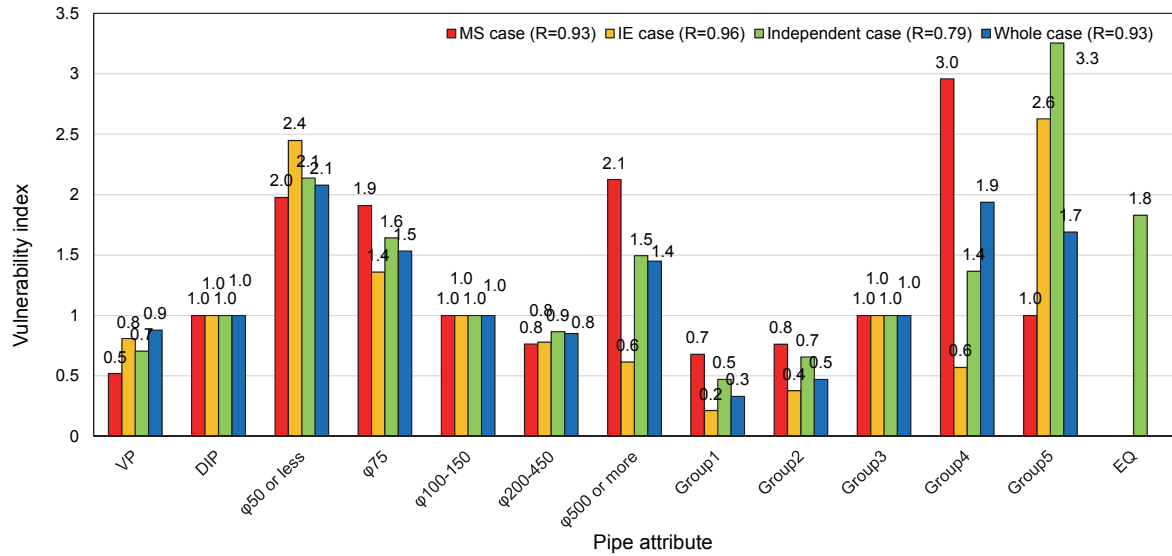
As for each correlation coefficient, the MS case was 0.93, the IE case was 0.96, the independent case was 0.79, and the whole case was 0.93. As a whole, high correlations were obtained. Fig. 5 shows the vulnerability index of each pipeline attribute according to the analytical cases. Comparing the indexes between the cases, the index of pipe material and diameter can be seen to vary within the range of 0.5 points, except in the case of a diameter of ϕ 500 or more. The pipeline with a diameter of ϕ 500 or more is only a DIP, and the damage locations were 11 after the MS and 9 after the IE. The number of damage locations does not seem to be very different between the two earthquakes, but it is considered to be due to a difference in geomorphology. Overall, it was confirmed that the index of DIPs is a little bit smaller than that of VPs, and it becomes smaller as the diameter gets larger, excluding the case of ϕ 500 or more. These tendencies are similar to the pipeline damage ratio of DIPs as mentioned in Fig. 4. In a word, the obtained indexes of pipe material are adjusted to the result of past earthquakes, whereas the indexes of diameter are evaluated for VPs that have not been damaged as easily compared to previous research reports.

While the indexes of pipe material and diameter indicate similar values between the cases, the index of the geomorphology group shows a large difference. In particular, the indexes of Group 4 and Group 5 show an opposite tendency to the MS and IE cases. These groups are marine sand and gravel bars, sand dunes, and filled lands. Since the pipeline length in filled lands is only about 1% of the total, it is thought that the index was either overvalued or undervalued. Moreover, there is a good reason to

Fig. 5 Vulnerability index of pipe attributes from each regression analysis case. *Note 1*. The index shows the MS case, IE case, independent case, and whole case from the left bar. *Note 2*. The number of () in the legend means the correlation coefficient of the regression analysis. *Note 3*. The value of EQ means the index of the IE when the earthquakes are dealt separately.

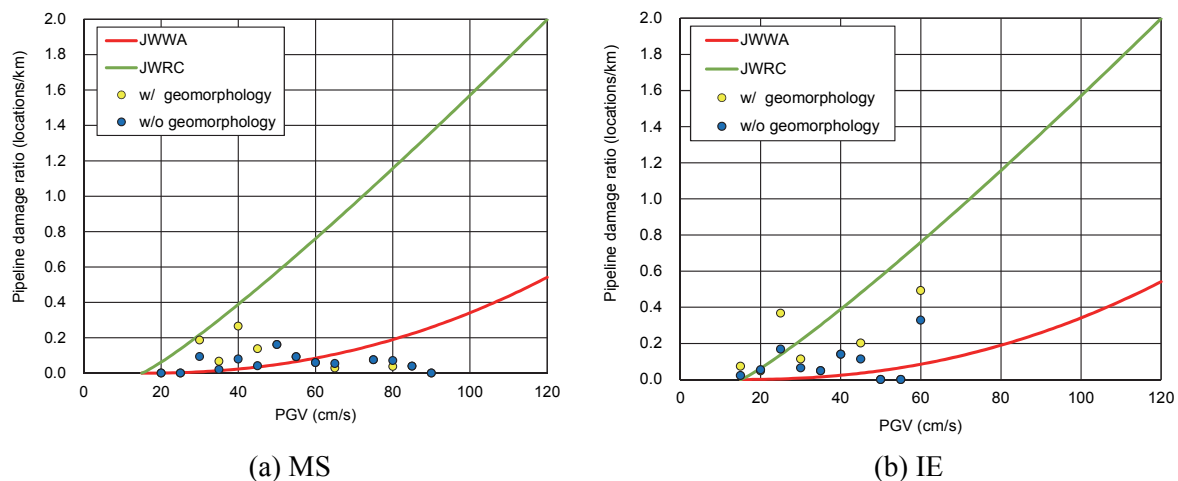
Fig. 6 Relationship between PGV and pipeline damage ratio considering the vulnerability index

Most of the pipeline damage ratios of the MS and IE are distributed around the JWWA curve and are smaller than the JWRC curve. Although the influence of locality on strong areas of ground motion in the IE was considered in the above analysis, the pipeline in the strong area was short and the tendency of the result does not change by this. However, the pipeline damage ratio of the IE reacts sensitively to the PGV rather than that of the MS. The ground motion estimated by interpolation of the observed records may not explain the locality of the strong ground motion well if the seismic zone is in the interpolation range. Moreover, when the index of geomorphology is not considered, the pipeline damage ratio corresponds well to the JWWA curve. This, therefore, suggests that when the estimated ground motion is considered, the site amplification by the engineering geomorphologic classification and multiplying the correction coefficient of geomorphology leads to doubly evaluating the effect of the geomorphology.

(a) MS   (b) IE
