Seismology and Ground Motion Features of 1995 South Hyogo Great Earthquake.....	220
Liquefaction and Damages to Harbour Facilities.....	228
Mountain Slope Failures Caused by the Great Hanshin Earthquake.....	233
Damages to Bridges on Highways and Railroads Caused by the Great Hanshin Earthquake of January 17, 1995.....	237
Damage to Large-Scale Underground Lifelines during the 1995 South Hyogo Prefecture Earthquake.....	272
Lifelines Performance and Damage during Jan. 17, 1995 South Hyogo Great Earthquake.....	283
Outline of the Geographical Information System (GIS) and Internet Information.....	296

## **Liquefaction and Damages to Harbour Facilities**

# Mountain Slope Failures Caused by the Great Hanshin Earthquake

# DAMAGE TO BRIDGES ON HIGHWAYS AND RAILROADS CAUSED BY THE GREAT HANSHIN EARTHQUAKE OF JANUARY 17, 1995

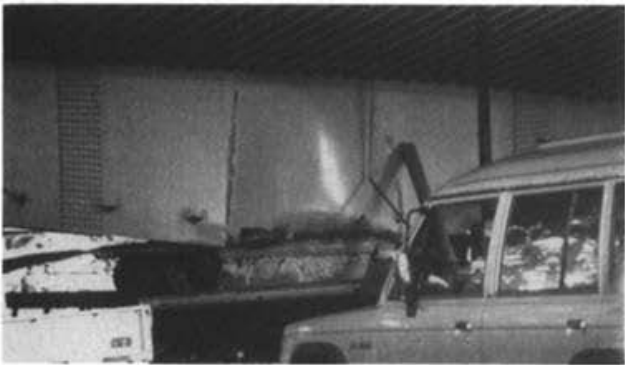
Photo 2.1.3 HANSHIN EXPRESSWAY  
(Nishinomiya City - Koroen)

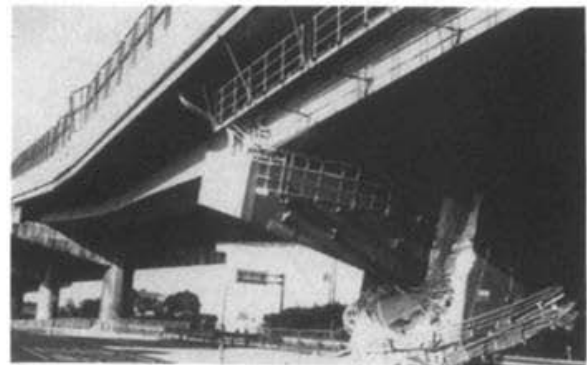
Photo 2.1.4 HANSHIN EXPRESSWAY  
(Higashinada-Ward - Fukae-Honmachi)

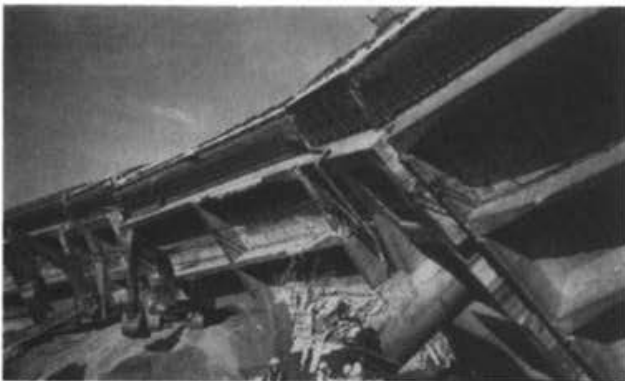
Photo 2.1.5 HANSHIN EXPRESSWAY  
(Higashinada-Ward - Uozaki-Honmachi)

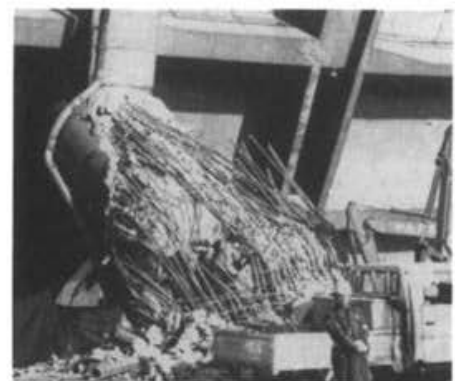
Photo 2.1.6 HANSHIN EXPRESSWAY  
(Higashinada-Ward - Uozaki-Honmachi)

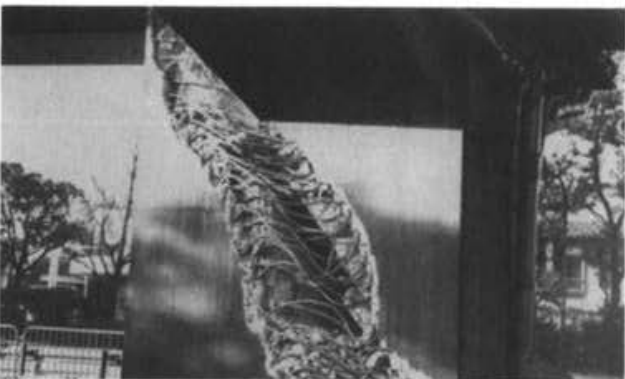
Photo 2.1.7 HANSHIN EXPRESSWAY  
(Higashinada-Ward - Mikage-Tsuka-cho)

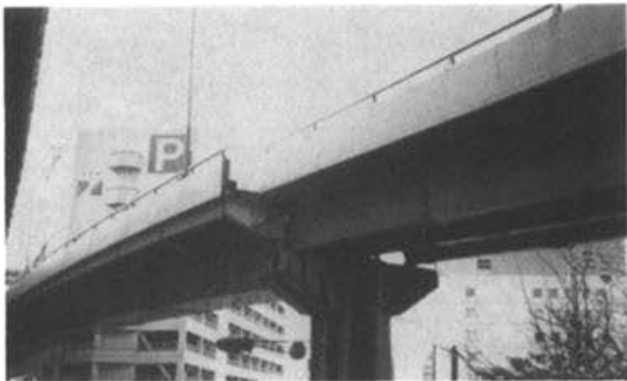
Photo 2.1.9 HANSHIN EXPRESSWAY  
(Chuo-Ward - Isogami-dori/ Ikutagawa Gateway)

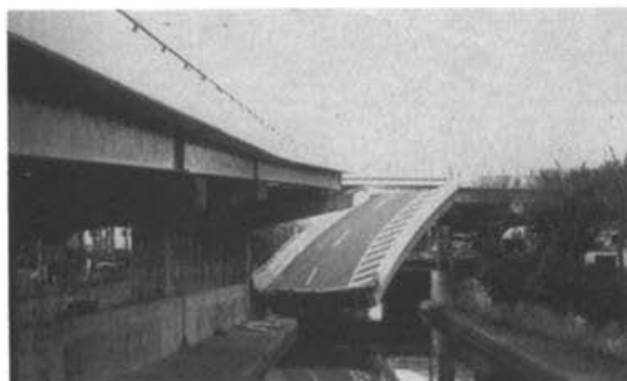
Photo 2.1.11 HANSHIN EXPRESSWAY  
(Minatogawa gate-way)

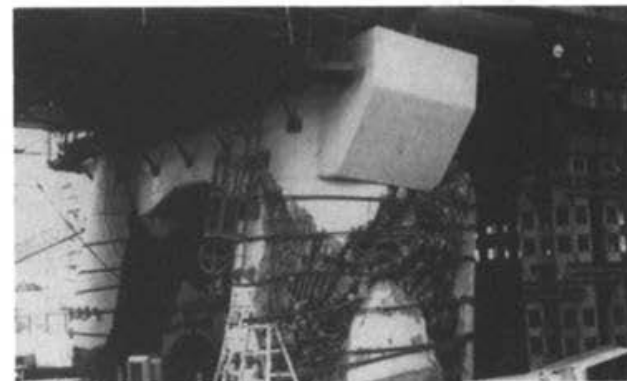
Photo 2.1.12 HANSHIN EXPRESSWAY  
(Suma-Ward - Ikuhira-cho /JR crossover bridge)

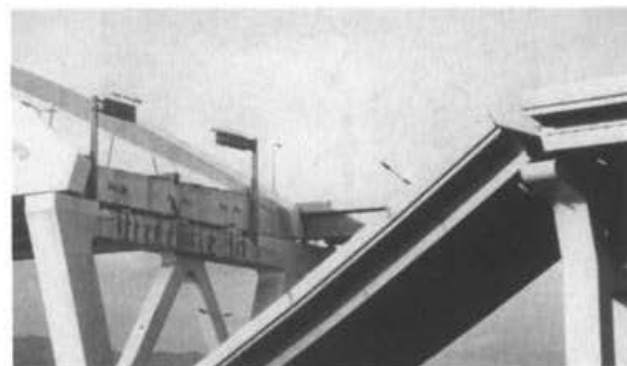
Photo 2.1.13 HANSHIN EXPRESSWAY  
(Wangan Line )

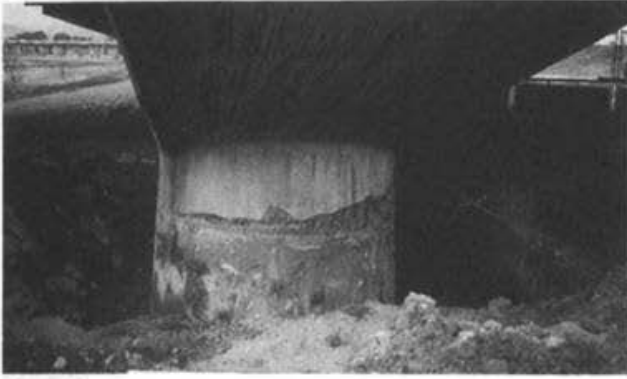
Photo 2.2.3 MEISHIN HIGHWAY  
(Mukogawa Bridge)

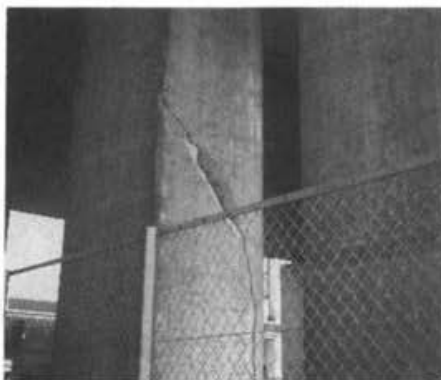
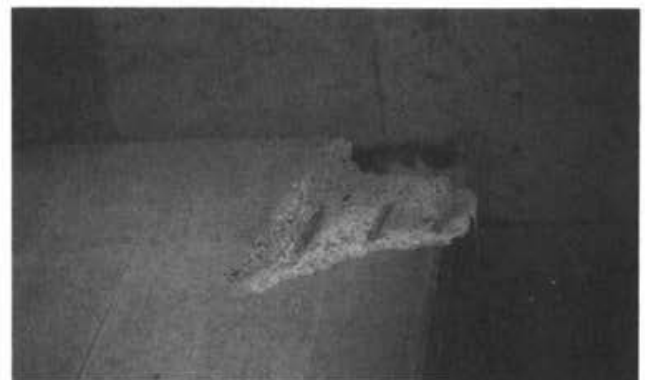
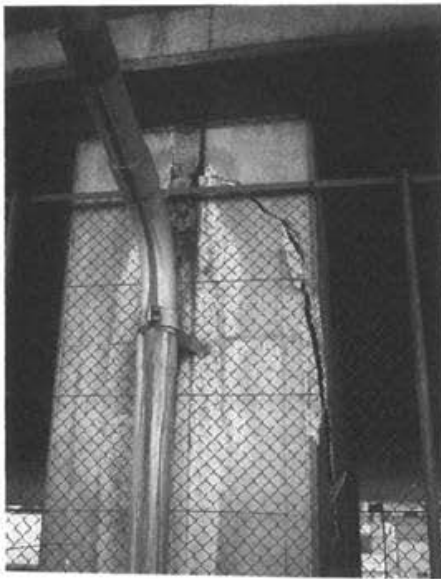
Photo 2.3.1 CHUGOKU HIGHWAY  
(Itami City - Hagino)

Photo 2.3.2 CHUGOKU HIGHWAY  
(Itami City - Hagino)

Photo 2.3.3 CHUGOKU HIGHWAY  
(Itami City - Hagino)

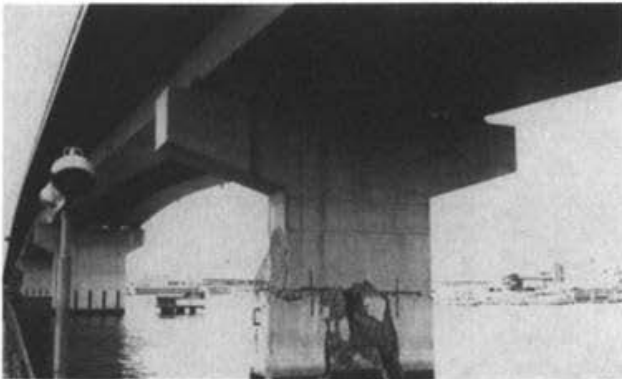
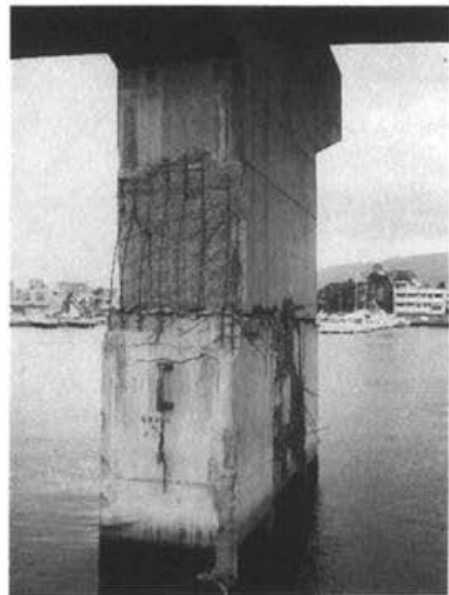
- Pictures 2.6.2 and 2.6.3

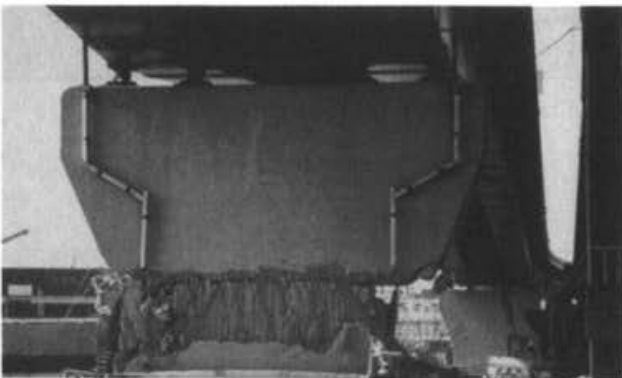
Photo 2.7.1 DAINI MAYA OHASHI BRIDGE

- Picture 2.7.1

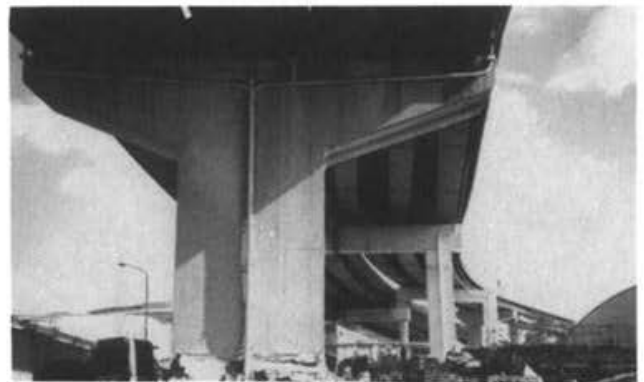
- Piers N. 74-75**
- Bridge type : Super-structure : Two-spans + Three spans Continuous steel box girder.  
Sub-structure : Pier N. 74 (Rectangular single RC pier)  
Pier N.75 (Two-column framed steel bent)
  - Damage situation : Extensive cracking and chunks at the lower part of the RC pier.  
Cracks and buckling at bent's upper corners on the south-side of the bridge.  
Failure and collapse of bearing supports, it caused a relative displacement at one end of the girder.
- Pictures 2.7.2 and 2.7.3

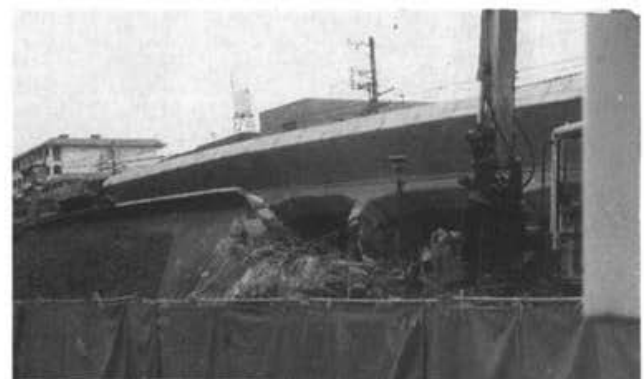
Photo 3.5.2 HANKYU LINE  
(Nishinomiya City - Wakamatsu-cho)

- Damage situation : Ditto (3.5.1)
- Picture 3.5.2
