資料－3 発表論文

神戸高速鉄道大開駅被害状況

DAMAGE TO DAIKAI SUBWAY STATION, KOBE RAPID TRANSIT SYSTEM AND ESTIMATION OF ITS REASON

Damage to Daikai Subway Station of Kobe Rapid Transit Railway during the 1995 Hyogoken-Nambu Earthquake

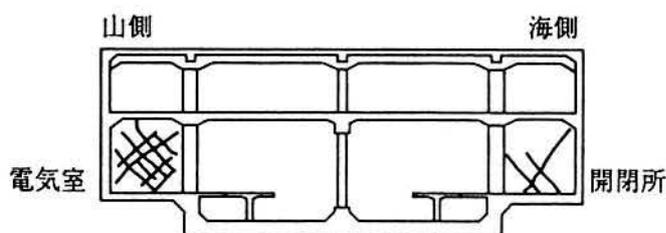
図-6 電気室・開閉所の壁のひびわれ発生状況

プラットホームの両端にある妻壁のひびわれ発生状況を図-5に示す。いずれの妻壁にもせん断ひびわれが発生しており、その程度は南西端の妻壁の方が多かった。地下2階にある電気室・開閉所の線路直角方向の壁のひびわれ発生状況を図-6に示す。いずれの壁にもせん断ひびわれが発生しており、かなりの水平方向地震力が線路直角方向に作用したことが分かる。

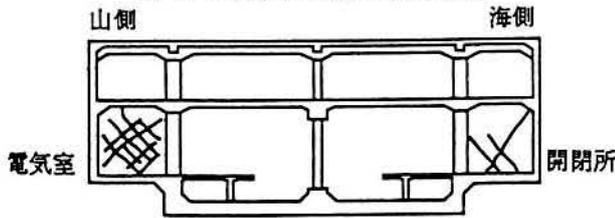
図-7 電気室・開閉所のひび割れ状況

地下2階にある電気室・開閉所の線路直角方向壁のひびわれ状況を図-7に示す。いずれの壁にもX方向にせん断ひびわれが発生しており、かなりの水平方向地震力が線路直角方向に作用したことが分かる。〈Cゾーン〉

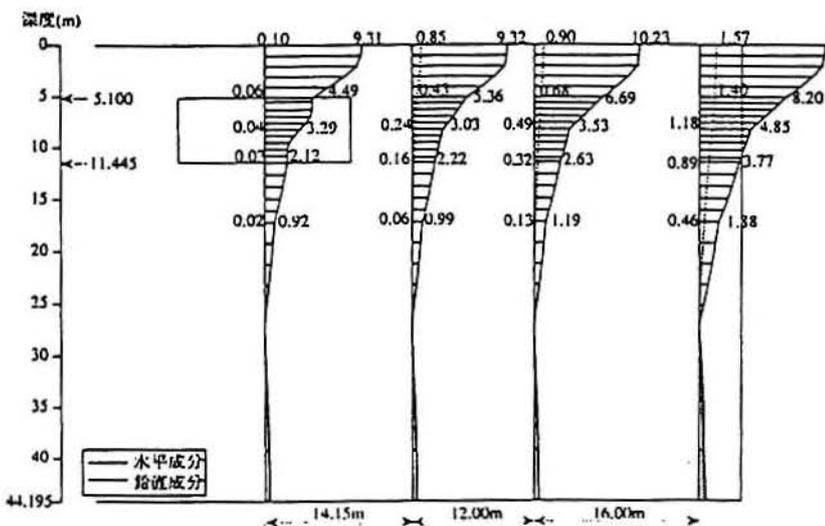
図-16 地盤・構造物の応答変位の最大値分布

対地盤変位分布を図-16に示す。これより、上床版の深度に着目すると構造物近傍の応答変位が周辺地盤より1~2.0cmほど小さな値となっている。これは、強い地震動により周辺地盤の剛性がかなり低下し、構造物の剛性が地盤より強くなり周辺地盤の変形を拘束したためと考えられる。

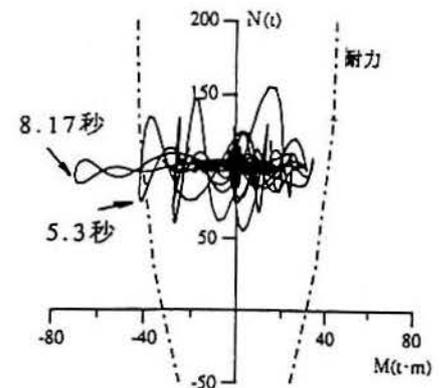
図-17 中柱の地震応答曲げモーメントと軸力の経時変化

次に、構造物の応答断面力のうち中柱上端部(梁下)における常時軸力を加えた作用軸力と地震応答曲げモーメントの経時変化と部材耐力(一点鎖線)との比較を図-17に示す。これらの値は単位奥行き当りの値である。まず、中柱に作用する軸力は、常時に98.7~102.4t前後(約88kgf/cm²)、地震時の増分が55.2~56.4t(約48kgf/cm²)であり、表-1に示した中柱コンクリートの設計基準強度に対する比68% $(=(88+48)/240)$ 、調査や試験により得られた地震時推定強度の36%とかなり高い値となっている。また、最大曲げモーメントは8.17秒近傍のみならず5.3秒近傍にて終局曲げモーメントより大きな値となっている。側壁や上・下床版の隅角部においても同様な傾向が見られる。中柱の応答が終局曲げモーメントを最初に越えた時点(5.3秒近傍)における応答軸力に常時軸力を加えた値に対する中柱の靱性率(終局曲げモーメントと降伏曲げモーメントに対する部材回転角の比)は1.3と小さい。このことから、応答曲げモーメントが降伏曲げモーメントを最初に越えた時点で破壊する可能性があると考えられる。また、土木学会によるコンクリートと鉄筋のせん断耐力を合わせた式により算出した終局せん断耐力²⁾

は19.3tであり、終局曲げモーメント(40.7t-m)とせん断スパン(1.9m)の比より得られる抵抗21tより小さな値となり、せん断破壊の可能性もある。

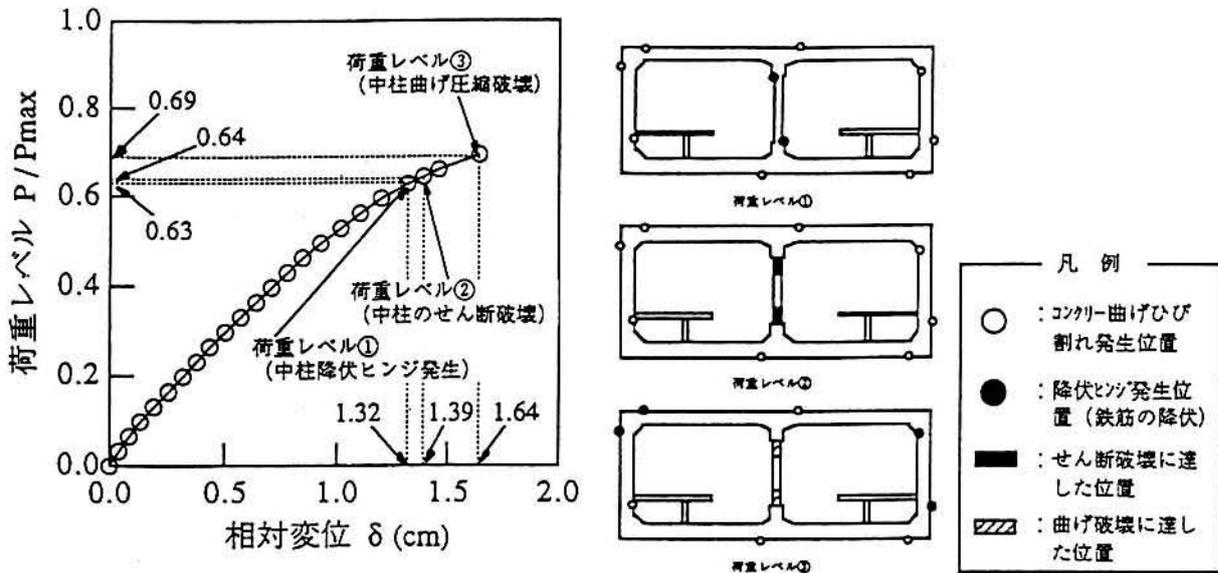
図-19 作用荷重レベルによる部材損傷モードの関係

δ の関係を図-19に示す。ここで、作用荷重は加える全荷重により正規化した比率として示している。最初に降伏する部材は中柱であり、その直後に中柱にせん断破壊が生じる。その際の他の部材にはひび割れ以上の損傷はみられない。継続的に荷重を増加すると、荷重レベルが0.69、相対変位が1.64cmになった時点で中柱に曲げ圧縮破壊モードが生じる。このことから、Aゾーンの崩壊は中柱の曲げせん断破壊により生じたものであると推測される。側壁上部ハンチ下の損傷は、地震力によるものではなく中柱の破壊に起因した上床版の変形により生じたものと推定される。

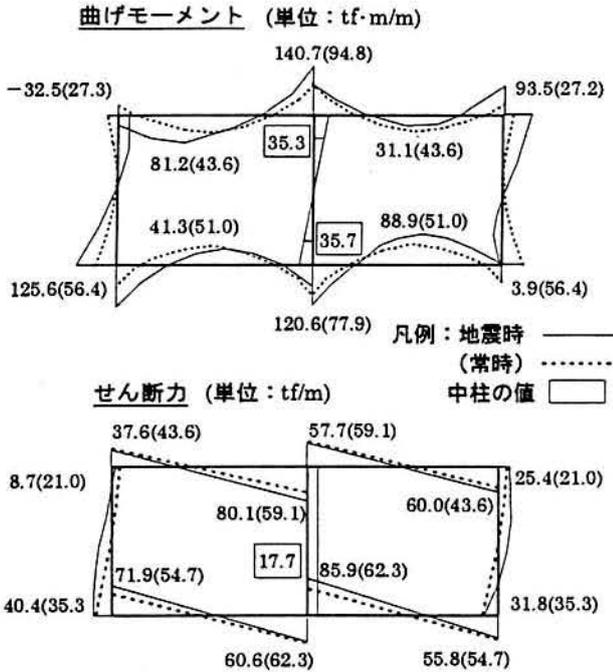
図-5 断面力分布

地震時の曲げモーメントおよびせん断力を図-5に示す。地震時の曲げモーメントは、側壁上・下端隅角部が常時に比べはるかに大きく、耐力の向上を要することから、再構築する上床版および側壁は必要鉄筋量を配置し、側壁下端隅角部は鉄筋コンクリートの増打ちで耐力増加を図った(図-6)。

図-7に配筋概要図を示す。せん断耐力向上のための帯鉄筋の増加も含め、鉄筋量の増加率は、側壁で2.5倍、上床版で1.3倍、全体で1.5倍である。中柱の断面力は、3.5 m 間隔であるので、1柱当たり曲げモーメント $M_d=125.0$ tf·m、せん断力 $V_d=62.0$ tfである。旧断面 0.4×1.0 m に対して、新設計では、図-8に示すように、 0.45×0.45 の角形鋼管(厚さ 12 mm)を3本組合わせて耐力向上を図った結果、鋼管を帯鉄筋とみなした帯鉄筋比 p_w は 5.3 %で、せん断に対する安全性は問題無いものとなった。

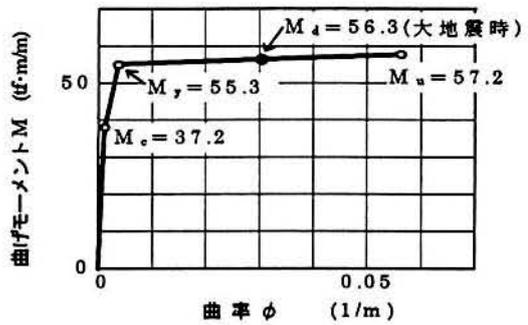
図-14 側壁下端のM-phi関係

断面力および躯体の変位量の計算結果を図-12に、各部材の発生曲げモーメントの非線形状況を図-13に示す。側壁下端の曲げモーメントが降伏曲げモーメントを超えているが、図-14に示すように終局曲げモーメントには十分入っている。一方、図-15に示すように角形鋼管柱の曲げモーメントは降伏曲げモーメントに対して余力を残している。

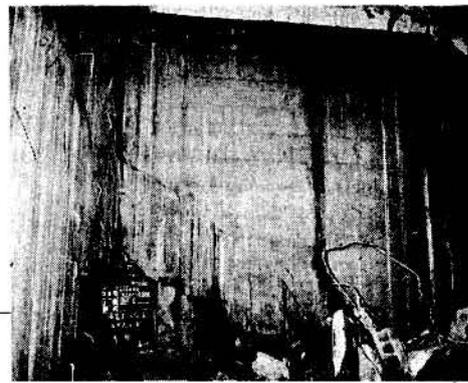
写真-1 妻壁のひび割れ

プラットホーム端部にある妻壁のひび割れの発生状況を写真-1に示す。その程度は新開地駅側の妻壁のより多い。

プラットホーム端にある妻壁のひび割れ数等の損傷の程度は高速長田駅側に比べ小さい。

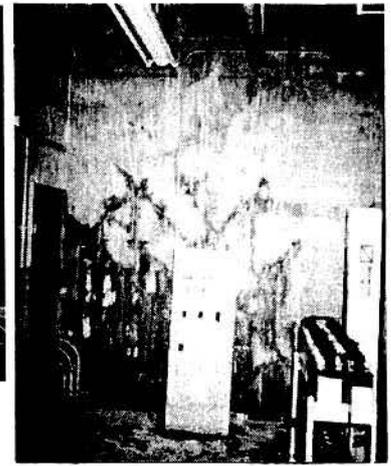
写真-2 電気室のひび割れ

地下2階にある電気室の線路直角方向壁のひび割れ発生状況を写真-2に示す。開閉所の壁にも電気室と同様にX方向にせん断ひび割れが発生しており, かなりの水平方向地震力が線路直角方向に作用したことが分かる。

る。Bゾーンは他ゾーンに比べ土被りが少ないため中柱に作用した常時・地震時の軸力が比較的小さいことに加え, 線路直角方向に電気室, 開閉所等の壁が多く存在し水平方向の変形を拘束したために, 被害が軽微であったと考えられる。

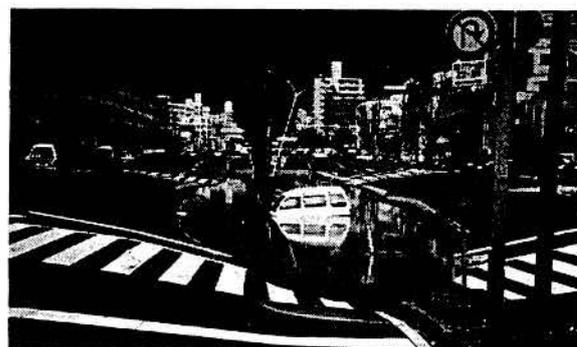
写真-1 道路陥没状況

今回の地震により大開駅の軌道階にある35本の中柱のうち31本が圧壊し、残りの4本もせん断ひび割れが生じ、これが引き金となって上床版は折れて沈下したことにより、直上の国道28号線は幅約23m、延長約90mの範囲で路面が最大2.5m陥没し、道路交通に大きな支障を与えた（写真-1参照）。

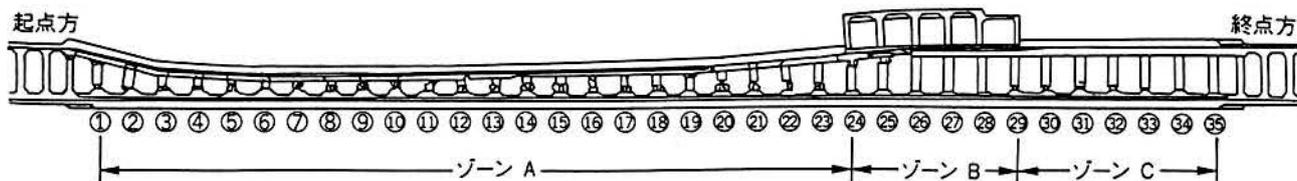
図-5 被害状況（縦断方向）

(1) ゾーンA（中柱①から⑳）

上床版は中柱が圧壊したために最大3m近く沈下し、折曲げ鉄筋が曲げ上げられて正鉄筋の本数が減少した位置である中柱中心から2m付近で折れ曲がり、線路に平行な数本の幅150~200mmの亀裂と、線路に直角にはしる多数の幅の5~70mmのひび割れが発生した。

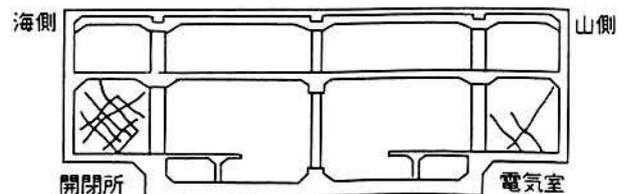
図-6 被害状況（電気室および開閉所の壁）

2層構造部分の地下2階の軌道階の中柱は㉒から㉒までは比較的被害は軽微で、中柱上端の山側および下端の海側のコンクリートにわずかな剝離とひび割れが認められる程度であった。㉒は柱の上端位置でかぶりのコンクリートがはがれ落ち、鉄筋が露出し座屈している。また㉒と㉒の間の上床桁はコンクリートが部分的に剝離し、鉄筋が露出している。階段下の両側部は電気室および開閉所に使用されているが、どちらの線路直角方向の壁にも図-6に示すようにX方向にせん断ひび割れが発生しており、大きな水平方向地震力が線路直角方向に作用したことが推測された。

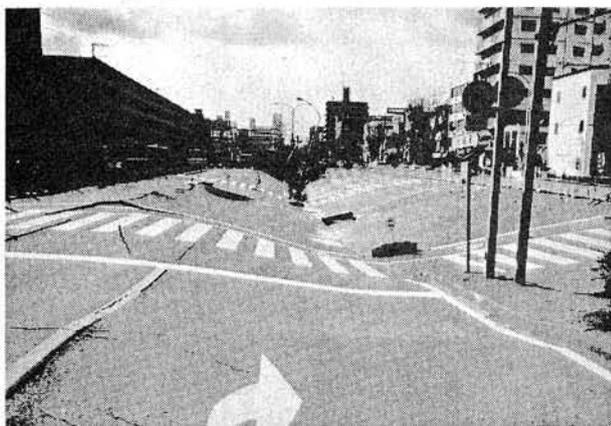
Photo. 1. National road No. 28 running above the Daikai station. Area 90 m long and 23 m wide settled more than 2.5 m at maximum because of the collapse of the station. The 5 story building on the left is the municipal Daikai apartment house

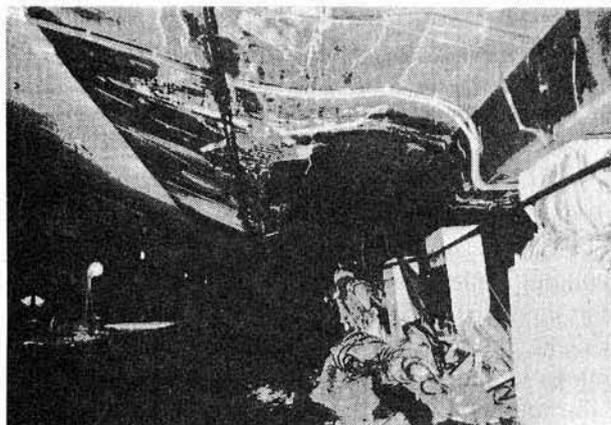
side. Almost all of the center columns completely collapsed and the ceiling slab fell down. As a result, the original box frame structure distorted to an M-shaped section as shown in Fig. 12. Typical damage to the center

Photo. 2. View of the Daikai station from the Nagata side. Center columns collapsed completely and the ceiling slab subsided

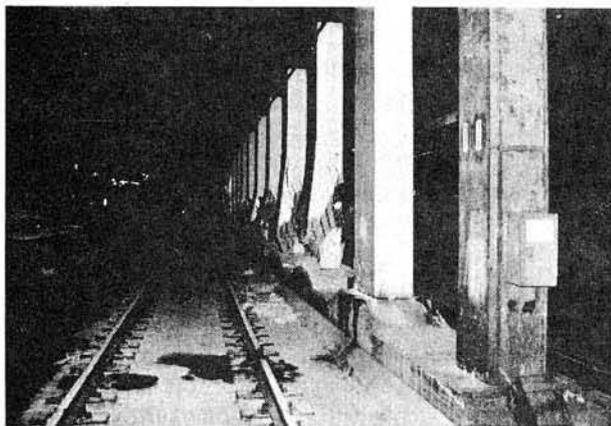
Photo. 3. View of the Daikai station from the Shinkaichi side. Damage was relatively less compared with the Nagata side

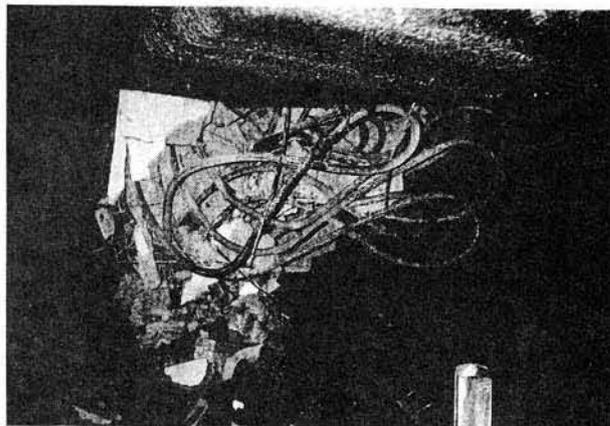
There were two types of collapse pattern in the center column in zone A; collapsed portion bends into one direction as shown in Photos. 4 and 5 and Figs. 12(b) and (c), and in two directions in a symmetrical manner as shown in Photo. 6 and Figs. 12(a) and (d). The collapsed portion was pushed toward the mountain side in columns 7, 11, 12, 16 and 19, and toward the sea in columns 2-6, 9, 10, 20, and 21, whereas the collapsed portion was pushed out into both directions in columns 8, 13, 14, 17, 18, and 22-24.

Photo. 4. Damage to center column No. 10 where damage was the severest

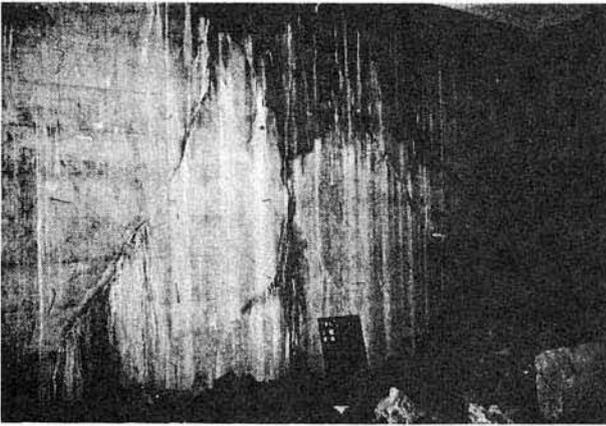
Photo. 9. Diagonal cracks appeared on the lateral wall on the mountain side at the end of the Nagata side

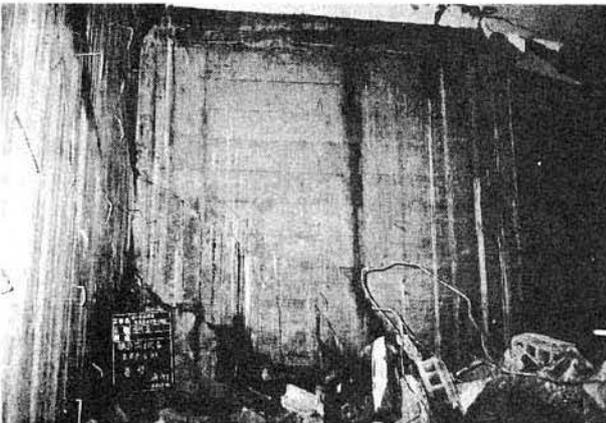
Photo. 10. Damage to transverse wall in the sea side at the end of Nagata side

There are several walls in the transverse direction: both ends, utility rooms, etc. The damage pattern of these walls is shown in Fig. 12(g)-(j) and Photos. 9 to 11. Di-

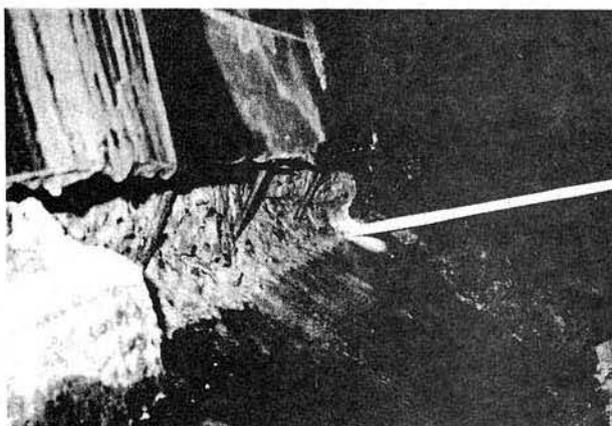
Photo. 12. Damage to lateral wall away from the Daikai station on Nagata side: Lower part of the lateral wall pushed toward the inside for about 1.0 to 4.5 cm along the boundary between lateral wall and haunch

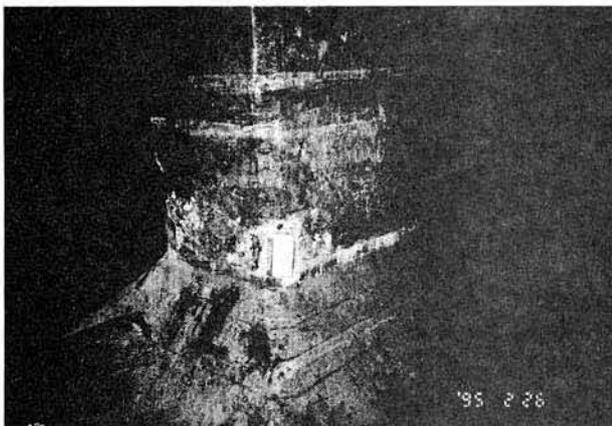
pushed inside and separation several centi-meters wide appeared on the boundary between the lower haunch on the Nagata side. Separation of the cover concrete was observed both at the top and bottom of the column as

Photo. 13. Damage to center pillar beyond the station on Nagata side

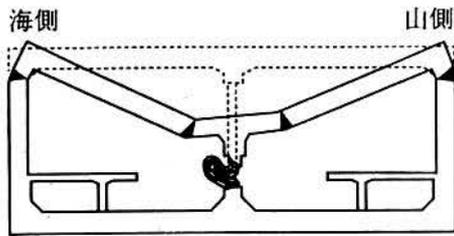
図-6 中柱(No.10)の破壊状況

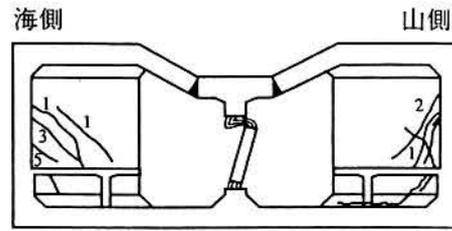
図-7 妻壁のひび割れ状況

プラットホーム端部にある妻壁のせん断ひび割れの発生状況を図-7、写真-2に示す。その損傷の程度は新開地駅側の妻壁に比べ大きい。

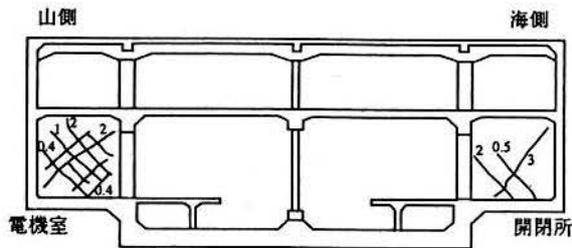
図-8 電気室・開閉所のひび割れ状況

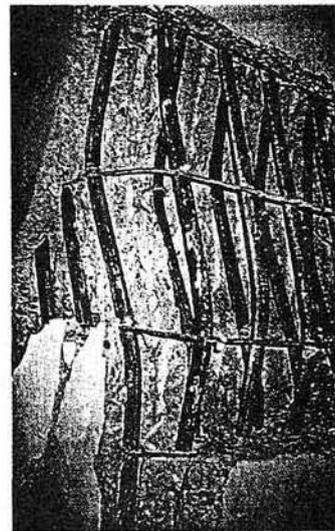
写真-5 中柱の帯鉄筋の効果

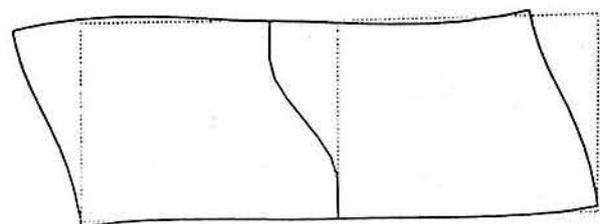
断ひび割れの状況やCゾーンにおける中柱の破壊状況に基づいて被害状況から判断できる駅舎Aゾーンの破壊のメカニズムを推定すると、周辺地盤の震動により駅横断方向のボックスラーメンに図-11の様な変形が生じ、中柱に発生した断面力が中柱に作用している上載土に起因する軸力に加わり中柱の耐力以上の断面力が作用し圧壊したものと考えられる。Cゾーンは中柱の破壊という意味ではAゾーンと同様であると考えられるが、妻壁の損傷が高速長田駅側より少ないことから駅横断方向の変形がAゾーンより小さく、上床版が被害の軽微なBゾーンの中床版とプラットホーム端の妻壁などに支えられた正方

図-11 構造物の変形(実線:地震時,破線:地震前)

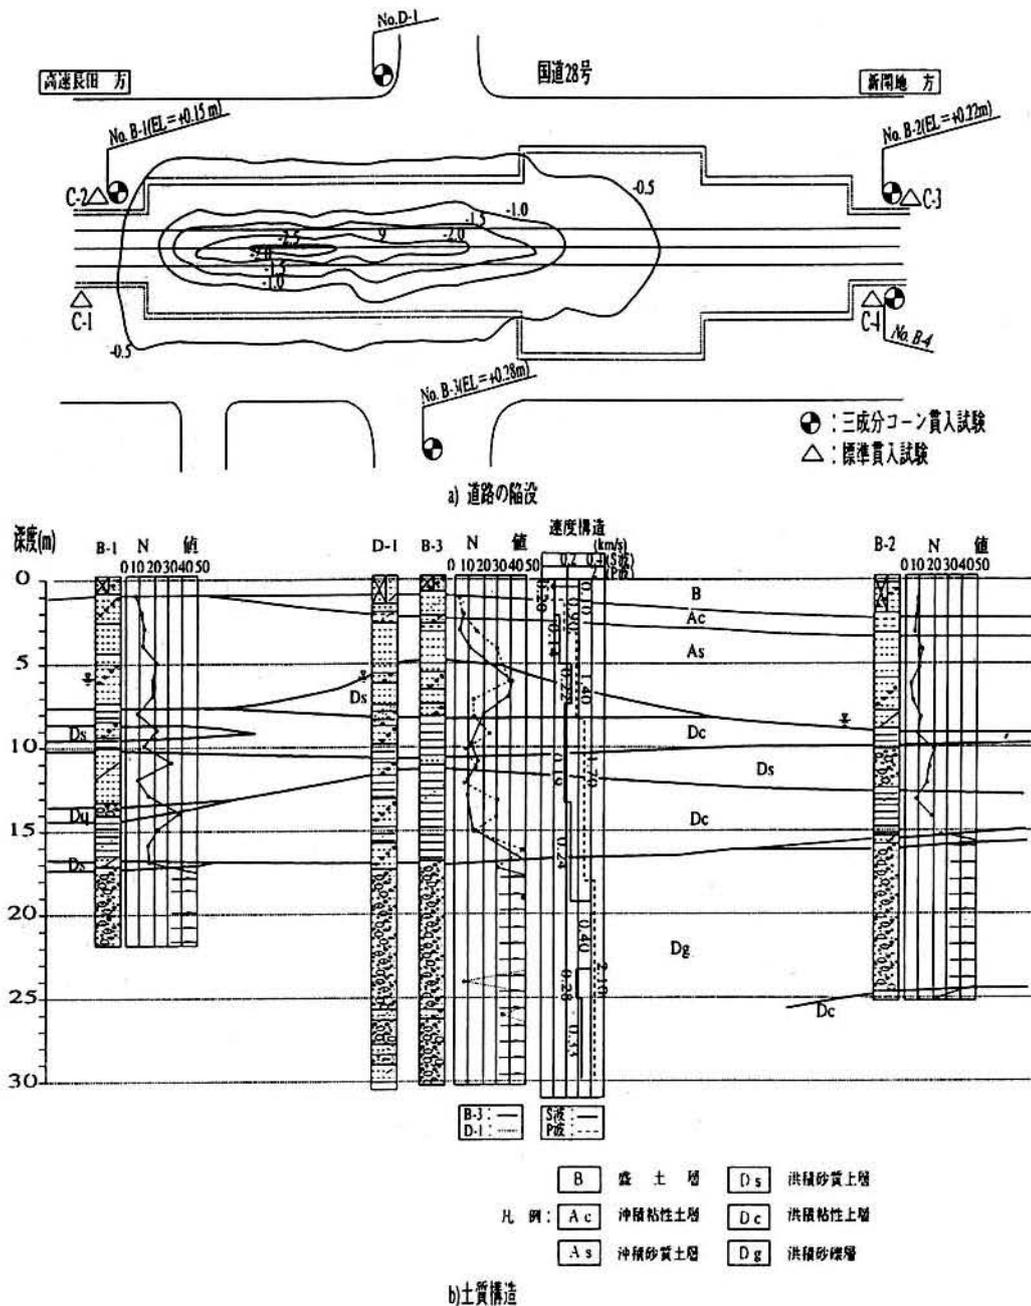
図-12 道路の陥没および土質構造

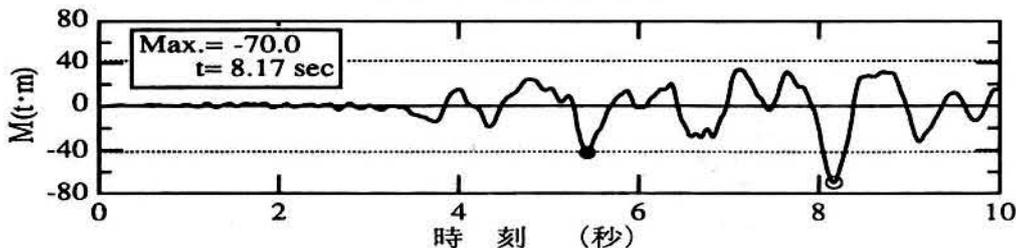
図-27 中柱に発生する曲げモーメント

図-26に示す。図には常時の断面力も合わせて示す。これらの値はいずれも単位奥行き当りの値である。曲げモーメントは、側壁、上・下床版とも外側鉄筋が引張り状態を正、中柱は左側が引張り状態を正としている。中柱の軸力に着目すると、常時に97.1～102.4t前後(約88kgf/cm²)、地震時に55.2～56.4t(約48kgf/cm²)であり、表-1に示した中柱コンクリートの設計基準強度に対する比率は68% [= (88+48)/240]、調査や試験により得られた地震時推定強度の26%とかなり高い値となっている。中柱上端部(梁下)における曲げモーメントの時刻歴と常時軸力に対して算出した終局曲げモーメント(図中破線)の関係を図-27に示す。これより、最大曲げモーメントの発生時点8.17秒近傍のみならず5.3秒近傍にて応答曲げモーメントは部材の終局曲げモーメントより大きな値となっている。側壁や上・下床版の隅角部においても同様な傾向が見られる。

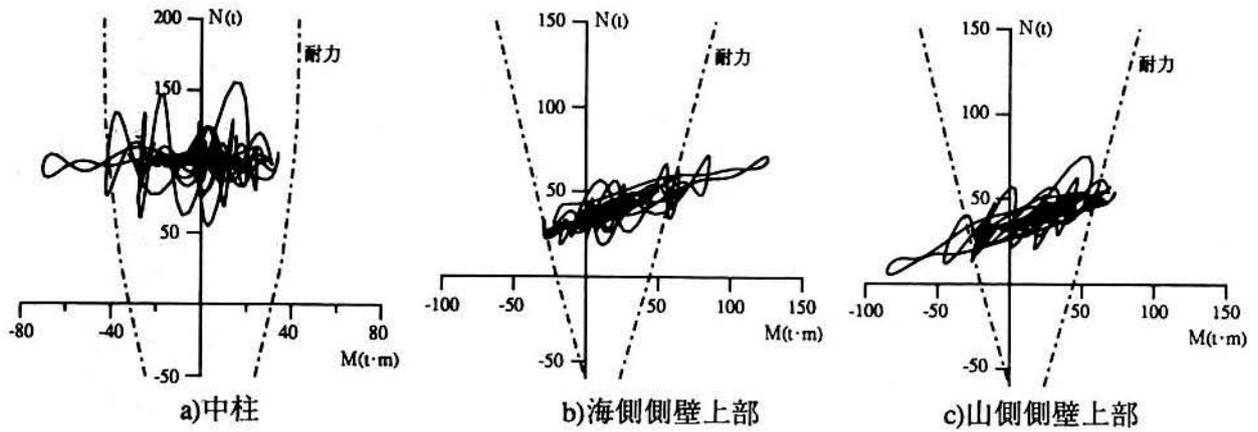
図-29 発生断面力の経時変化

応答軸力の変動が終局曲げ耐力に及ぼす影響を把握するため、常時軸力を加えた作用軸力と地震応答曲げモーメントの経時変化と各部材耐力との比較を図-29に示す。側壁においては応答曲げモーメントの増加とともに軸力が増加するという相関がみられる。一方、中柱の応答断面力は部材の耐力近傍で軸力と曲げモーメントが大きく変動しており、中柱の損傷には両者の変動が密接に関連していると考えられる。

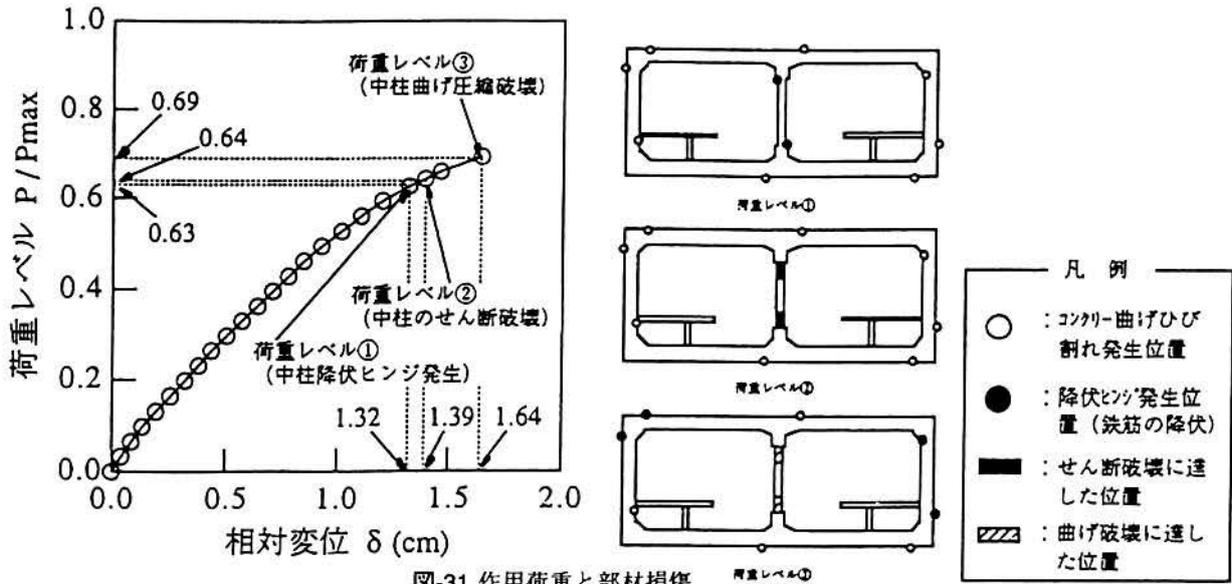
図-31 作用荷重と部材損傷

まず、作用荷重と上床版と下床版の水平方向の相対変形 δ の関係を図-31に示す。ここで、作用荷重は水平方向に作用した荷重の和を最大作用荷重の水

平成分の和(動的解析により得られた節点力のうち水平成分の和)により正規化した比率として示している。最初に降伏する部材は中柱であり、その時の荷重レベルは0.64、変形は1.32cmである。この中柱が降伏した直後に、中柱にせん断破壊が生じる。その際の他の部材にはひび割れ以上の損傷はみられない。本来は、ここで中柱が上床版の支持柱として役割を果たさなくなり圧壊するものと考えられるが、継続的に荷重を増加すると、荷重レベルが0.69、相対変形が1.64cmになった時点で中柱に曲げ圧縮破壊モードが生じる。

この解析ではAゾーンの崩壊は中柱のせん断破壊により生じたものであると推定されるが、せん断破壊から曲げ圧縮破壊に至る荷重レベルの差異は0.05と小さいことや、部材の強度特性のばらつきを考えれば、損傷モードとして曲げせん断破壊であろうと推定される。

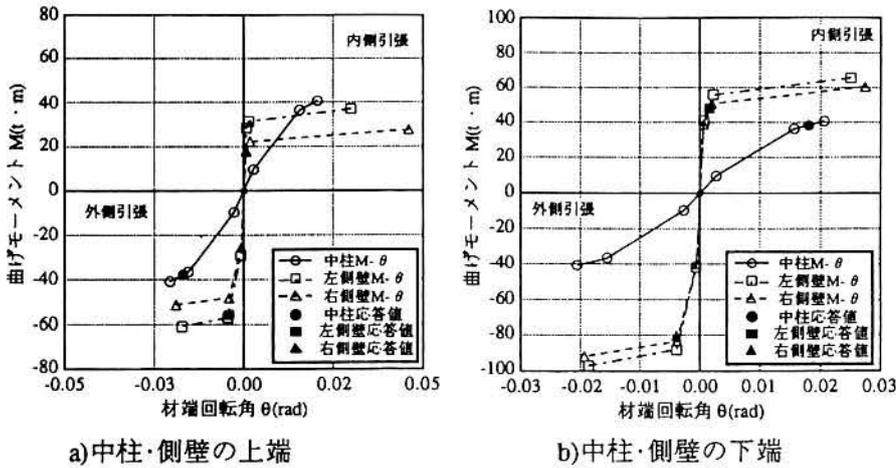
図-32 中柱・側壁の復元力特性と応答断面力

一方、側壁上端や上床版には中柱が曲げ圧縮破壊した時点で曲げ降伏が生じる。それら部材の変形性能を明らかにするため、図-32に中柱がせん断破壊した時点での、中柱と側壁部材端のバネ要素の復元力特性(曲げモーメントと回転角の関係)と発生曲げモーメントの関係を示す。破壊時における中柱と側壁の回転角が異なるのは、中柱が上・下床版の梁と接合し柱高さが3.82mと側壁の上・下床版の内寸より小さいことに起因している。側壁の曲げ破壊に対する変形裕度は中柱が曲げ圧縮破壊時つまり側壁の曲げ降伏時における上・下床版の相対変位1.69cmの3.7倍(側壁の靱性率)以上つまり5.9cm以上となり、地震応答解析により得られた上・下床版位置における構造物また地盤の最大相対変位2.7cm、3.7cmより大きな値となっている。このことから、表-3に示した側壁上部ハンチ下の損傷は、地震力によるものではなく中柱の破壊に起因して上床版が上載土荷重を支えることが出来なくなり破壊したことによる上床版の変形によって生じたものと推定される。

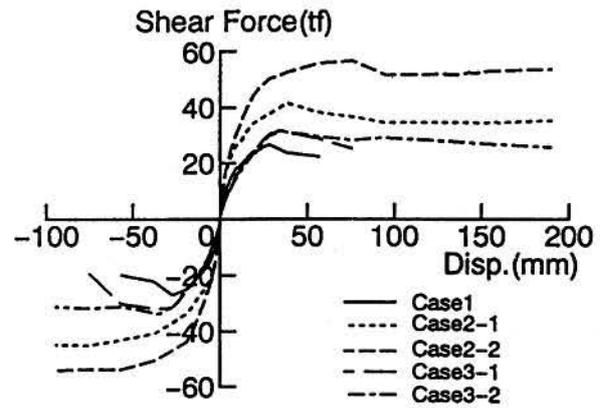
図-3 各ケースの荷重～水平変形関係のヒック包絡線

各試験体における柱頭荷重と柱頭変位関係(以後、荷重-水平変形関係と呼ぶ)のピーク値を包絡した関係を図-3に示す。図中の荷重と変位の関係は軸力によるP-δ効果を補正している。ここで加力中に破壊したCase1は最大耐力の生じる前にコンクリートに圧壊が生じ、Case3-1は最大耐力の生じる直前に鉄筋の降伏が生じていることから、両ケースの破壊モードは曲げせん断破壊であると考えられる。また、破壊に至らないケースは最大耐力の生じる前に鉄筋の降伏が生じていることから、変形モードとしては曲げ型であると考えられる。

Case1を除き大きな値となっていることが分る。さらに、表中に示したせん断耐力と終局曲げモーメントより得られた最大荷重の比より、Case1を除きその値はほぼ1.0以上であり曲げ破壊型であることを示している。しかし、実験ではCase3-1も曲げせん断破壊を示している。このことから、比較的高い軸力下でのせん断破壊の可能性の評価としてこの最大荷重比を用いる場合にその値に注意が必要であろう。最後に、復旧柱のCase2-1,2の耐力はCase1に対して、それぞれ1.5, 2.0倍とかなり向上している。

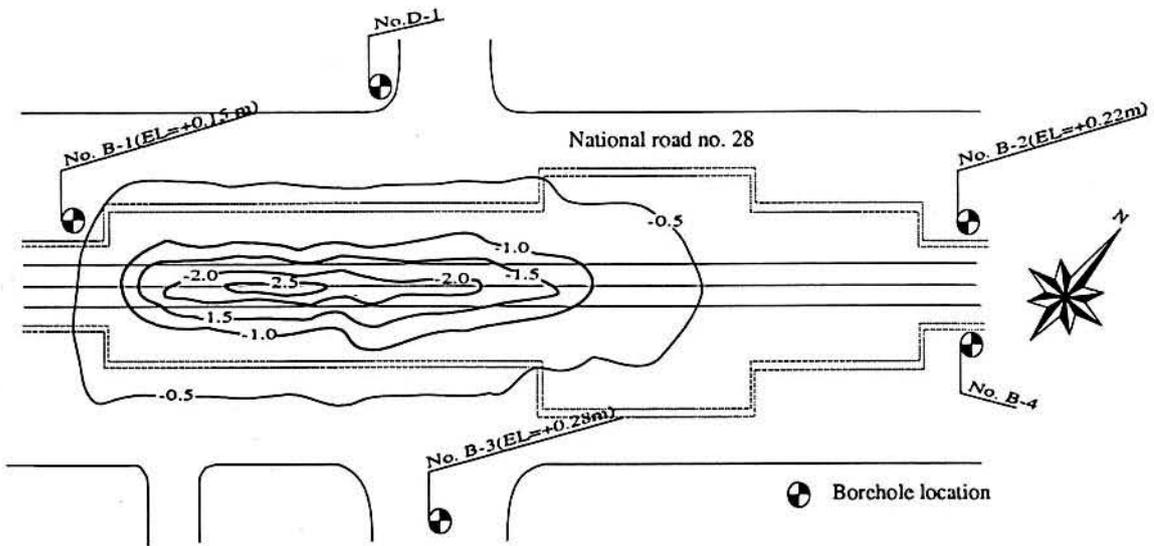
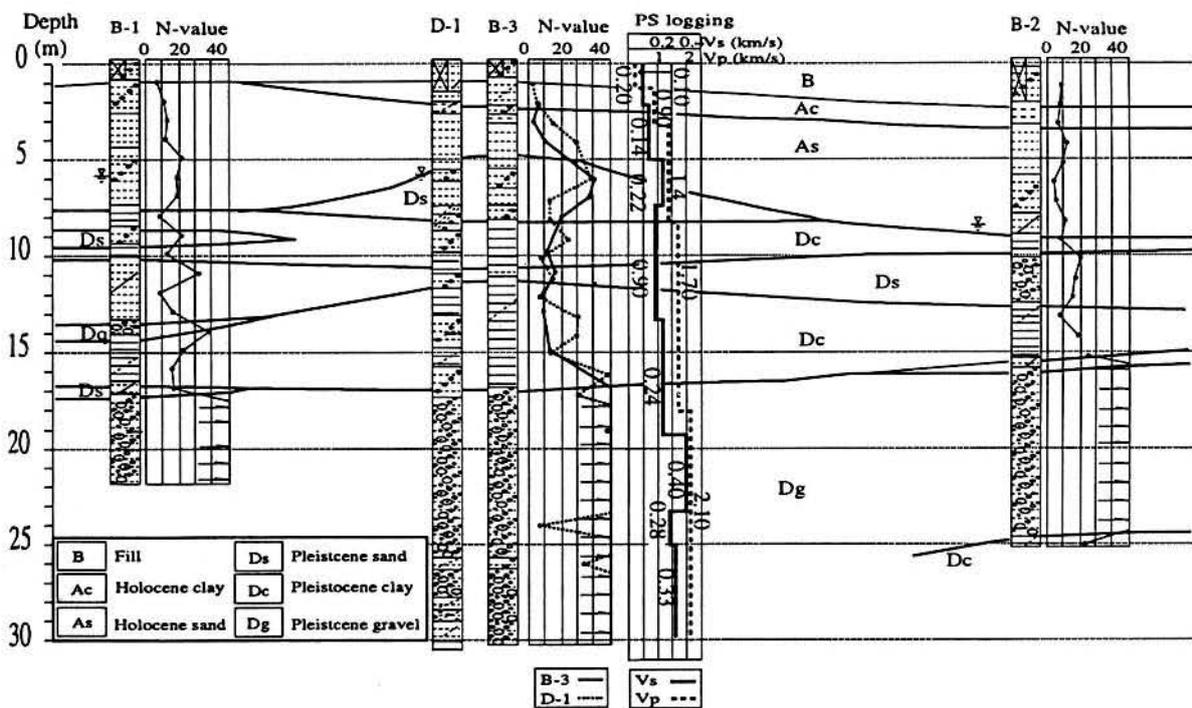
Fig. 5 Settlement of the ground surface (numeral in (a)) and soil profile based on the borehole investigation after the earthquake. Boring No.4 is fill whose SPT-N value is shown in Fig. 6.

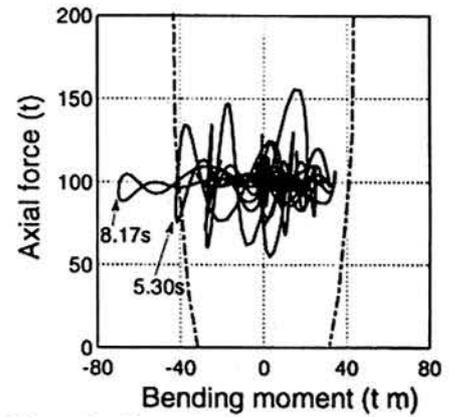
Fig. 12 Bending moment-axial force relationship at the bottom of the center column

axial force and bending moment at the bottom of center column is shown in Fig. 12. Here, axial force is the sum of the dynamic response value and initial force under ordinary load condition. In the figure, the ultimate bending moment under given axial force is shown as a chained line. The maximum axial force (sum of forces under ordinary load and increment due to earthquake) is about 1520 kN (13300 kN/m²), which is high in comparison with the strength of concrete. The ratio of the axial stress to the strength of concrete is about 0.36. Response bending moment at the bottom of the center column exceed the ultimate bending moment twice, at around 5.3 and 8.13 seconds, respectively. The same tendency is observed at the response of lateral wall, ceiling and base slab. The ductility of the center column is a very small value, 1.3. The ductility is defined as the ratio of the rotational angle of member at the ultimate bending moment to that at the yield of reinforcing bar with respect to the axial force at 5.3 seconds. Therefore, center column was possible to collapse just after the bending moment exceed the yield bending moment. Furthermore, the ratio of the shear strength of center column calculated by the Standard Specification of Reinforced Concrete (JSCE, 1991) to the converted shear force from the ultimate bending moment is less than 1.0. Therefore, center column was also possible to collapse under shear.

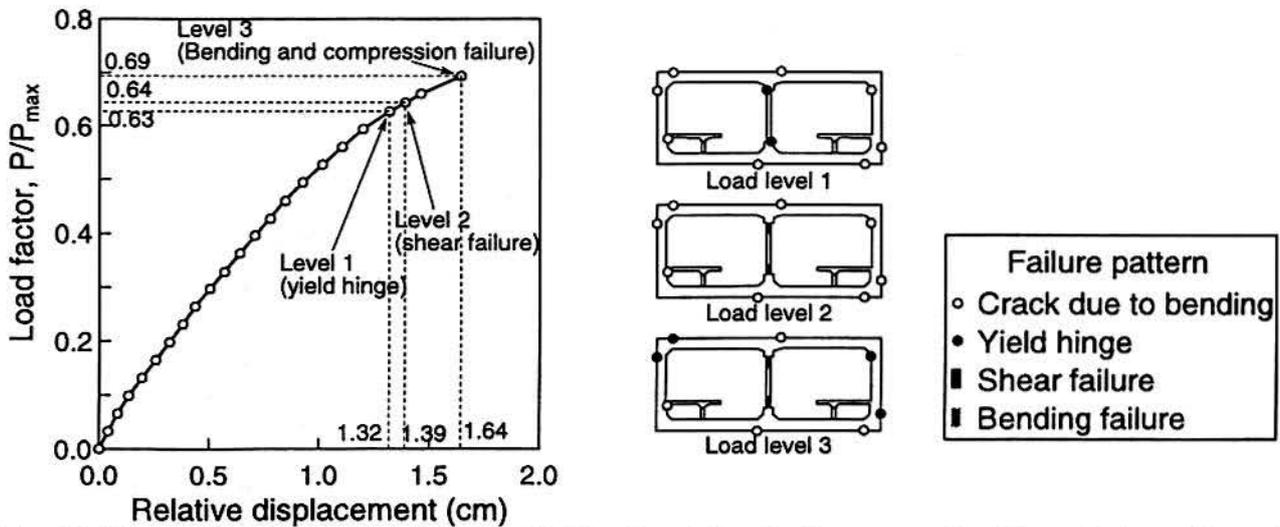
Fig. 14 The relationship between the applied load and the displacement of ceiling relative to base slab

The relationship between the applied load and the displacement of the ceiling slabs relative to base slab are shown in Fig. 14. The vertical axis (sum of the applied forces) is the normalized by the sum of the final force. Shear failure of center column occurred when the relative displacement was 1.39cm, just after the yield. Damages more than crack isn't recognized to the other members. After subsequent loading the load, bending combined with compression failure occurred right after the relative displacement and increase to 1.64 cm where normalized load was 0.69. Therefore, failure mechanism of one story box frame in Zone A is that ceiling slab failed the lack of the load carrying capacity of center column.

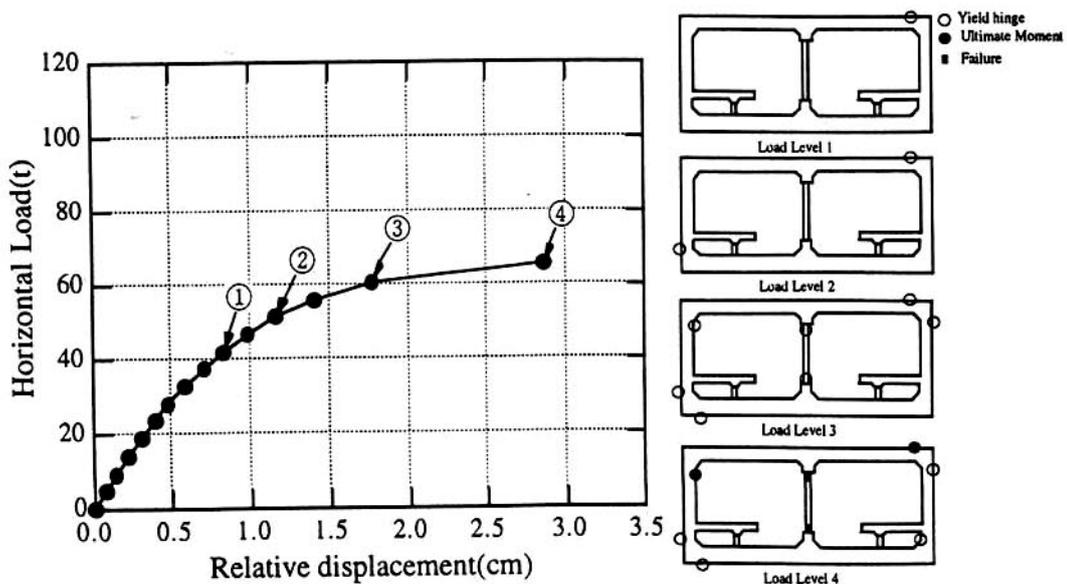
Figure 12 The relationship between the applied load and the displacement of the ceiling slab to base slab

The relationship between the applied load and the displacement of the ceiling slabs relative to base slab are shown in Fig. 12. Shear failure of center column occurred when the relative displacement was 2.89cm, just after the yield. The dynamic response of the relative displacement exceeds the ultimate relative displacement at shear failure of the center column maintained to the structure. Therefore, failure mechanism of one story box frame in Zone A is that ceiling slab failed the lack of the load carrying capacity of center column.

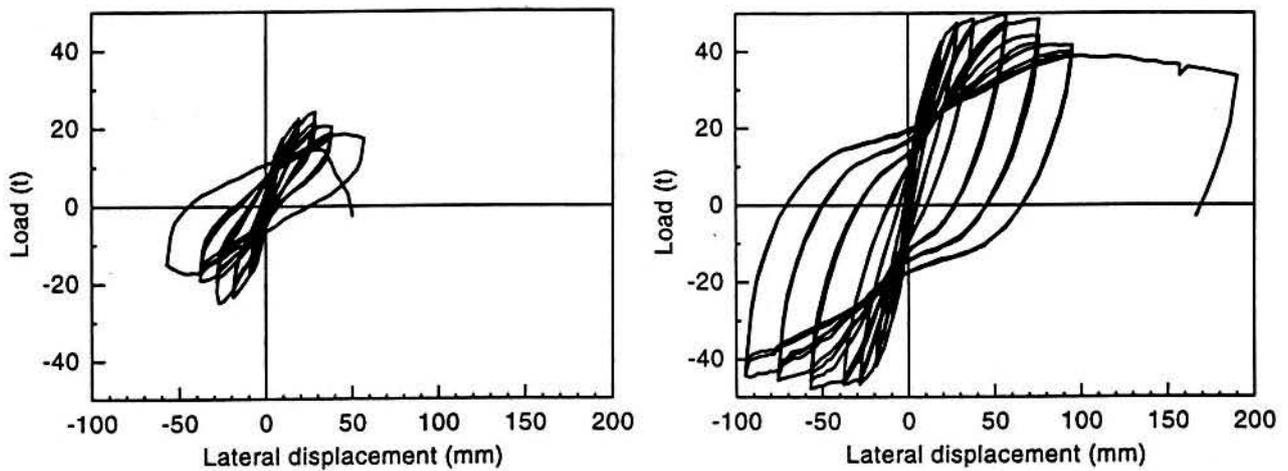
Figure 14 Load-displacement relationships of the center column obtained by laboratory test. A column with cross-section of 40×40 cm is tested. The new column is 2 times strong and several times ductile compared with original center column.

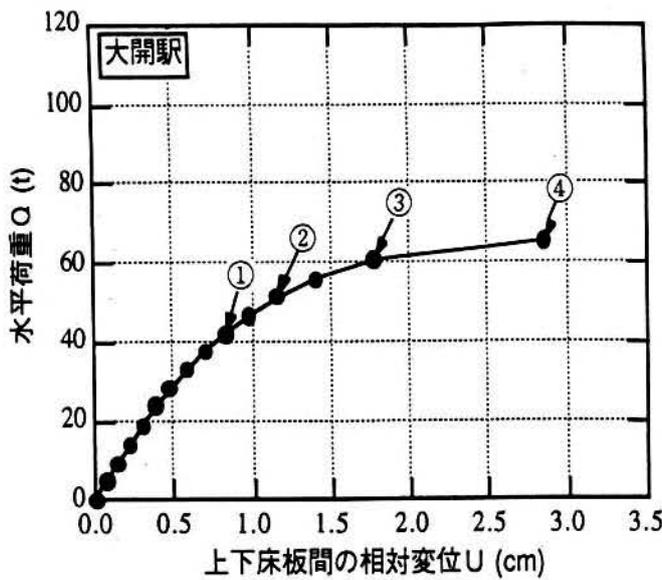
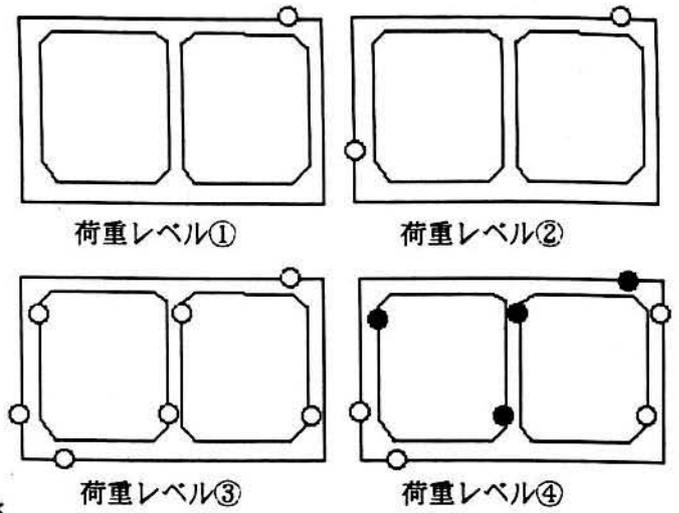
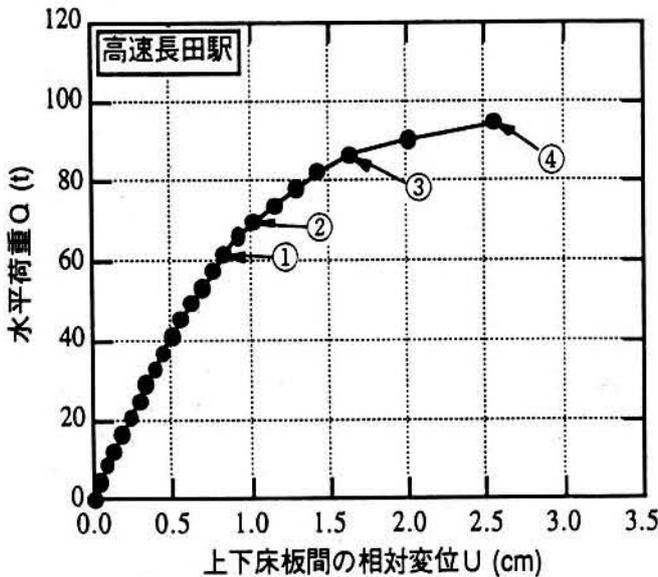
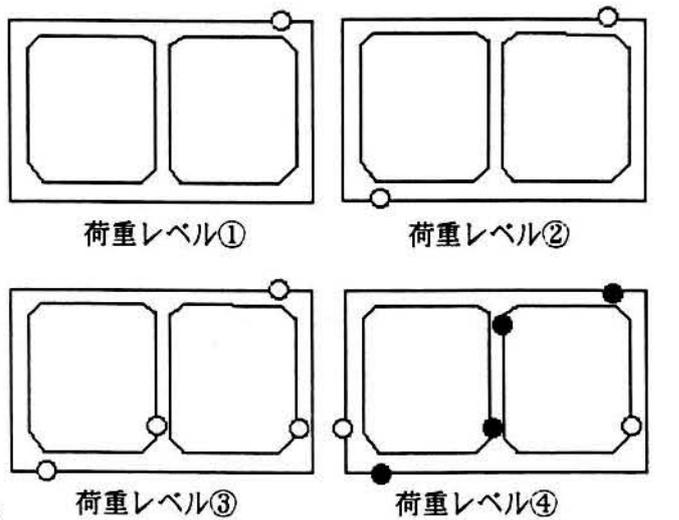
図-10 作用荷重と上下床版間の相対変位の関係

実験における終局状態は大開駅と同様のせん断破壊であることから、その終局状態は中柱のせん断破壊を意味する。これより、両駅における水平保有水平変形能は、大開駅が3.46cm、高速長田駅が2.73cmと大開駅の方が大きな値となっている。この差異は、両駅における中柱の剛性の差異及び構造物の作用す

まず、大開駅についてみると、動的応答変位3.7cmに比べ水平保有変形能は2.85cmと小さく中柱は地震時に破壊したといえる。さらに、その破壊は上床版が下床版に対して六甲山側に変形している際に生じたものと推定され、大開駅中柱の破壊のうち上床版が崩壊していない新開地側の破損状況と良く対応している。

次に、高速長田駅についてみると、動的応答変位2.7cmは水平保有変形能2.55cmとほぼ同程度の値となっている。この検討は1断面のみ検討であり、駅軸の沿った地盤の構造が必ずしも均一でないことや高速長田駅が曲線部を有していることなどから、構造物の水平保有変形能が動的応答変位に比べ大きい場合も小さい場合もあり得ると考えられる。また、高速長田駅における中柱の被災状況と比較してみると、破壊及び損傷した中柱は曲線部の16本と全体の34%であり大開駅に比べ被害が少く、この結果は被害状況にも対応していると考えられる。

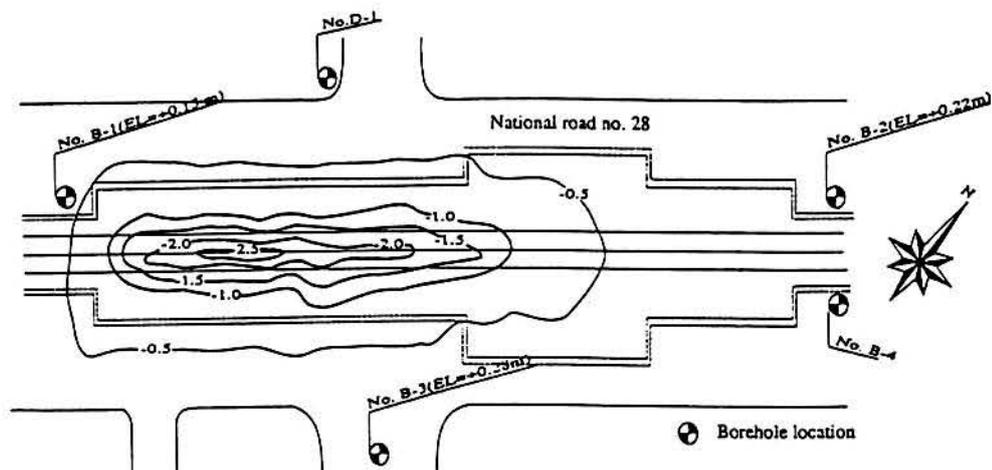
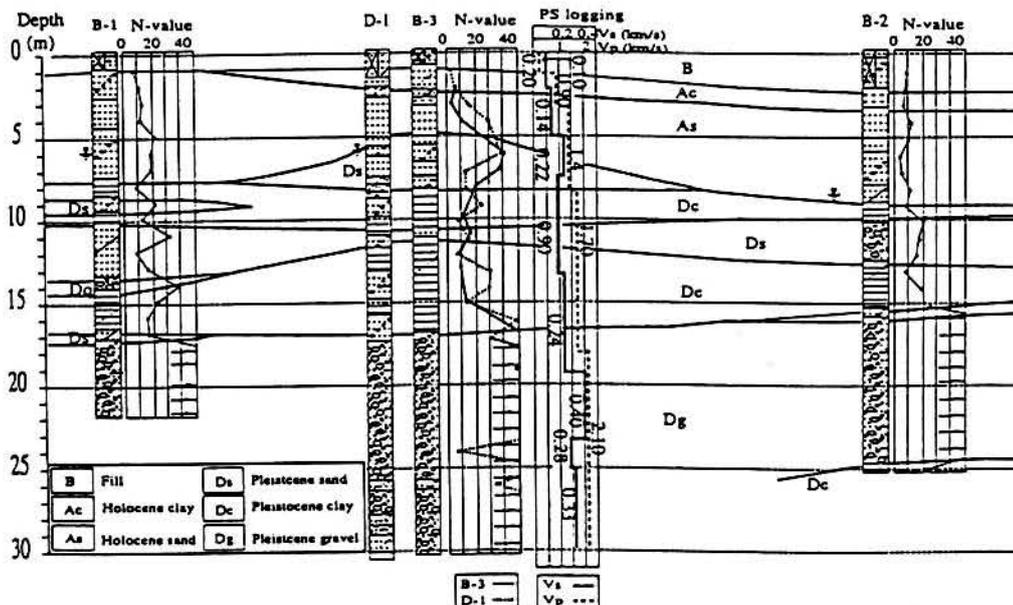
Figure.4 Settlement of the ground surface (numeral in (a)) and soil profile based on the borehole investigation after the earthquake.

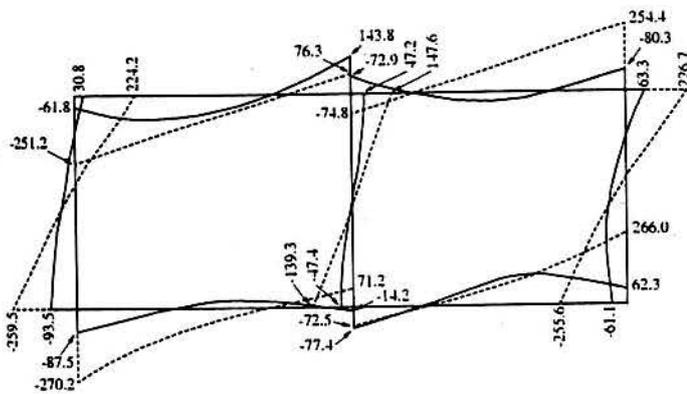
As for the structure response, the comparison of the maximum bending moment M_r distribution calculated by two dimensional analysis to that obtained by the seismic deformation method is shown in Figure.11. M_r at each corner obtained by the two dimensional analysis is extremely larger than that obtained by the seismic deformation method. The difference is caused by that of the member property model.

Figure.11 Comparison of the Bending Moment M_r calculated by both procedures. Hence, M_r calculated by 2-D analysis shown in solid line is that when the relative displacement of center pillar between the top and the bottom became maximum

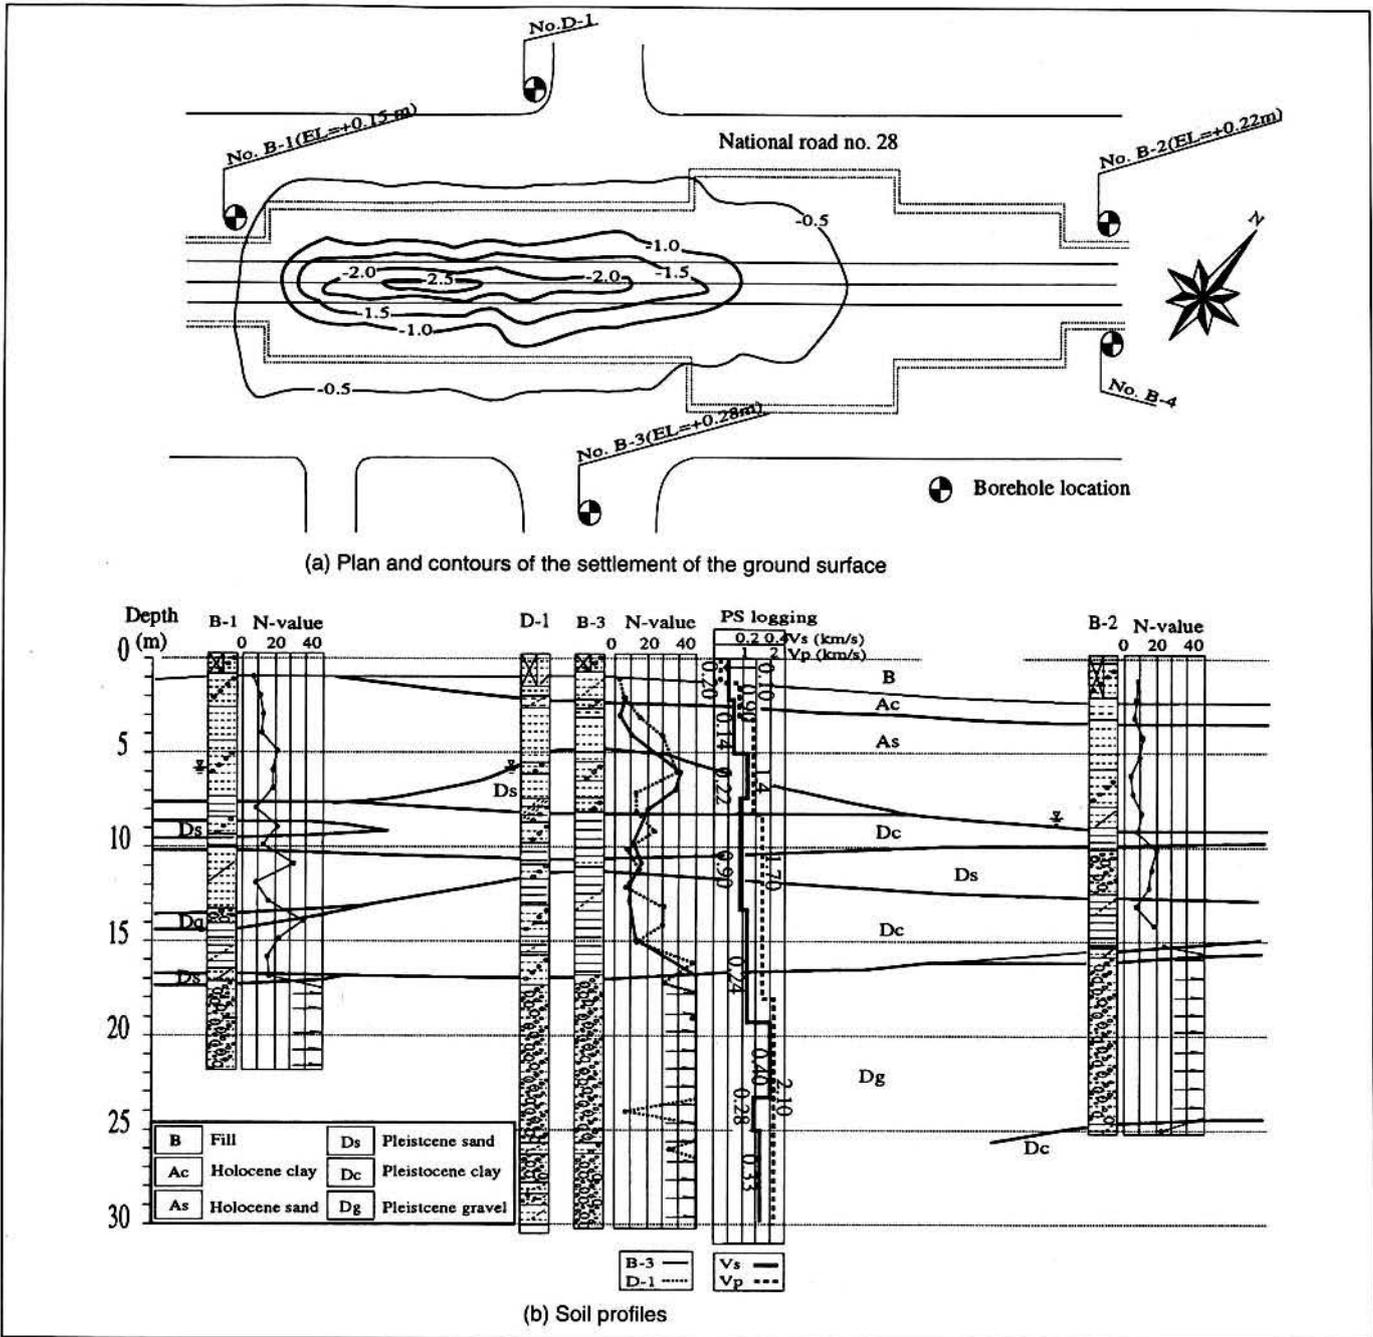
Figure 5 - Settlement of the ground surface (numeral in (a)) and soil profile based on the borehole investigation after the earthquake. Boring No 4 is fill whose SPT-N value is shown in Figure 6

settlement of the road surface are shown in Fig. 5, which was measured on January 28. Referring to Figs. 2 and 8, the station can be divided into 3 zones in the longitudinal direction along the station depending on the structural system: zones composed of columns 1-23, columns 24-29, and columns 30-35, which are designated zone A, B and C, respectively, hereafter. Zones A and C are a one story box frame structure whereas zone B has utility rooms adjacent to the platform as well as the B1 floor (concourse).

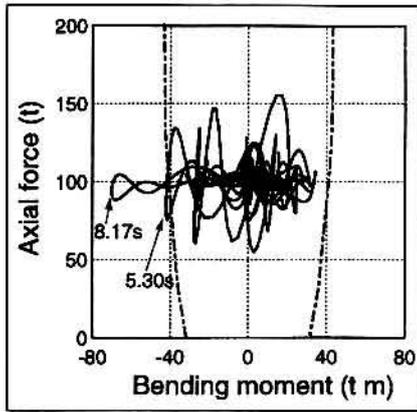
Figure 12 - Bending moment-axial force relationship at the bottom of the center column

from the center of structure. Acceleration at the ground surface is more than 400 cm/s^2 , which correspond to the JMA seismic intensity 7 around this area. The relationship between axial force and bending moment at the bottom of center column is shown in Fig. 12. Here, axial force is the sum of the dynamic response value and initial force under ordinary load condition. In the figure, the ultimate bending moment under given axial force is shown as a chained line. The maximum axial force (sum of forces under ordinary load and increment due to earthquake) is about 1520 kN (13300 kN/m^2), which is high in comparison with the strength of concrete. The ratio of the axial stress to the strength of concrete is about 0.36. Response bending moment at the bottom of the center column exceed the ultimate

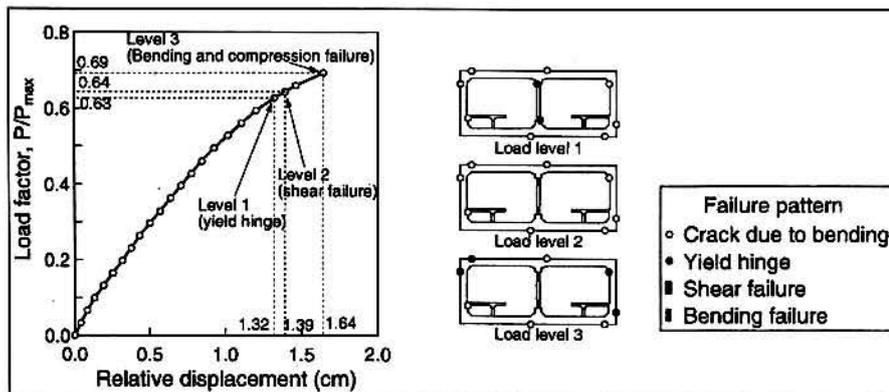
Figure 14 - The relationship between the applied load and the displacement of ceiling relative to base slab

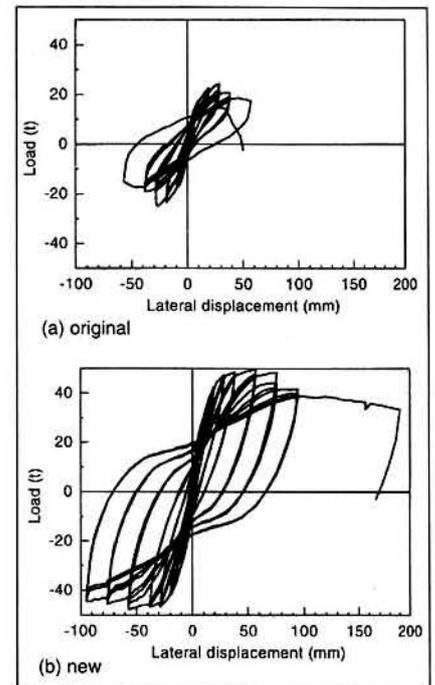
Figure 18 - Load-displacement relationships of the center column obtained by laboratory test. A column with cross-section of 40 cm x 40 cm (same depth, 1/3 width) is tested. The new column is 2 times strong and several times ductile compared with original center column.

conducted later in order to confirm the safety of the design. The safety was also confirmed by the laboratory test; the comparison between original and new design is shown in Fig. 18.
