# **Damages and disasters caused by the Great Hanshin Earthquake, Japan 1995**

Takashi Okimura 1)

**Abstract:** On 17 January 1995, a big earthquake, registering magnitude 7.2 on the Richter scale hit the western part of Japan, claiming 6,394 lives, injuring at least 40,071 people, and destroying properties and infrastructures, causing an estimated damage of between 95 to 140 billion U. S. dollars. This paper gives a detailed description of the disaster and attempts to provide a scientific explanation to the disaster.

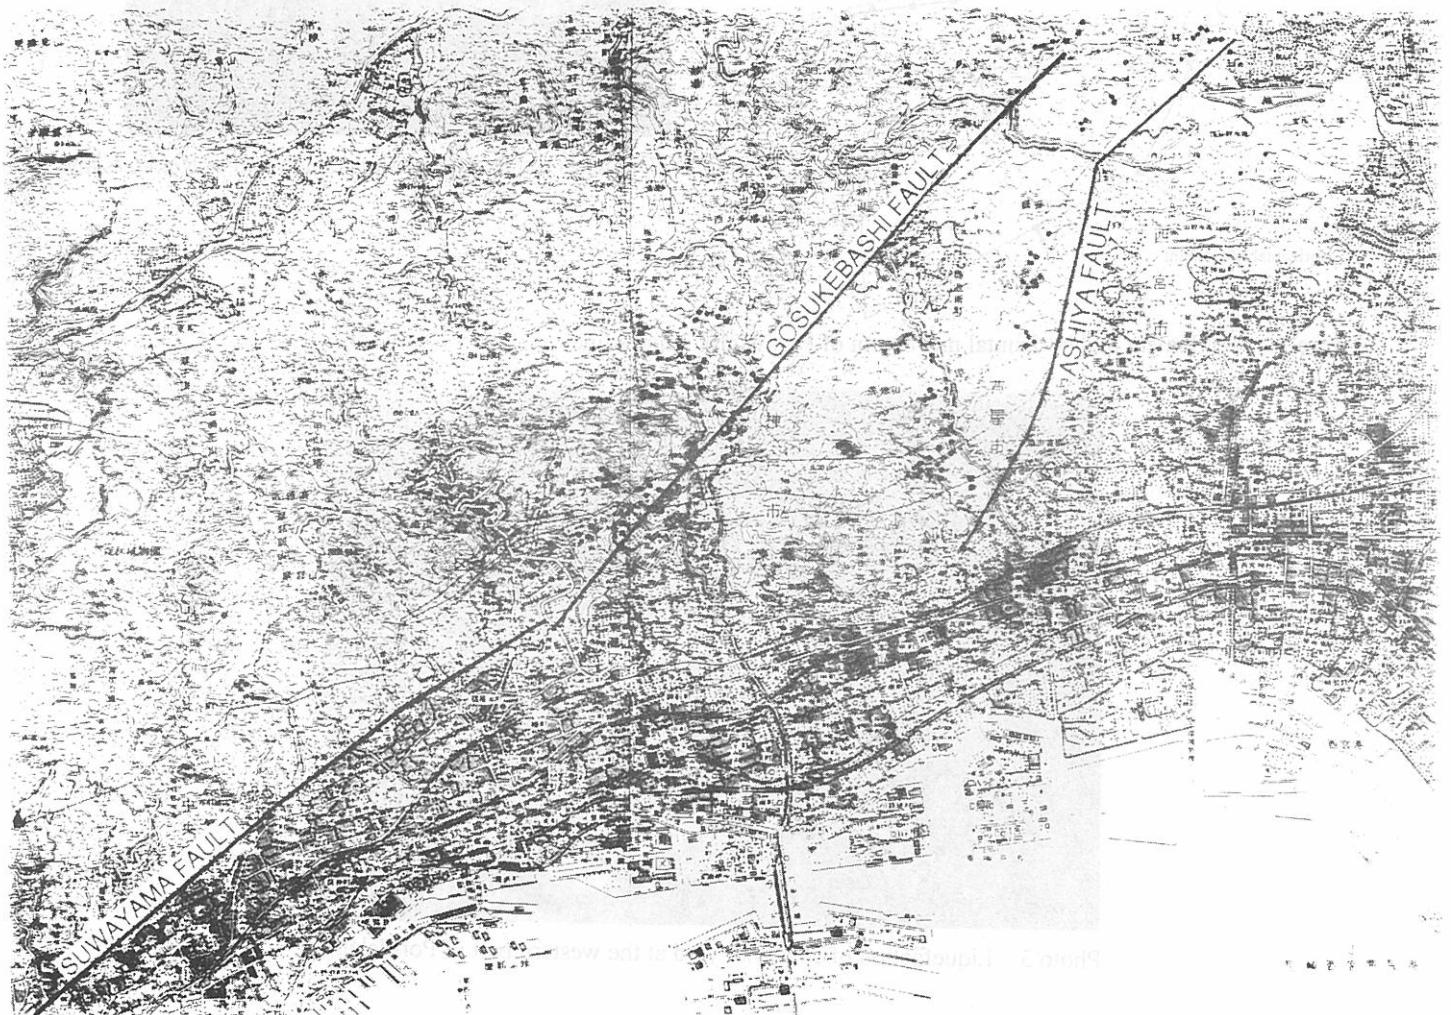
Figure 13 Distribution of the mountain slope failures at the eastern part of the Rokko mountains

Figure 13 shows the distribution of mountain slope failures at the eastern part of Rokko mountains, which is composed of granite. As a whole, these failures were distributed along two belts. The big faults, namely, Suwayama, Gosukebashi and Ashiya faults are shown in this figure. The failures occurred parallel to these faults. The reasons for this failure distribution are thought to be: (1) shear movement of these faults by the quake, (2) these failures would have appeared on steep slopes which are usually seen along faults even if there were to be no shear movements, or (3) both (1) and (2). In the near future, the causes of this failure distribution will be studied by using equi-acceleration maps.

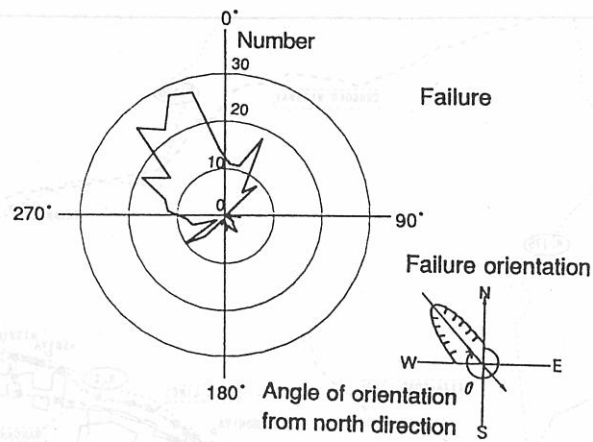
Figure 14 Orientation of the failures

Figure 14 shows the aspect of the mountain slope failures caused by the quake. The failures occurred along the NW to SE direction. There are many faults in Rokko mountains which are perpendicular to this orientation as can be seen in Figure 13. Digital maps of mesh spacing 231 by 286 m were used to obtain the aspect distribution. The results are shown in Figure 15. From this figure, it can be seen that there are more slopes whose crest are along the NE to SW direction compared to the opposite direction. The ratio of mountain slope failures to their orientation is obtained by dividing the number of failures (Figure 14) to the number of slopes (Figure 15) respective to the

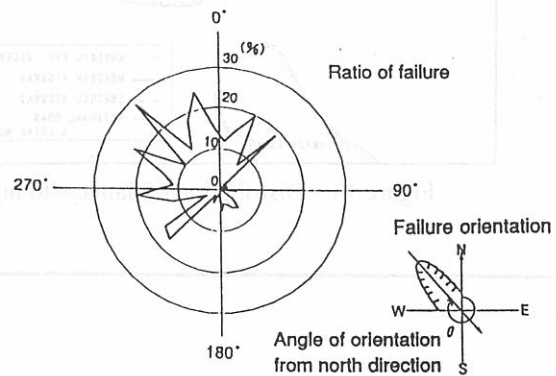
Figure 16 Ratio of failures

orientation. The results are shown in Figure 16. There were many failures along the NW to SE direction and some failures along the NE to SW direction. It may be implied that the failures along the former direction appeared on the terminal facets while the failures along the latter direction appeared on the side walls of the small valley which developed perpendicular to the direction of the main faults.

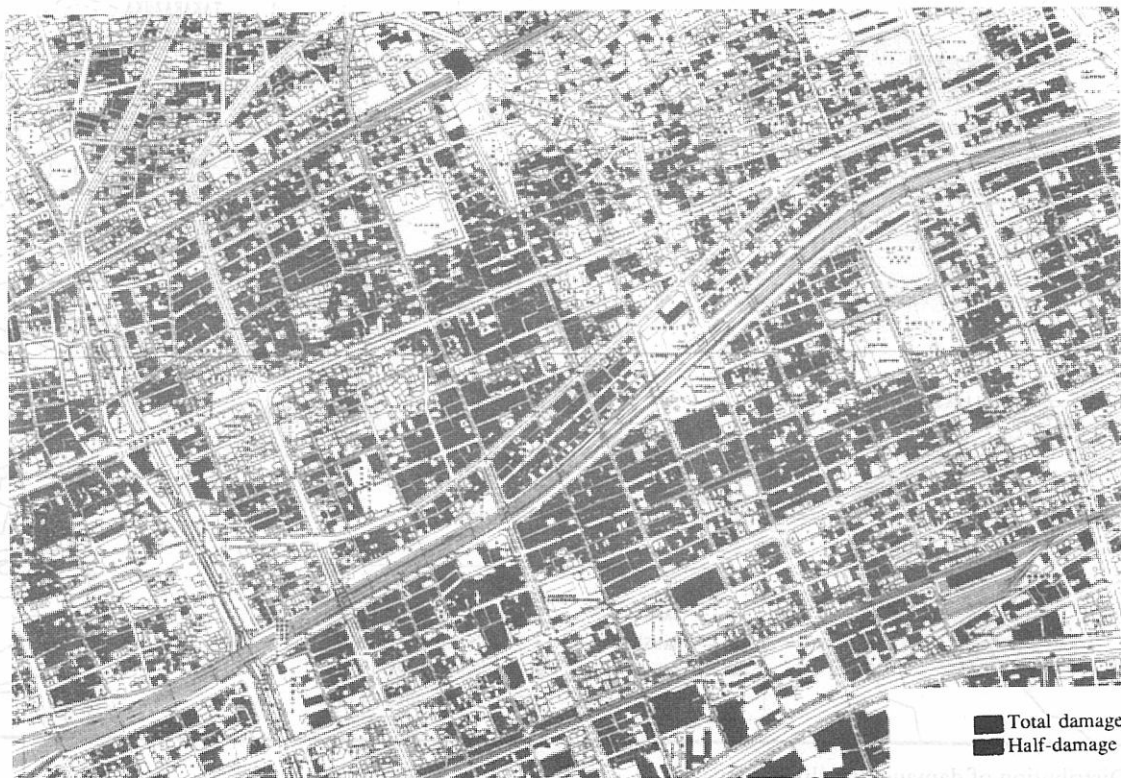
Figure 17 Part of the distribution of the damages sustained by buildings

More than 247,000 buildings were destroyed by this quake, out of which 7,119 were burned down. The majority of the collapsed buildings were old timber houses which were located parallel to the fault line and most probably, were founded on weak ground. Some of the taller buildings in downtown Sannomiya, Kobe had shear failures in their intermediate floors. More than 2,900 out of 8,863 commercial premises in Kobe city suffered heavy damages. According to a survey carried out by the board of education, about two thirds of the schools or 223 schools sustained damages, out of which about 30 schools either collapsed or were unstable while 38 other schools were severely damaged with cracks in walls and fissures on the ground. Part of the distribution of the damages suffered by buildings is shown in Figure 17.

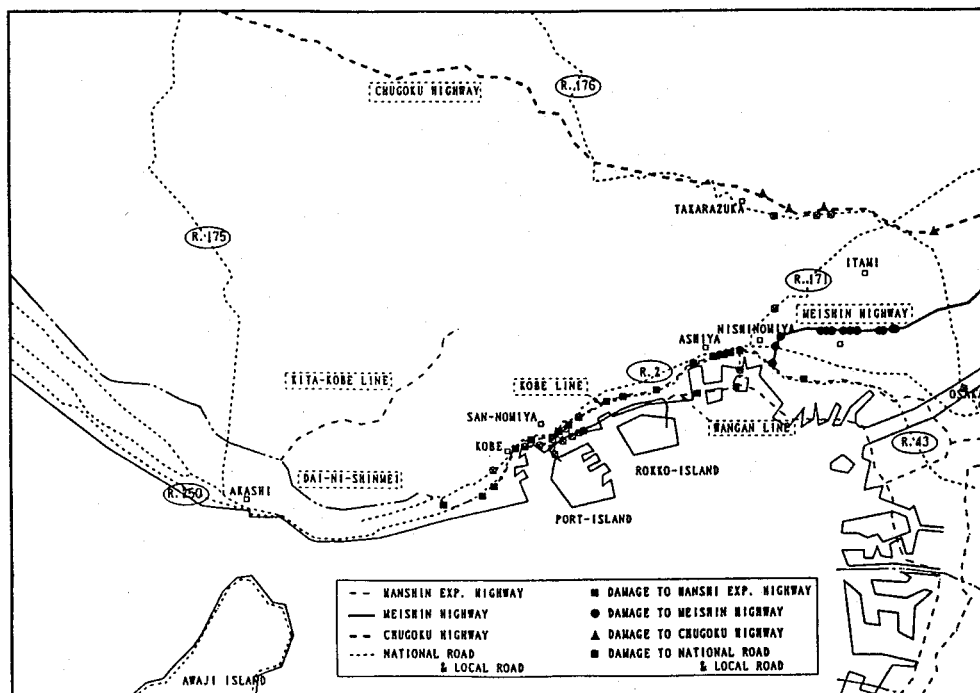
Figure 18 Distribution of damage to highway network

Two of the bridges along national route 43 completely collapsed. There were not much damage along national route 2. One of the bridges along Meishin expressway which connect Kobe to Nagoya collapsed. The longest suspension bridge in the world linking Kobe City and Awaji Island which was under construction was also affected by the quake. Both the piers on the northern part as well as on Awaji Island moved 20 and 30 cm, respectively. Examples of collapsed highway are shown in Photos 10 and 11. The distribution of the damage to the highway network is shown in Figure 18.

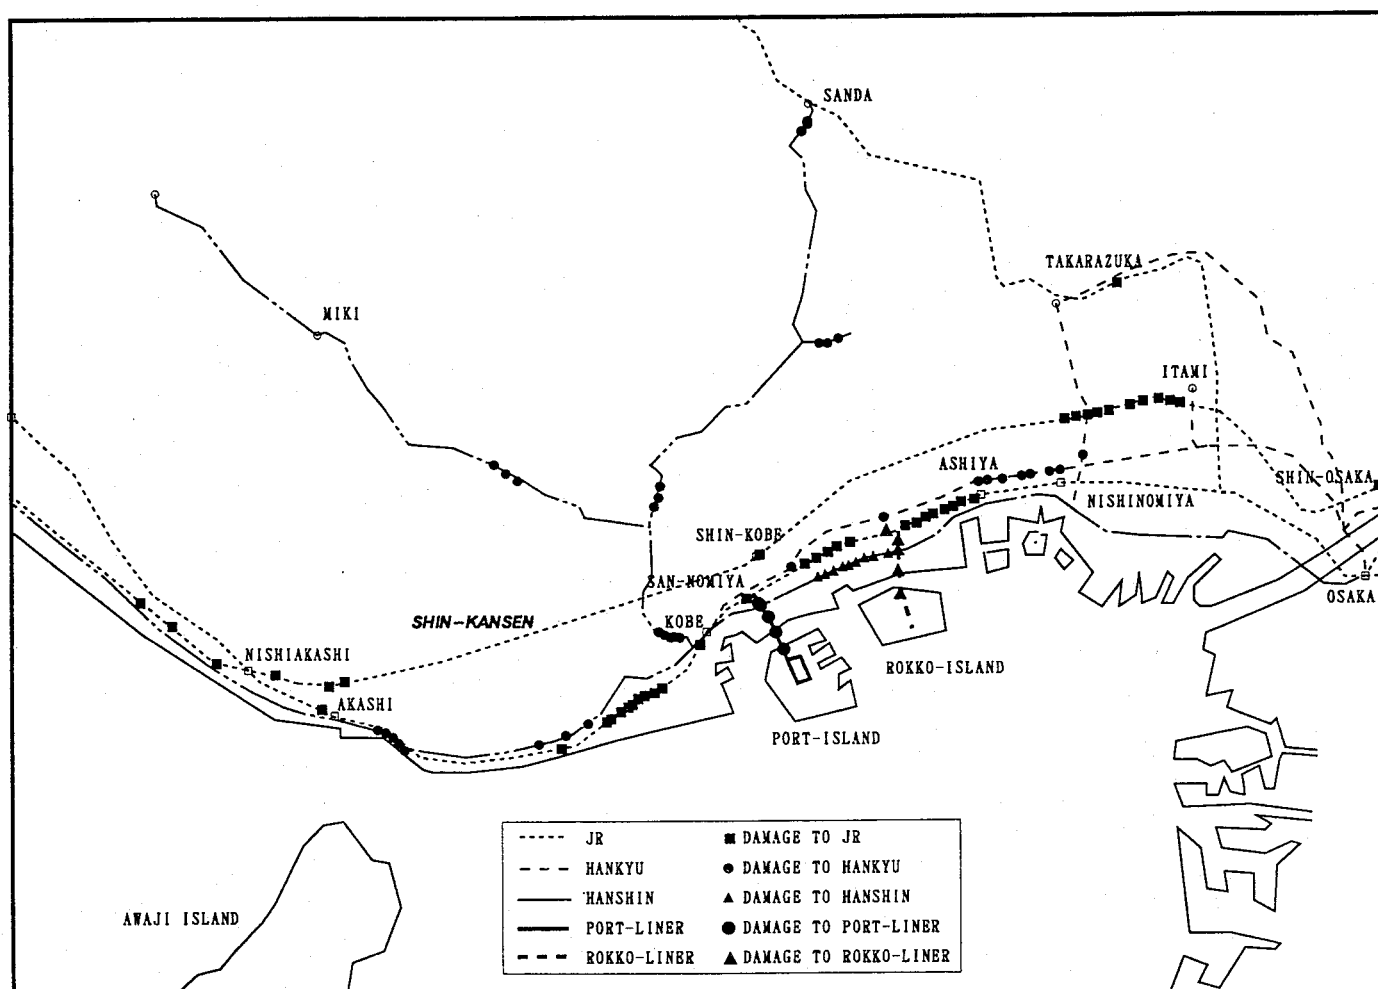
Figure 19 Distribution of damage to railway network

A number of elevated sections of the JR, Hanshin and Hankyu lines collapsed. Some of their stations were completely destroyed. 15 trains were derailed. One of the badly damaged Kobe city subway station's tunnel and 30 out of its 35 reinforced concrete columns collapsed. As explained in Section 4, the Port liner and Rokko liner both suffered severe damages with tilted, settled or collapsed columns, failed connections and/or joints, displacements of girders, etc. Examples of the damages sustained by the railway network are shown in Photos 12-15. The distribution of the damages is shown in Figure 19.
