# Observed structural bridge damage report for the 2023 Turkey-Syria earthquake

**Abstract:** On February 6, 2023, a series of seismic events, comprising two consequential earthquakes characterized by robust ground shaking, unfolded in the geographical expanse spanning southern Turkey and Western Syria. The repercussions of these seismic disturbances reverberated across a vast terrain, resulting in widespread devastation to both built structures and critical infrastructural networks. In the wake of these seismic events, the authors embarked on an investigative expedition to the affected region, more than three months after the occurrence of the seismic events. Through a meticulous examination and systematic elucidation of the facets above, this report aims to contribute valuable empirical knowledge to the scholarly discourse surrounding seismic vulnerability and resilience of critical infrastructure networks, particularly focusing on bridges, in regions affected by the events on February 6, 2023.

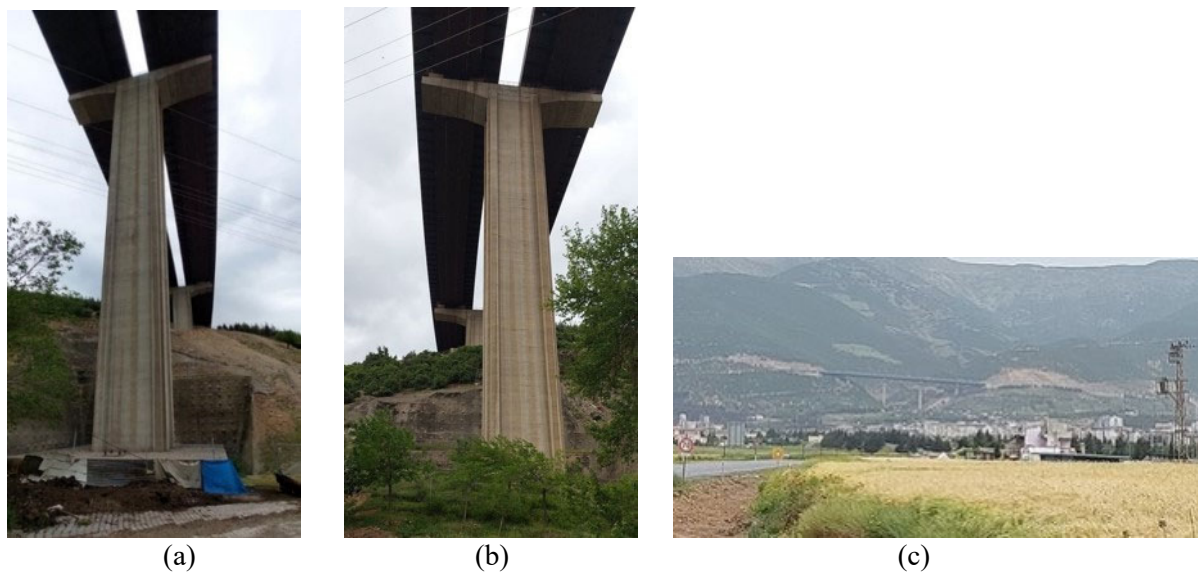
Bridge cases B and C are multiple single piers, Precast, Pre-stressed I girder superstructure with RC Columns, including two parallel lines with a slight minor curve Figure 9, located at GPS coordinates 37°11'20.3"N, 36°43'03.3"E and elevation of 641 m. No structural damages were observed in the main body of the bridge but some minor cracks on the retaining wall created for the piers were observed in Figure 10.

Figure 9 Bridge in Nurdagi (a) and (b) General view of the bridge piers and (c) General view of the bridge

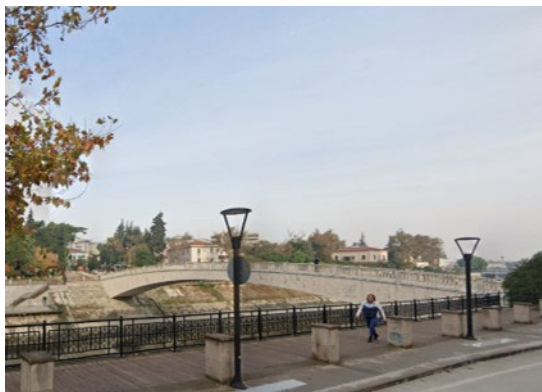
Figure 13 (a) No damaged bridge before the earthquake (b) Google Maps location (c) Non-structural damages of concrete blocks and hangers (d) Damages to structures at the opposite side of the bridge

Conversely, Figure 13(a) provides a contrasting depiction of an undamaged bridge prior to the earthquake event. Figure 13 (c) damages to structures located on the opposite side of the bridge. This figure serves as a poignant reminder of the imperative for robust seismic design and retrofitting measures aimed at safeguarding critical infrastructure against seismic hazards. The pristine condition of the bridge exemplifies the potential efficacy of proactive engineering interventions in mitigating seismic risks and preserving structural integrity.
