## Investigation on Improvement of Wide-area Damage Estimation Method for Historical Masonry Structures- Beyond The 2015 Gorkha, Nepal Earthquake -

doctoral thesis

Investigation on Improvement of Wide-area Damage Estimation

- Beyond The 2015 Gorkha, Nepal Earthquake –

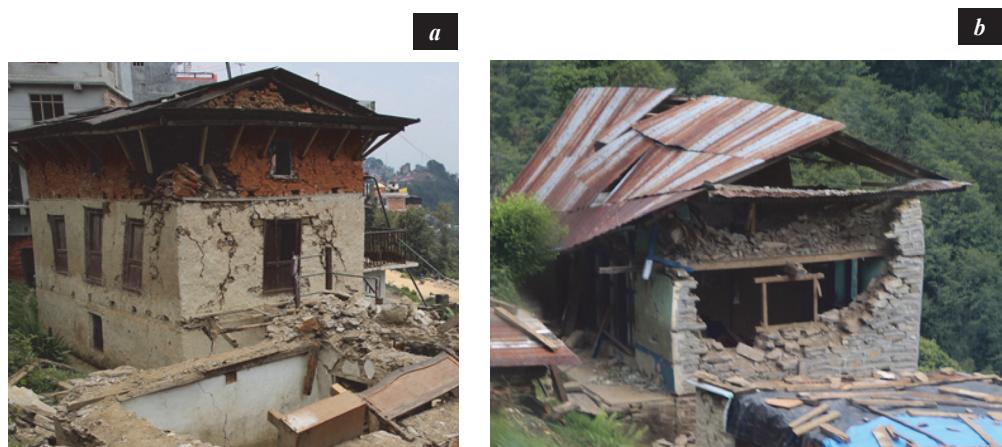
Urban and rural housing is significantly different. In the suburban and rural areas where there are many stone houses, a lot of damage occurred. The collapse of heavy stones used in house construction, resulted directly in deaths and property destruction. In Dolakha district, adobe style houses collapsed. Primarily, adobe houses collapsed as a result of cracks in the gables and corner foundations as a result of ground motion. Many adobe style houses were broken at their gables (**Figure 5**). Stone houses could also collapse as a result of delamination.

**Figure 5** Adobe style houses (a) and Stone style house (b) in Charikot,  
12  
(photo by T. Ohsumi)

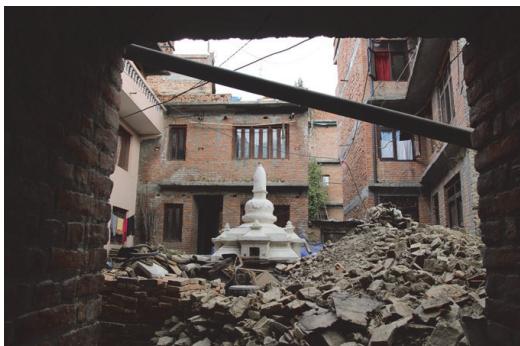
**Figure 3** Traditional buildings are gradually becoming less common as a result of rebuilding. (photo by T. Ohsumi, taken after earthquake in Sankhu)

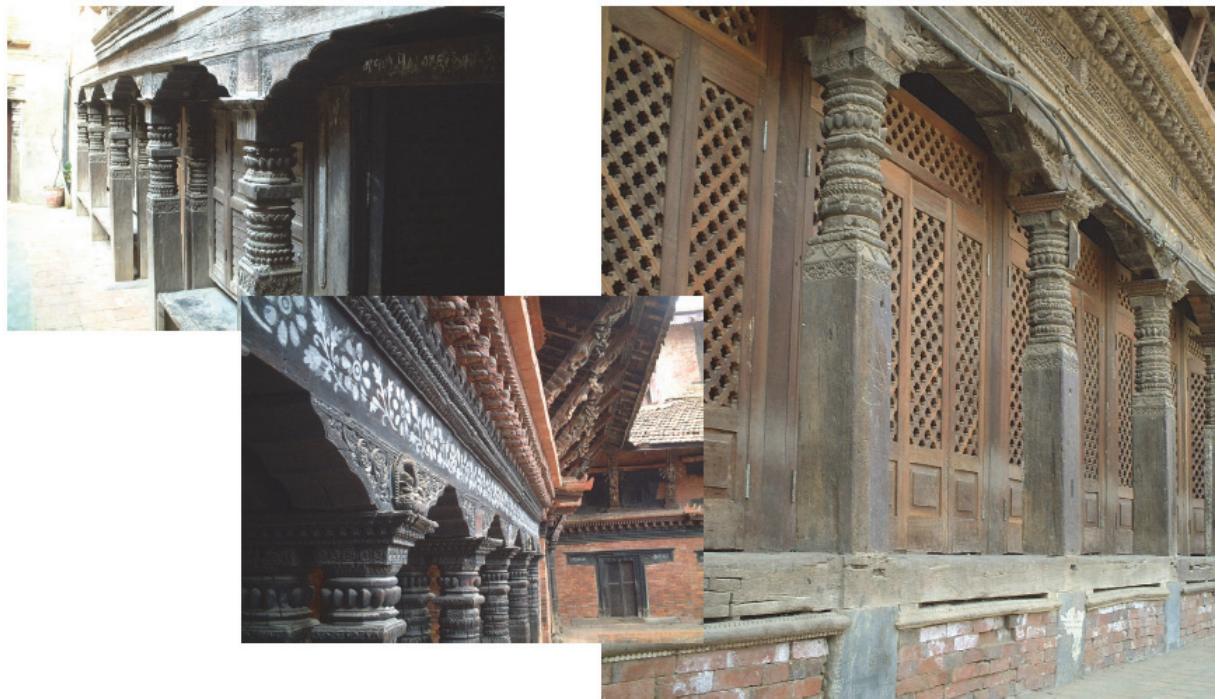
The traditional method of construction, which does not use metal with timber (**Figures 5 and 6**) has prevented degradation for a long time. Comparison of colonnade peristyle Patan Royal Palace show in 2001 (**Figure 7**) and in 2015, after the Gorkha Earthquake (**Figure 8**). Patan's vibration level of the Gorkha Earthquake is discussed in **Chapter 5**. This type of construction should be repaired using traditional methods without resorting to modern methods. **Figure 9** shows a house's peristyle colonnade and an indoor column with a sub-beam. **Figure 10** shows timber lattice replacements. New timber latticework has been fabricated to replace damaged or lost elements.

**Figure 8** Peristyle colonnade in Patan (photo by T.Ohsumi after the 2015 Earthquake).

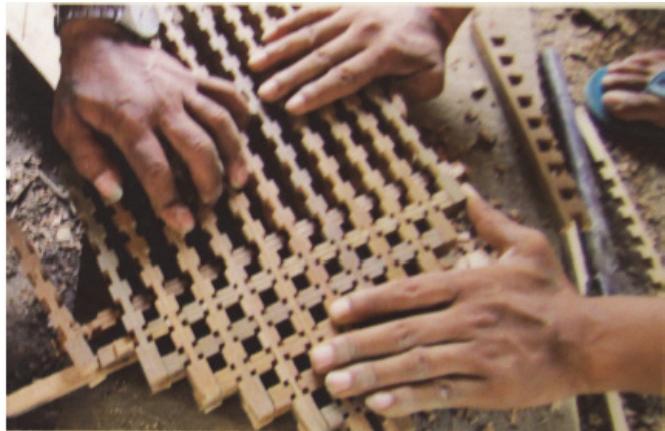
**Figure 10** Timber lattice replacements. New timber latticework has been fabricated to replace damaged or lost elements (from information plate at the Patan Museum).

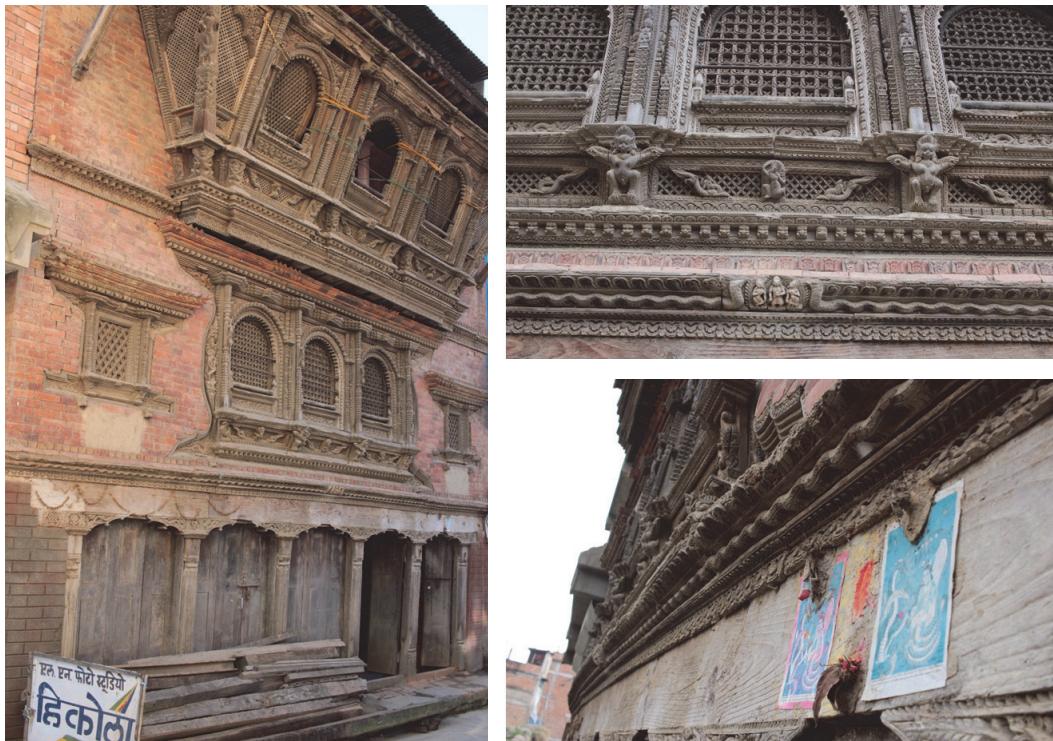
**Figure 16** shows a *Naga* band on an altar in Sankhu. A band, designed by *Naga*, has been installed between the first floor and the second floor in the house, throughout the whole building. There is a *Naga* band in a historical masonry building. Damage in Sankhu was extensive in the 2015 Gorkha Earthquake. However, this type of structure survived (**Figure 17**).

**Figure 17** Masonry building with a *Naga* band installed that survived the 2015 Gorkha Earthquake in Sankhu (photo by T. Ohsumi after the 2015 Earthquake).

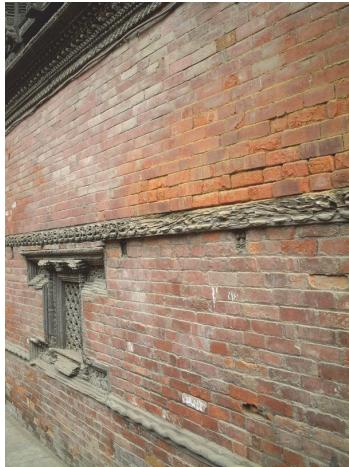
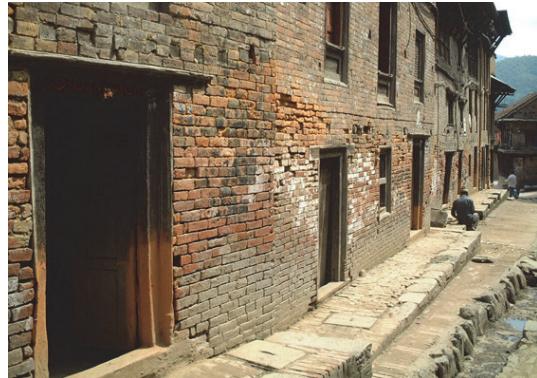
Water rises from underground, and its evaporation deteriorates the wall surface of masonry structures (**Figures 23 and 24**). Repair for the brick is required for deterioration with the prevention of the water rise. **Figure 25** shows the scree of bricks. Sun-dried bricks (adobe) of the interior are seen.

**Figure 24** Private house wall in Bhaktapur  
(photo by T. Ohsumi in 2001)

**Figure 23** Royal Palace wall in Kathmandu (photo by T. Ohsumi in 2001)

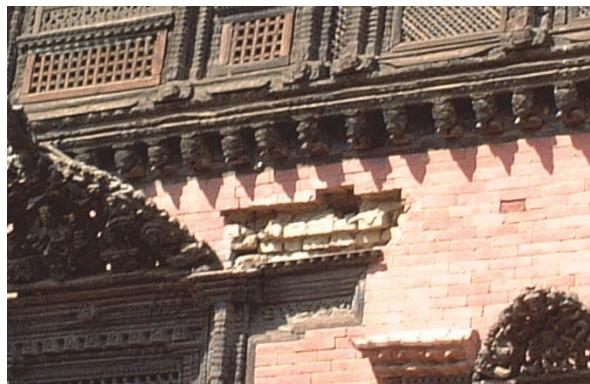
**Figure 25** Scree of bricks. Sun-dried bricks (adobe) of the interior are seen  
(photo by T. Ohsumi in 2001).

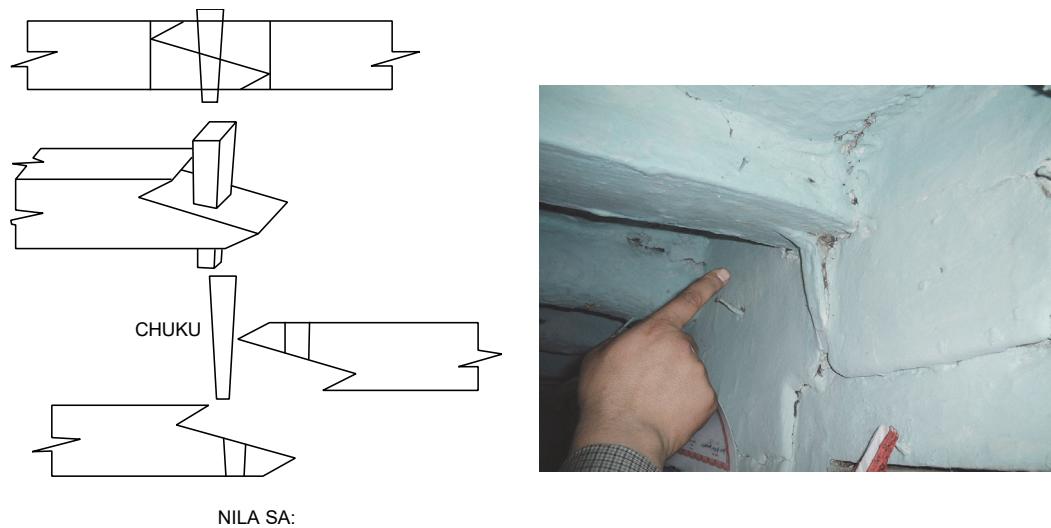
The floor joists are held in position by a *chuku* (wooden peg) through holes on either side of the wall plate (**Figures 26 and 27**). The *chuku* is wedged to provide earthquake resistance, but use of the *chuku* has been dropping in recent housing.

**Figure 26** Details of member joints (photo by T. Ohsumi in 2001).

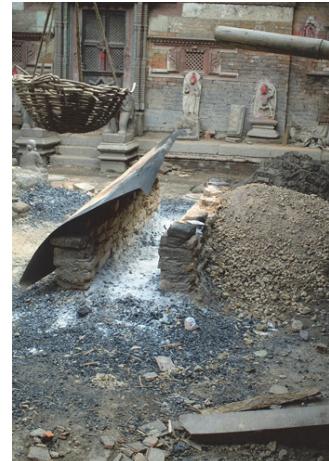
Soil is put in the roof and prevents heat conduction from sunlight and water resistant to the indoors (**Figure 28**). Though the soil is cured in the construction (**Figure 29**), flying weeds by long years and the roof deteriorates. For the infiltration of rainwater, the building deteriorates. The roof renovation is important periodically.

**Figure 28** Cured soil for roof.  
(photo by T. Ohsumi in 2001)

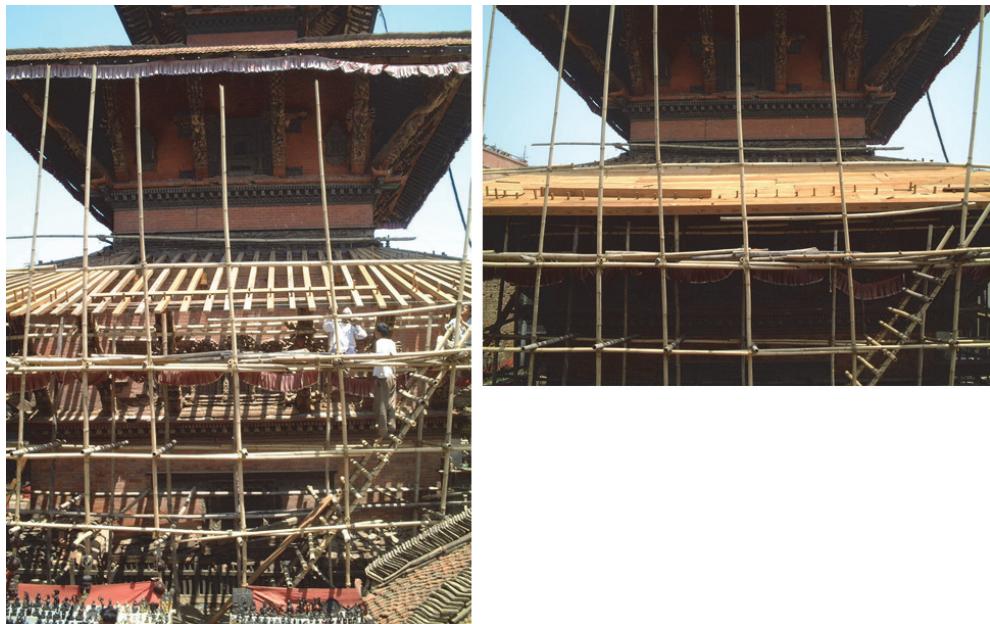
**Figure 30** Renovation of a temple's roof was carried out in 2015 (photo by T. Ohsumi).

- 6) Roof repair is very important. The survived temples had renovated the temples' roof before the earthquake.

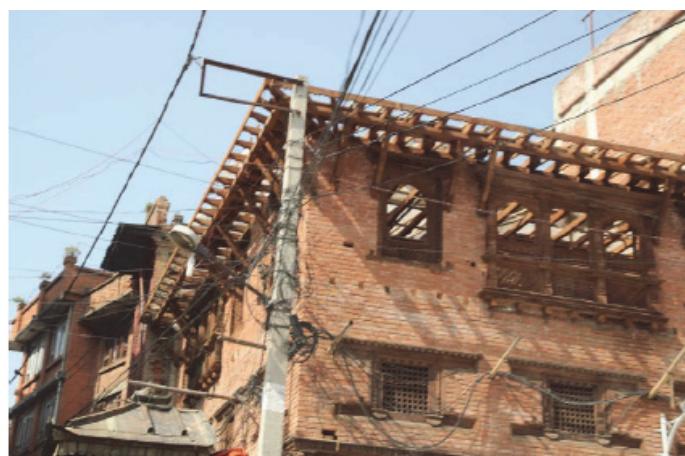
**Figure 31** Renovation of a house roof was carried out in 2015 (photo by T. Ohsumi).

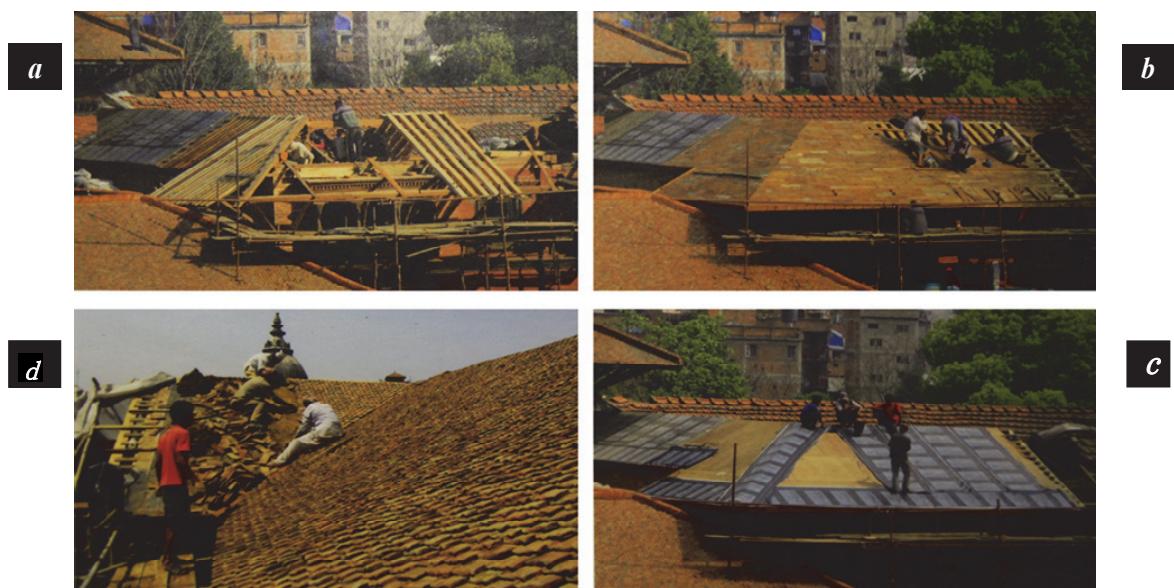
The Patan palace was renovated with assistance from the Kathmandu Valley Preservation Trust (KVPT) and the Sumitomo Foundation in 2013 (**Figure 32**). Thus, in Patan, after the earthquake, this palace had only partial damage at the top of the structure (Gajur and Baymvah).

**Figure 32** Renovation of the structure and the covering of the roof was carried out in 2011:

*a*: (top left) installation of timber rafters, *b*: hand wood planking, *c*: waterproof membrane, *d*: traditional terracotta roof tiles on a mud bed (from information plate at the Patan Museum).

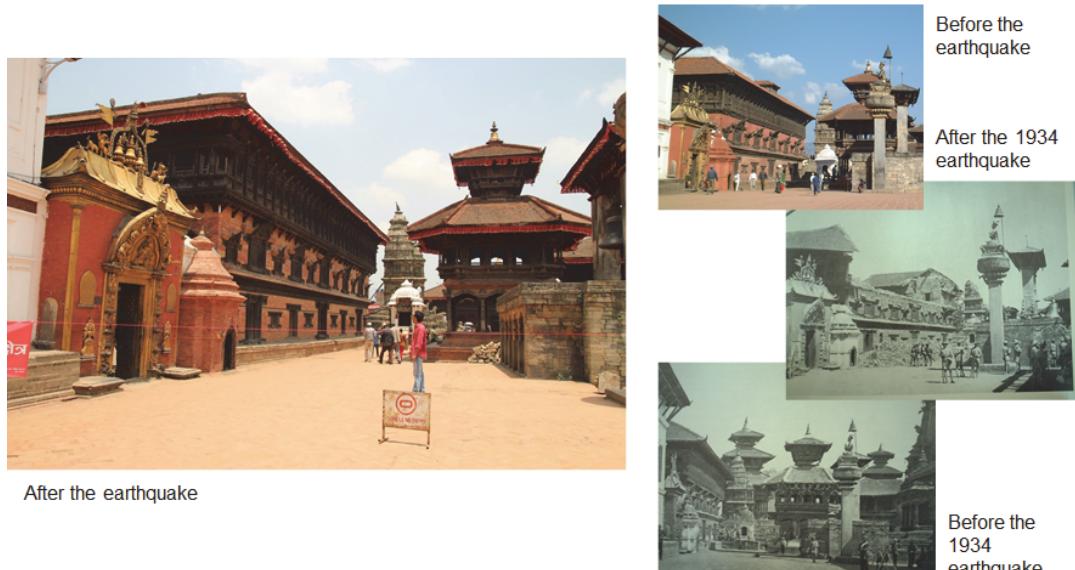
“*Bhakta*” means Devotee in Sanskrit, and “*pur*” means city. Thus, “*Bhaktapur*” is the city of devotees. The center areas of these palaces are called “*Durbar Square*”. Bhaktapur’s Durbar Square is a conglomeration of pagodas and many of Sikhara style temples in Bhaktapur’s Durbar Square were severely damaged in the 1934 earthquake (**Figure 11**).

**Figure 11** Bhaktapur before/after the earthquake (photo by T. Ohsumi), before/after the 1934 earthquake in Bhaktapur (Courtesy of MoHA)

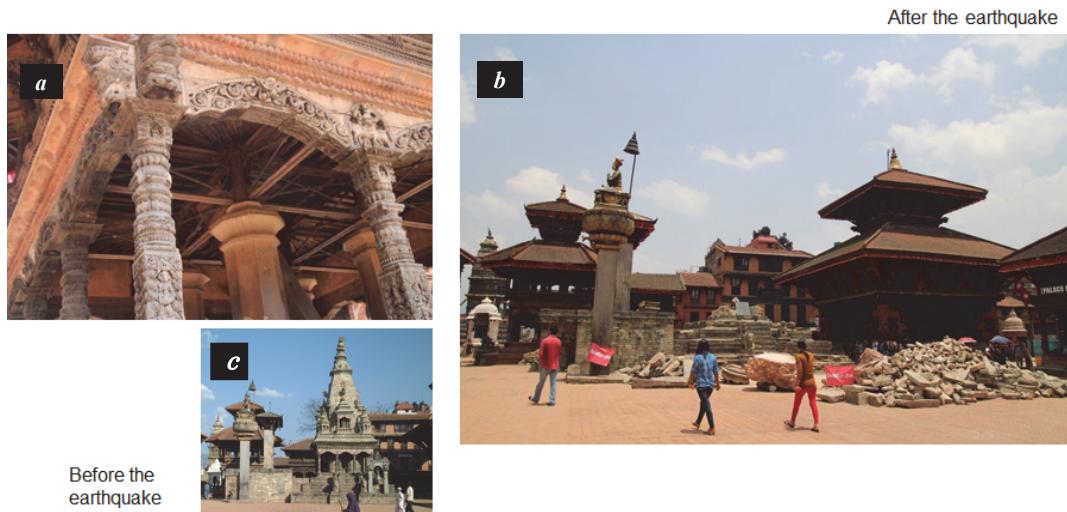
The steel frame reinforced Chayslin Duga temple (**Figure 12a**). This temple was not damaged. During the 1934 earthquake Chyasilin Mandap was completely destroyed. The architects Götz Hagemüller and Niels Gutschow set about rebuilding this temple using metal reinforcements by Deutsche Gesell-schaft fur Inter-natio-nale Zusam-men-arbeit (GTZ) funding. The Vatsala temple (**Figure 12b**: center and **Figure 12c**), which is a Newar style temple, was established *ca.* A.D. 1690, but destroyed. Yaksheshvara temple (**Figure 12b**: right) survived.

**Figure 12** Reinforced Chayslin Duga temple (*a* and *b*: left) by steel frame, Vatsala temple (*b*:center and *c*) was destroyed and Yaksheshvara temple (*b*:right) survived, before / after 2015 earthquake in Bhaktapur (photo by T. Ohsumi).

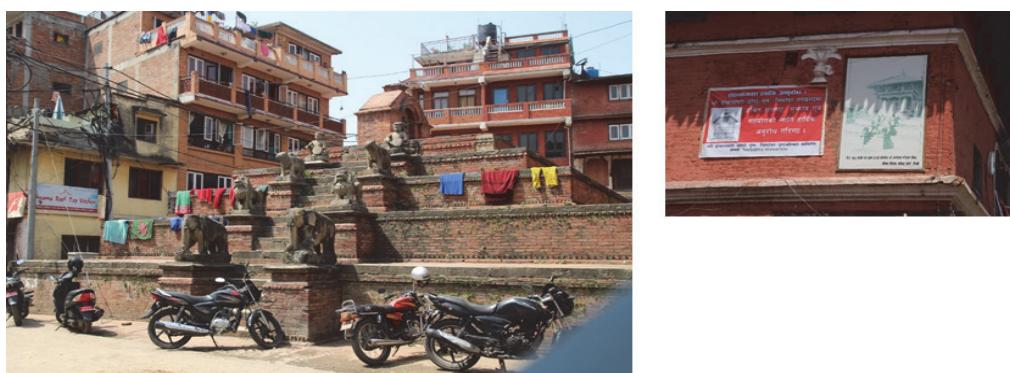
One of the temples in Bhaktapur collapsed in the 1934 earthquake, and has not been rebuilt (**Figure 13**). If the reconstruction of historical buildings that have been lost during earthquakes does not proceed, this will be a major blow to future developments in Nepal’s tourism-oriented country.

**Figure 13** This temple in Bhaktapur collapsed in 1934 earthquake, but has not been rebuilt.  
(photo by T. Ohsumi)

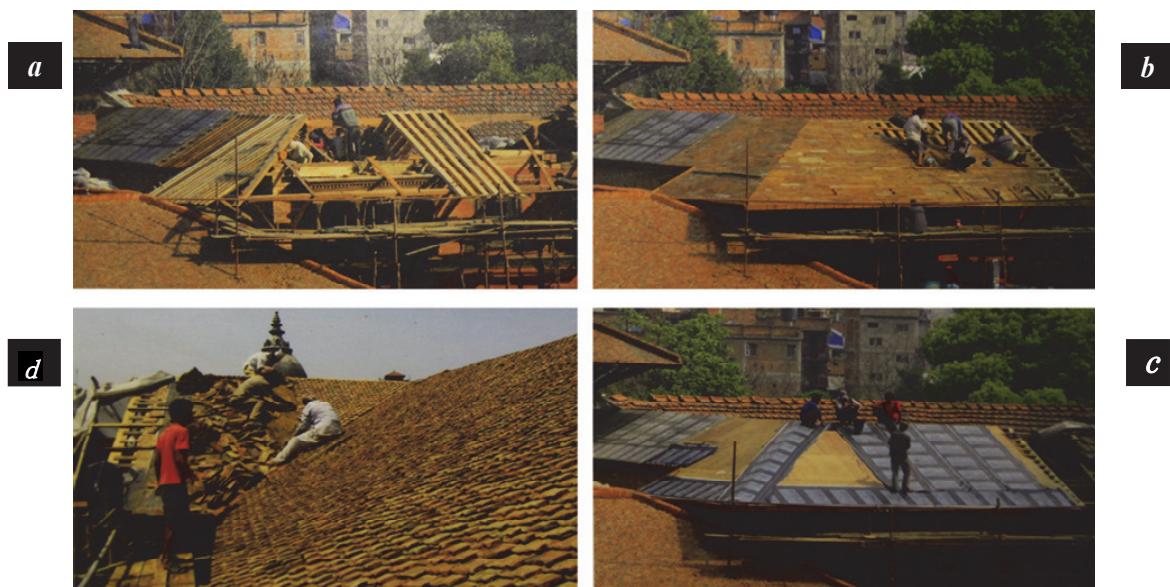
The Patan palace was renovated with assistance from the Kathmandu Valley Preservation trust (KVPT) and the Sumitomo Foundation in 2013 (**Figure 14**). Thus, in Patan, after the earthquake, this place had only partial damage at top of structure parts (Gajur and Baymvah) (**Figure 15**).

**Figure 14** Renovation of the structure and the cover of the roof was carried out in 2011.  
a: top left Installation of timber rafters, b: hand wood planking, c: waterproof membrane,  
d: traditional terracotta roof tiles on a mud-bed (from Information plate of Patan Museum).

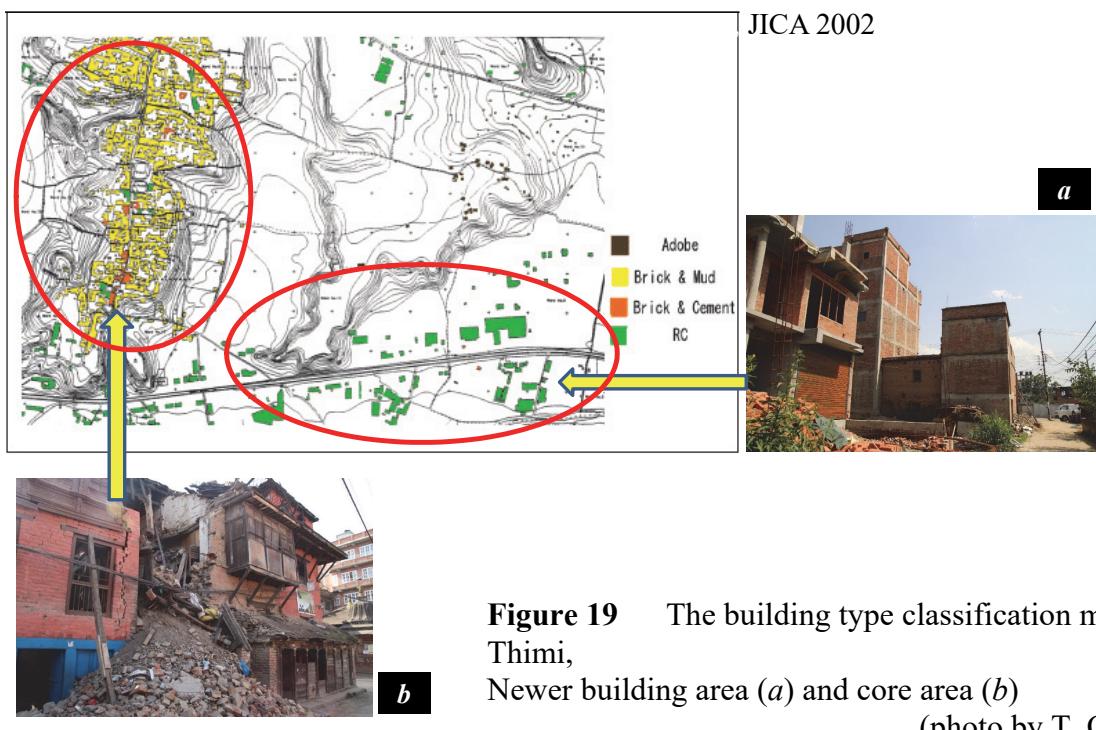
In the JICA (2002) report, building types were classified for the whole Katmandu. The investigation was mainly based on visual observations (**Figure 19 upper**). In newer building areas (**Figure 19 a**), the damage has been reduced in the building of the RC structures. The core area located on a small hill (**Figure 19 b**), the houses had been destroyed in 1934 rebuilt and again received severe damages.

**Figure 19** The building type classification map in Thimi,  
Newer building area (a) and core area (b)  
(photo by T. Ohsumi)

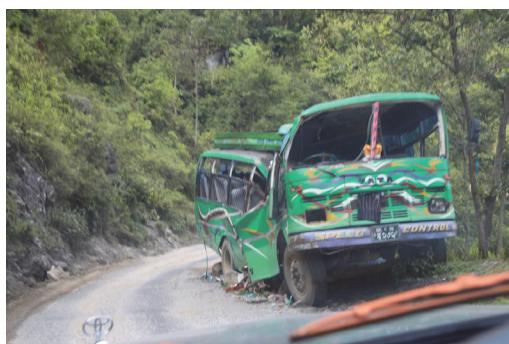
A numerous huge slope failures which occurred in the mountainous area buried villages and valleys, and provided the loss of many lives. Our team visited a landslide zone in Ramche, and it is located in the northwest of Kathmandu city in a mountainous area. Many of fallen rocks were on the roads, also our team encountered a bus that hit by falling rocks (**Figure 21**). Thick talus is deposited in the landslide area in Ramche, in Rasuwa district (**Figure 22**). The town is located at an altitude of 2,060 m. There are houses that had been caught in a landslide, but the damage was limited. However, the whole scope of the slope failures is not clear at the

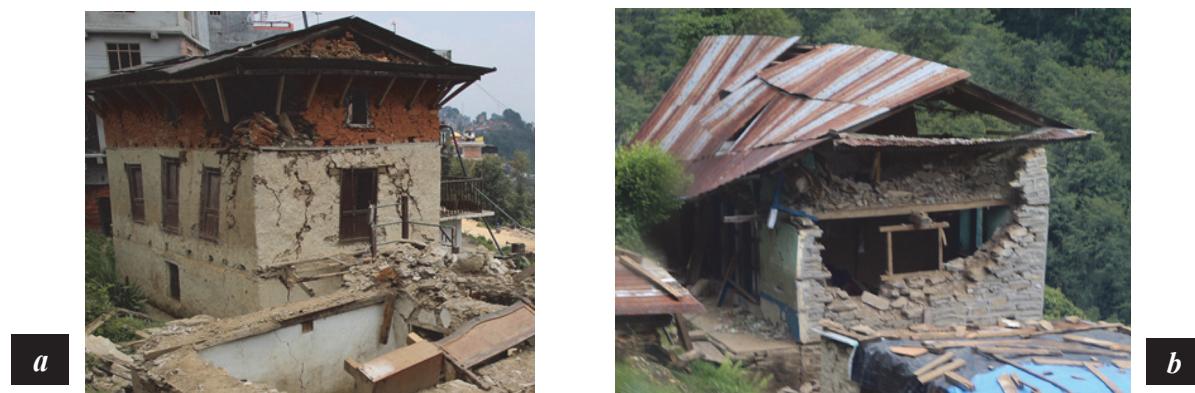
Urban and rural housing is significantly different. In the suburban and rural areas where there are many stone houses, a lot of damage occurred. The collapse of heavy stones used in house construction, resulted directly in deaths and property destruction.

In Dolakha district, adobe style houses collapsed. Primarily, adobe houses collapsed as a result of cracks in the gables and corner foundations as a result of ground motion. Many adobe style houses were broken at their gables (**Figure 23 b**). Stone houses could also collapse as a result of delamination. Stone style houses also collapsed by delamination.

**Figure 23** Adobe style houses (*a*) and Stone style house (*b*) in Charikot, (photo by T. Ohsumi)

constructions undertaken more than 30/40 years ago. In the rural areas, this type of housing is still the most popular method of housing construction. Thus, the retrofitting of low-cost earthquake-damaged housing without the consideration of engineering standards is a key issue.

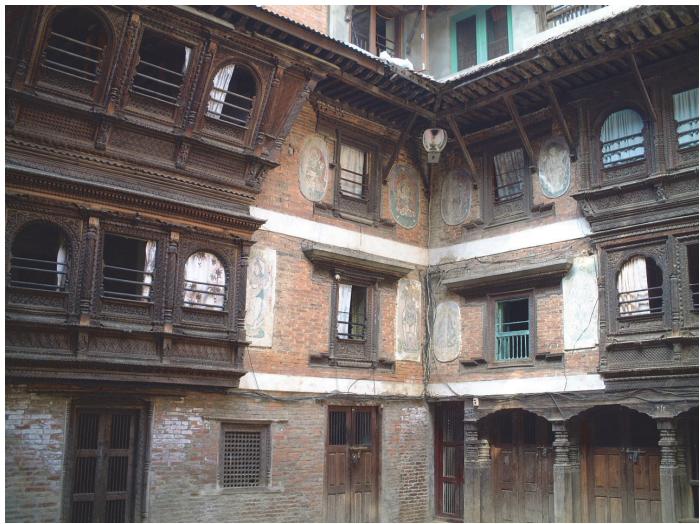
A *chowk* is a type of the courtyard typical in the community of Newar in Nepal (**Figure 25**). The *chowk* is characterized by a square or rectangular space surrounded by buildings on all sides. The surrounding buildings are built on a raised platform called Falcha ground. Opposite the main entrance on the ground floor is an area devoted to the god Guthi and other Gods with idols of deities. The *chowks* generally are quite resistant to earthquake damage; however, *chowks* that have been altered and/or changed were often damaged (**Figure 26**).

**Figure 25** Buildings with the *Chowk*, in Lalitpu  
(photo. by T. Ohsumi)

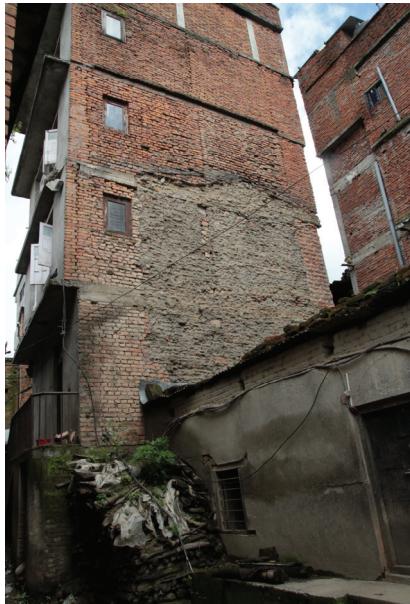
**Figure 5** shows the housing situation after the 2015 Gorkha earthquake. The upper part of a three-story building with collapsed parts was demolished; only the first floor remained and is usable. A three-story building was reduced to one story. This building was classified as Grade 4.

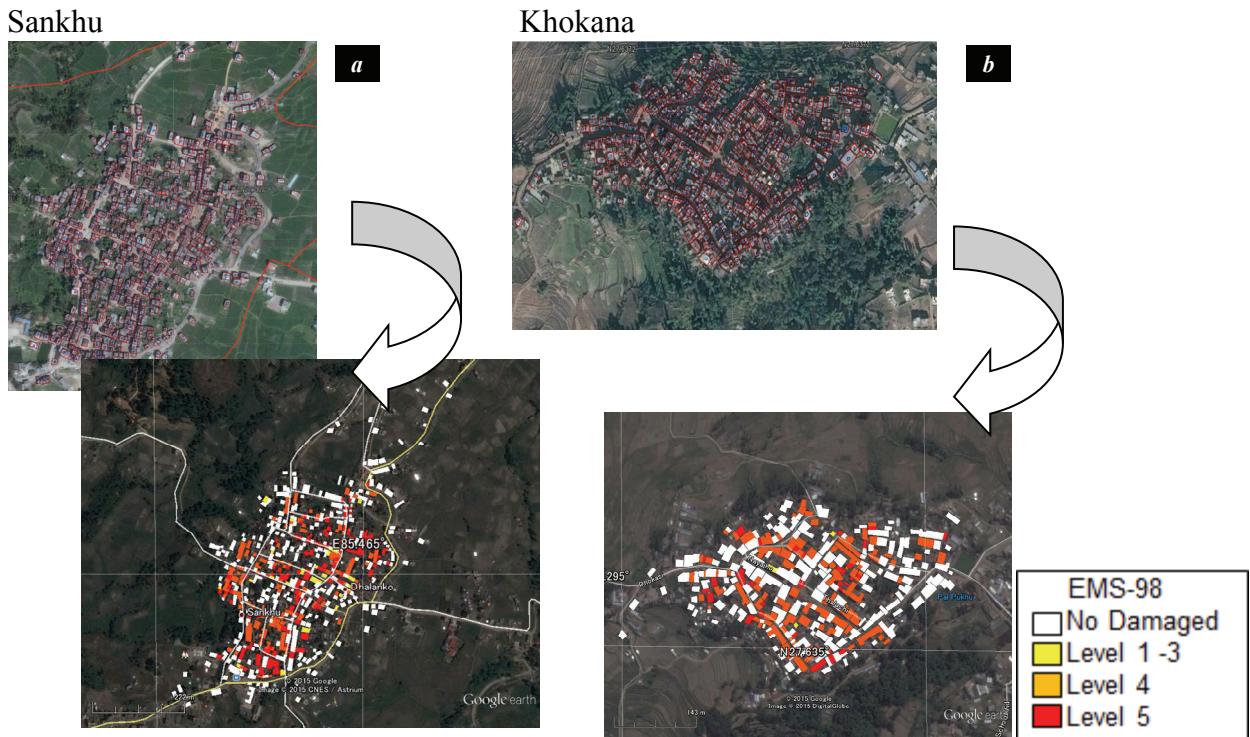
**Figure 6** Survey of the damage extent for every house in *a*) Sankhu: (August 17–18, 2015) and *b*) Khokana: (August 19–20, 2015)<sup>5), 6)</sup> by the European Macroseismic Scale (EMS) -98.

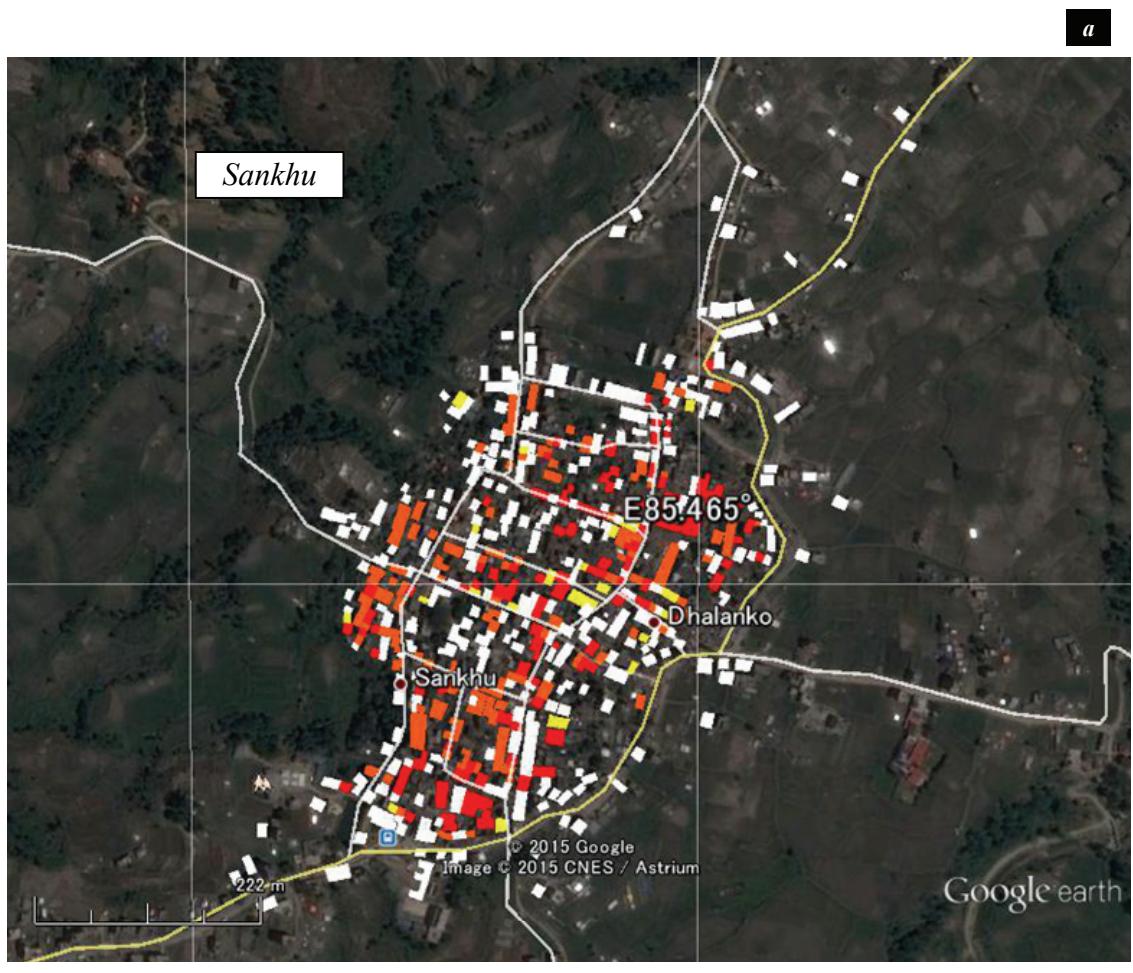
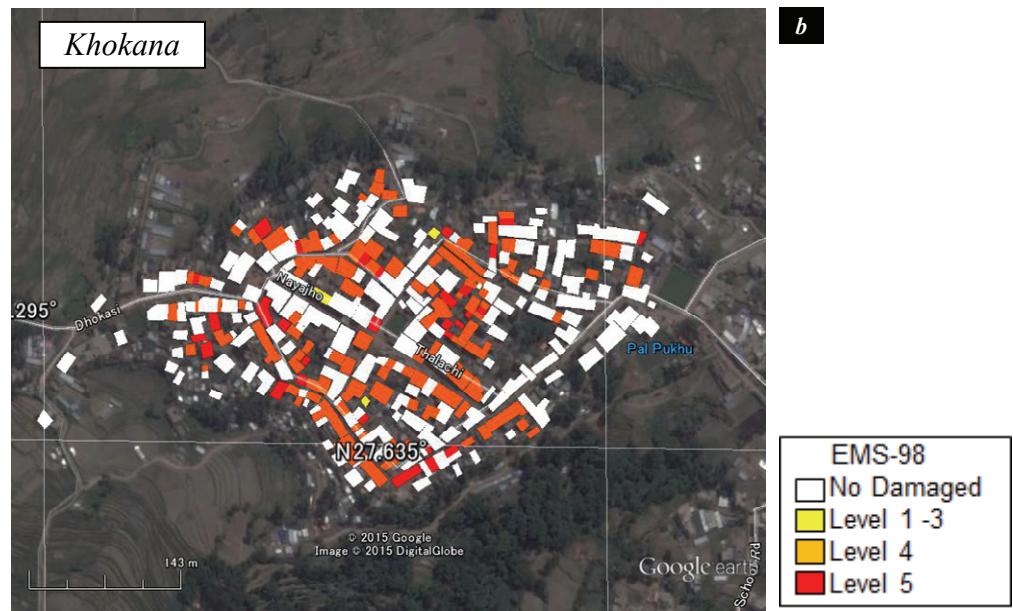
**Figure 7** Survey of damage extent for every house in Sankhu and Khokana<sup>5)</sup>.

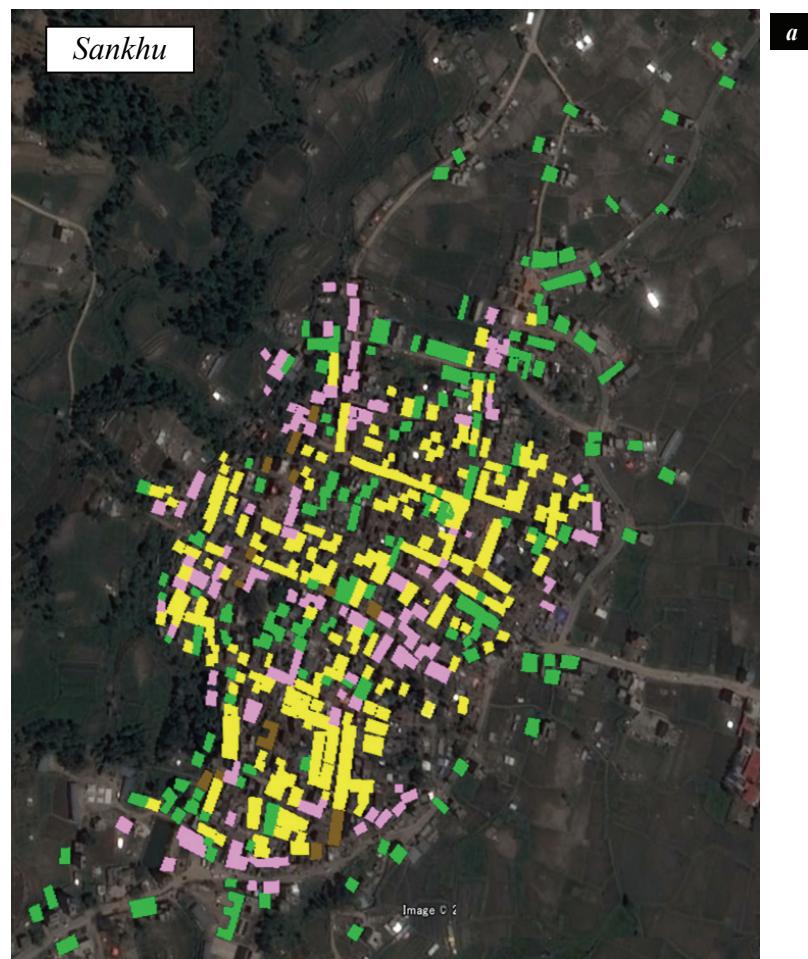
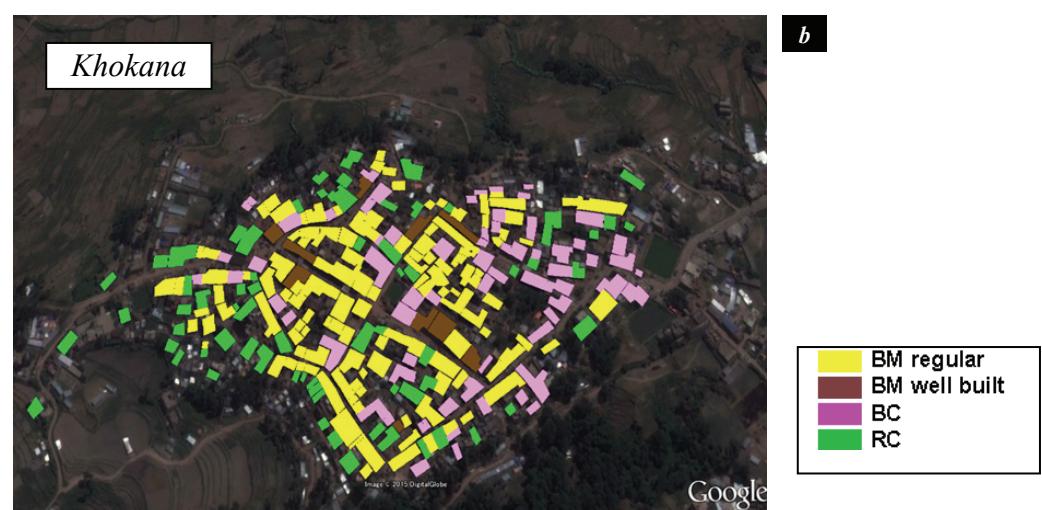
**Figure 10** *a* and *b* show the survey of building type classification for every house in Sankhu and Khokana. The number for damage extent of each building type for every house is shown in **Tables 4** and **5**. The difference in damage by building type was remarkable. Damage in Sankhu was extensive. Brick and cement mortar houses without RC columns experienced substantial damage. In contrast, damage to RC structures, particularly those erected in recent years, was generally minor.

**Figure 10** Survey of building type for every house in Sankhu and Khokana.

The total number of buildings for each area are shown in the upper stage, and the percentages of each item are shown in the lower stage. There was no damage to 94% of the surveyed RC buildings. From the comparison of BM and BC, the collapse ratio was improved by 27% in Sankhu, which EMS-Level 40% (BM) was improved 13% (BC), and 16% in Khokana, which EMS-Level 19% (BM) was improved 3% (BC). There was 0% BM Well with very heavy structural damage in both areas (**Tables 5 and 6**).

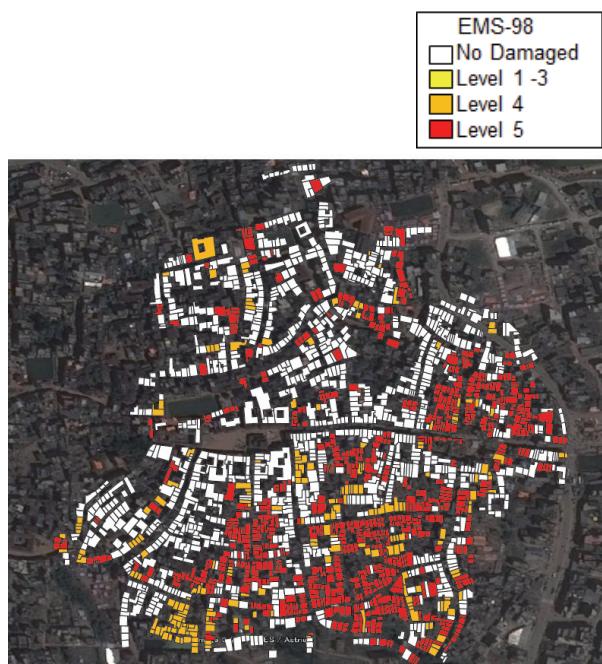
**Figure 13** Survey of damage extent for every house in Bhaktapur .

The total number of buildings for each area are shown in the upper stage, and the percentages of each item are shown in the lower stage. There was no damage to 99% of the surveyed RC buildings. From the comparison of BM and BC, the collapse ratio was improved by 6% for BC houses, which EMS-Level 9% (BM) was improved 3% (BC). There was 0% BM Well with very heavy structural damage (**Table 7**).

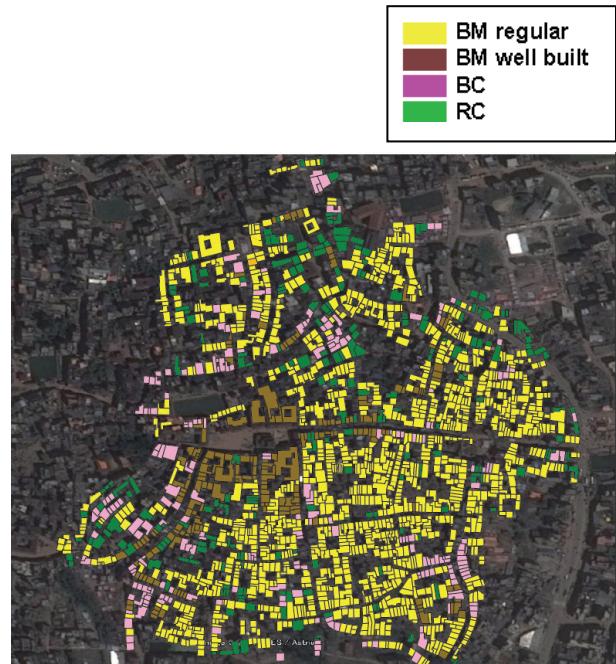
**Figure 14** Survey of building type for every house in Bhaktapur.

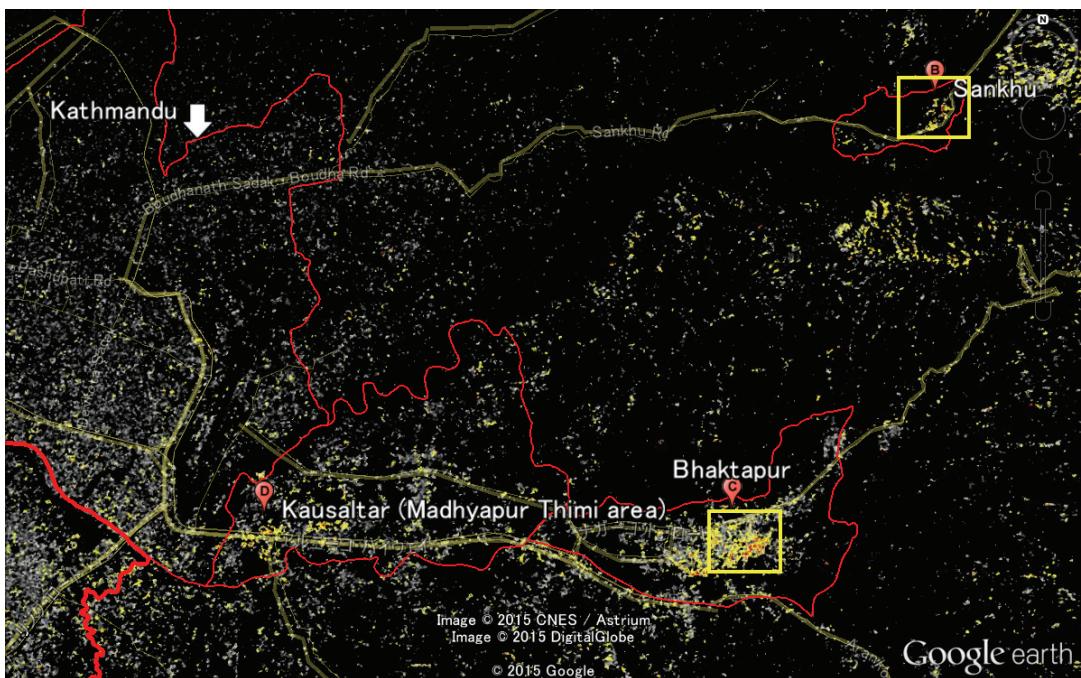
**Figure 24** shows regions of bright reflections within severely damaged core areas such as Bhaktapur and Sankhu. **Figure 25** shows the coherence magnitude and a survey of damage extent for every house in Khokana and Bungamati. The decrease in coherence ( $\gamma$ ) in the SAR imagery observed before and after the disaster readily facilitated detection of damage in the region. Reflections in the slightly damaged Kirtipur core area are not as clear and bright as those in the severely damaged core areas of Khokana and Bungamati.

**Figure 24** Bright reflection areas for severely damaged urban area such as Timi, Bhaktapur and Sankhu core areas.

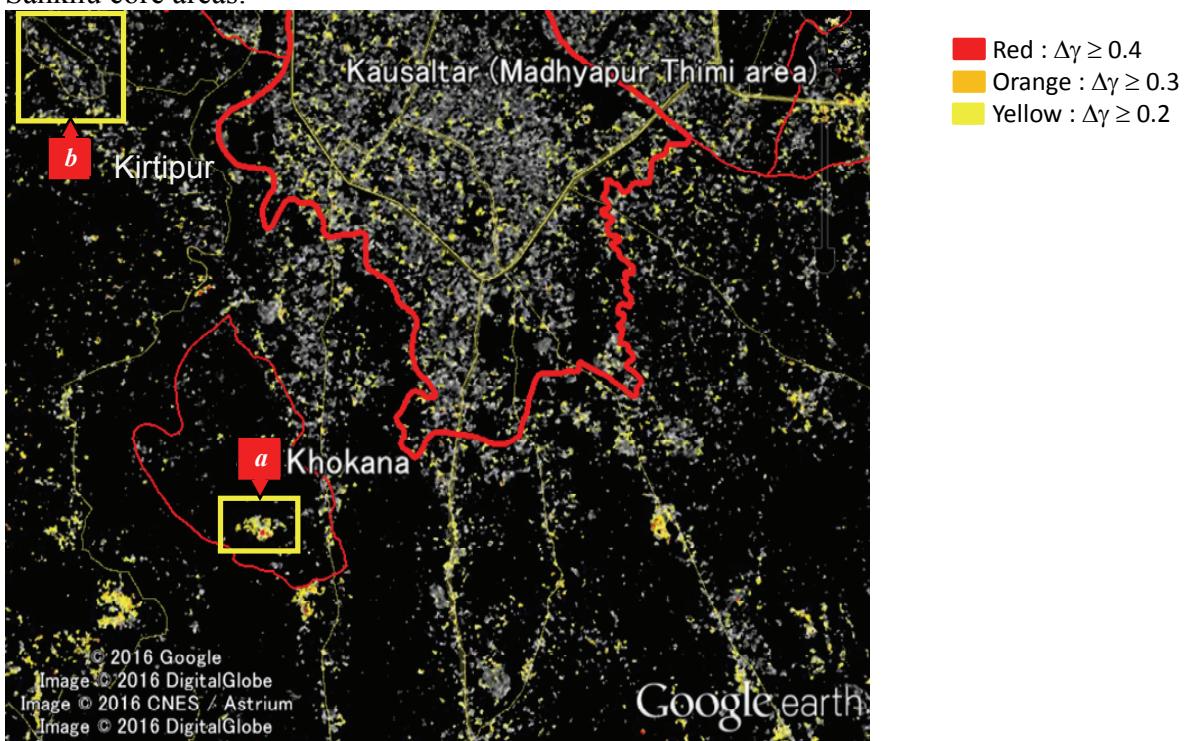
**Figure 25** Bright reflection areas for Khokana and Bungamati core areas. Kirtipur was not clear bright reflection.

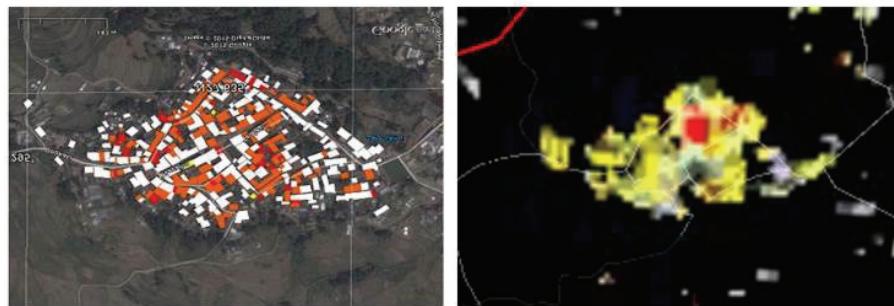
**Figure 26** shows regions of bright reflections within severely damaged core areas such as Khokana. **Figure 27** shows the coherence magnitude and a survey of damage extent for every house in Sankhu. **Figure 28** shows the coherence magnitude and a survey of damage extent for survey area house in Bhaktapur. Reflections in the heavily damaged areas survey area are as clear and bright.

**Figure 26** Coherence magnitude and the survey of damage extent for every house in Khokana.

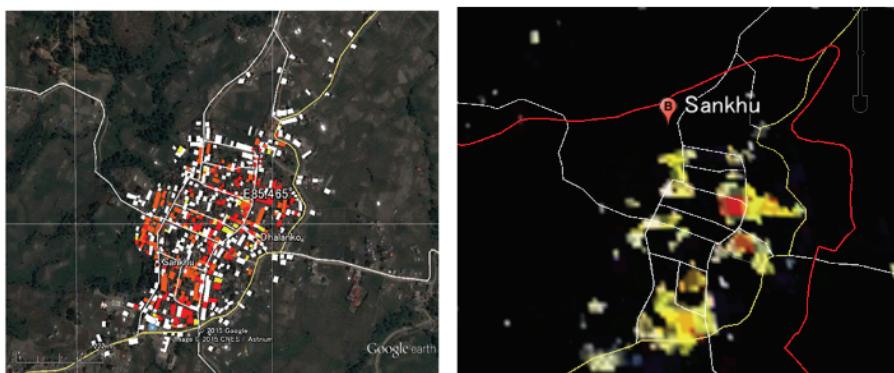
**Figure 27** Coherence magnitude and survey of damage extent for every house in Sankhu.

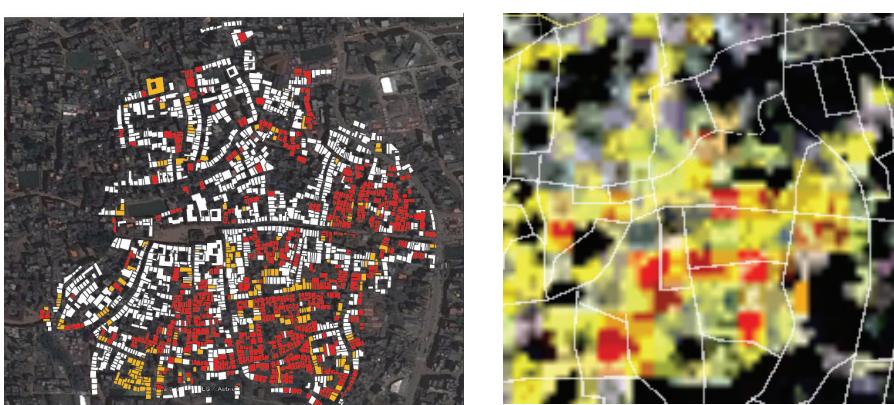
**Figure 28** Coherence magnitude and survey of damage extent for survey house in Bhaktapur.

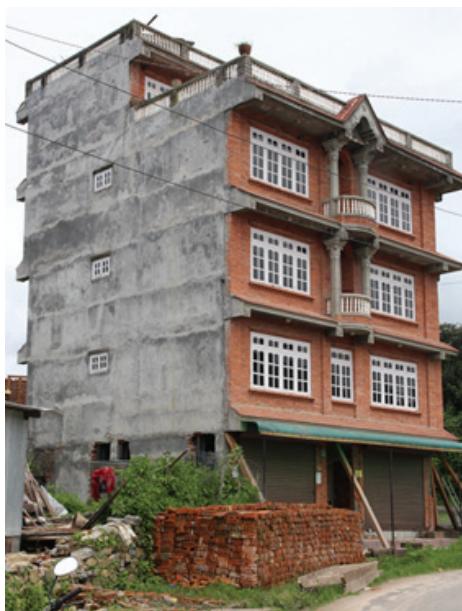
In Sankhu, repeated types of damage occurred in houses as a result of the Gorkha earthquake (**Figure 6**). The earthquake damage level was not serious enough that the houses had to be evacuated and was classified as “yellow level” damage (**Figure 7**), but earthquake repairs are still being carried out by the house owners. The main damage was to ground floor columns used for entrances and storage areas. Cracks occurred in the corners of these structures. Surface bricks were removed by the significant ground motion and RC columns were damaged.

**Figure 6** Damaged housing in Sankhu.  
(photo by T. Ohsumi)

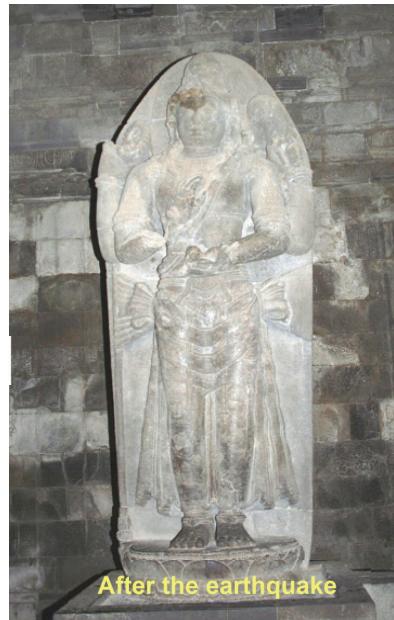
The statue of Siwa niched inside the Siwa temple was not damaged by earthquake. It is clear by comparison of before (*left side of Figure 11*) and after (*right side of Figure 11*) the earthquake. The Ramayana epic engraved on the inner wall of the Siwa temple is very well known (**Figure 12**). Regrettably, this sculpture was damaged by the earthquake (**Figure 13**). The falling stones damaged some parts of the gallery of the Siwa temple (**Figure 14 and 15**). Some cracks are observed in all corners of this temple. The structure of this temple is a cantilever structure supported by the base stage, then, shaking by earthquake caused a large moment at the support, consequently cracks happened. The width-wise of the cracks is deemed not so serious, and depth of crack is not clear. It is difficult to judge whether temple suffered serious damage or not. Thus, detailed diagnosis of these temples is recommended to be done.

Figure 11 Statue of Siwa. There was no damage to the statue of Siwa.

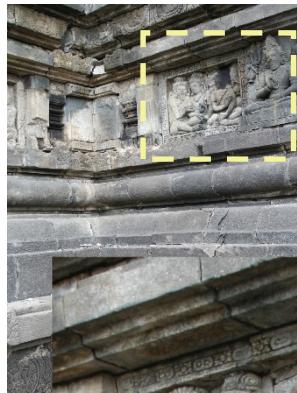
Figure 12  
Ramayana epic  
Regrettably, this  
sculpture was  
damaged in the  
earthquake.

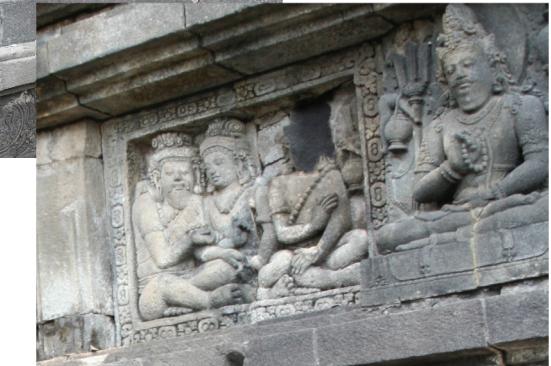
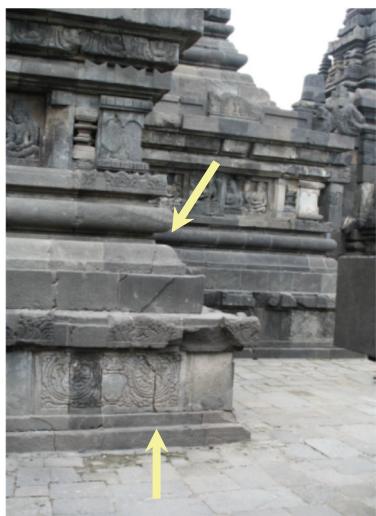
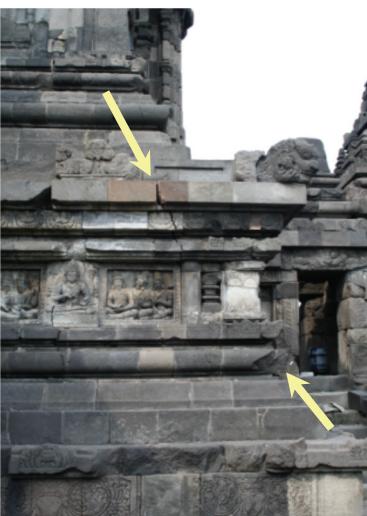
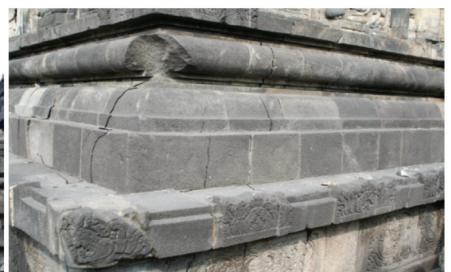
Figure 13 The gallery of the Siwa temple were damaged. Some cracks appeared in the corner section of this temple. All corner sections of the Siwa temple had cracks.

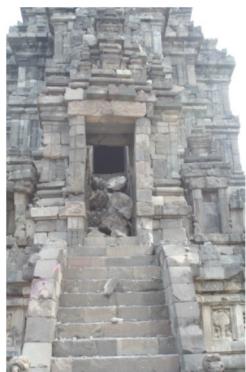
Figure 13 Falling parts from the top of the Brahma temple.

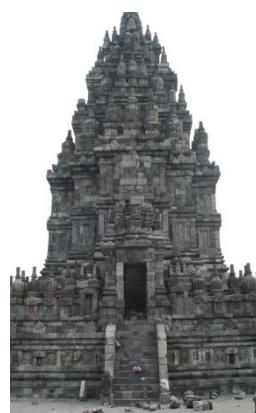
Figure 14 All corner sections of the Siwa temple had cracks.
