## Investigation on Improvement of Wide-area Damage Estimation Method for Historical Masonry Structures- Beyond The 2015 Gorkha, Nepal Earthquake -

doctoral thesis

Investigation on Improvement of Wide-area Damage Estimation

- Beyond The 2015 Gorkha, Nepal Earthquake –

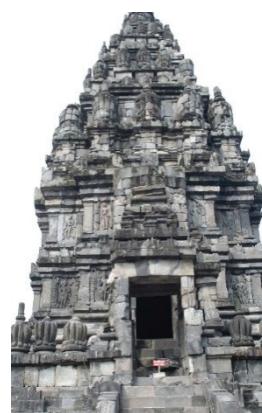
Figure 15 The Wisnu temple sustained relatively little damage.

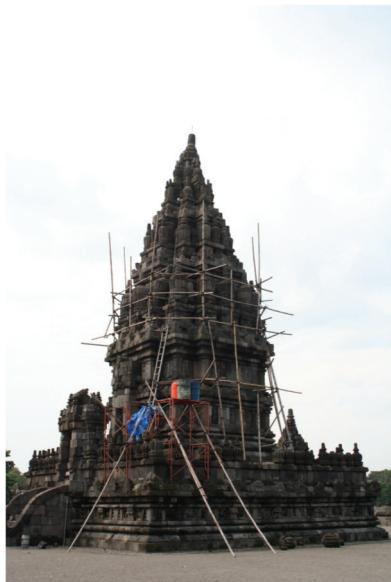
The Garuda temple was being repaired and many parts suffered serious damage. This temple is leaned slightly due to the earthquake (**Figure 18**).

**Figure 18** The Garuda temple is leaning due to the earthquake.  
(photo by T. Ohsumi)

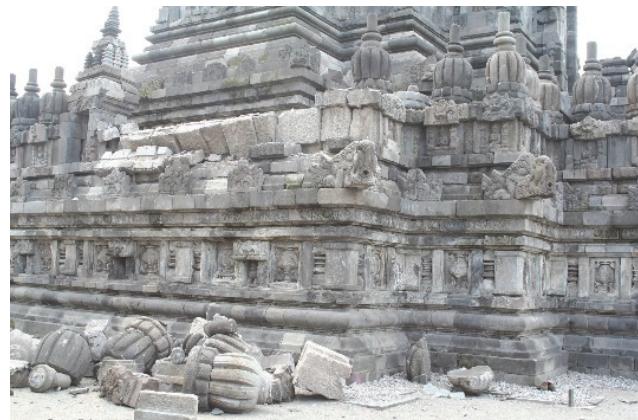
## Figure 17

The Wisnu temple is damaged relatively light by the earthquake. Many parts of Ratna which fell from the top caused damage to the corridor (**Figure 16 and 17**).

Many Ratna parts which fell from the top of the Wisnu temple caused damage to the corridor.  
(photo by T. Ohsumi)

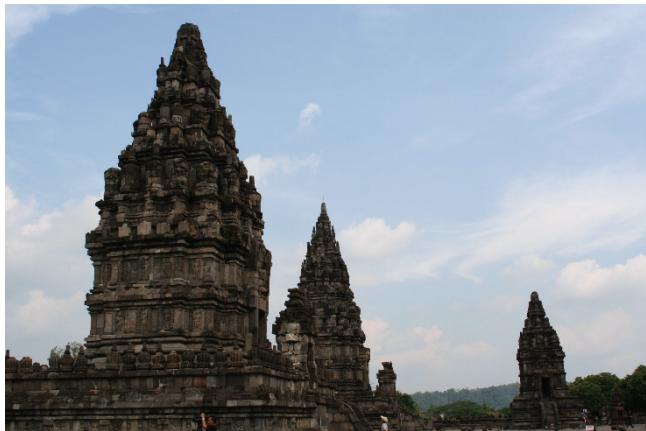
Many parts, which fell from the top of Nandi damaged the front stairs. However, the damage was not so serious (*right side of Figure 19*).

Many parts, which fell from the top of Angsa damaged the side wall. However, the damage was not so serious (*center of Figure 19*).

**Figure 19** The damage sustained was not so serious at the Nandi temple (*right*) and the Angsa temple (*center*). (photo by T. Ohsumi)
