# MEASUREMENT OF INUNDATING FLOW FROM A BROKEN ENBANKMENT BY USING VIDEO IMAGES SHOOT FROM A MEDIA HELICOPTER

*Ichiro Fujita*<sup>1,\*</sup>, *Yuichi Notoya*<sup>2</sup>, and *Takanori Furuta*<sup>3</sup>

<sup>1</sup>Department of Civil Engineering Kobe University, 1-1 Rokkodai, Nada-ku, Kobe, Japan

**Abstract.** The heavy rain disaster in the Kinugawa River basin that occurred along with the passage of the Typhoon 18 caused the embankment destruction in the middle reach of the river on September 10, 2015. Due to the overflow, the houses in the vicinity of the embankment collapsed, causing a flood inundation spreading over a wide area. Because the embankment breakwater occurred during the daytime, the state of the inundating flow was recorded from various angles by media helicopters or drones. In this study, we developed a method to extract quantitative flow information from a helicopter video image in which the shooting position and angles are changed one after another, because it was taken in emergency. In the analysis, the images were orthorectified after stabilizing the images, from which surface velocity distributions were measured by image-based technique such as the large

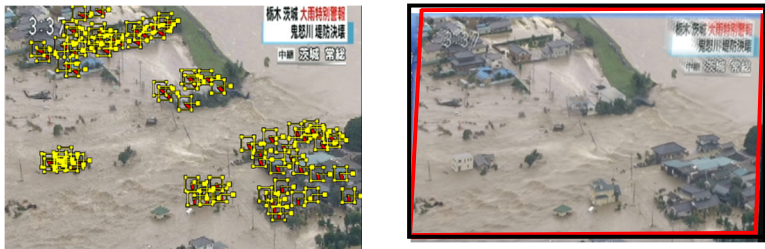
**Fig.3** Application of marker tracking method. left : yellow square is the search window and red line is the shift vector, right : stabilized image.

marker tracking (MK) method as indicated in Figure 3. A free software (Blender) is used in this step. Figure 3 provides an example of the background shift measurements by using MK method. MK method can measure the background shift vector by applying a technique similar to the particle image velocimetry (PIV). In the example shown in Figure 3, a lot of reference windows indicated by yellow squares are set manually on the positions of objects

that are fixed to the ground such as houses. In Figure 3, a shearing deformation is detected and with this information the second image is deformed to coincide with the first image. This process is repeated for all the extracted frames indicated in Table 1. The third image row in Table 1 provides the deformed image for the last frame.

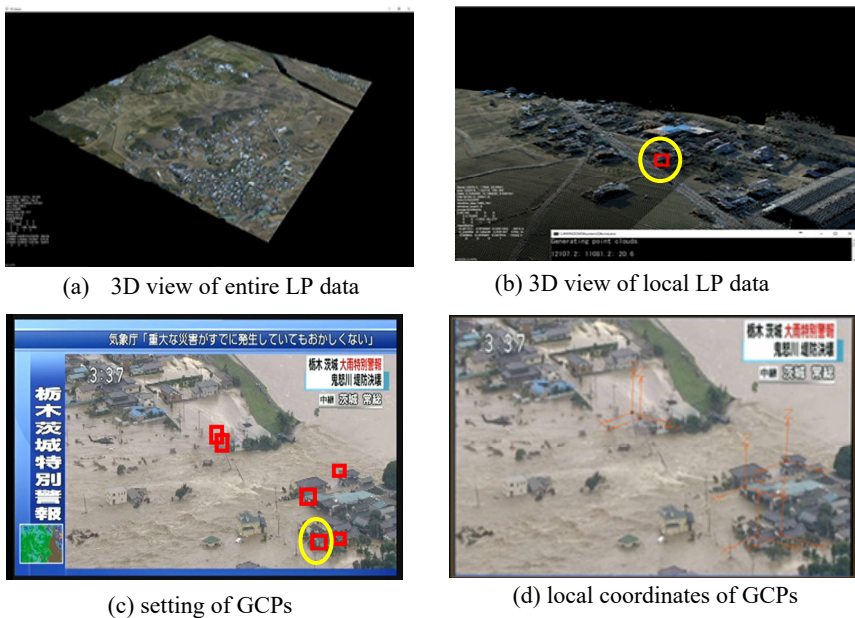
**Fig.4** Picking up GCPs using LP data.

In the second step, three dimensional coordinates of more than six ground control points (GCPs) to use for the image rectification are obtained by using detailed LP data of the site. Specifically, the LP data is expressed as CG shown in Figure 4(a) and the detailed original measurement data is plotted as indicated in Figure 4(b). The GCPs are carefully selected at some fixed points such as the tip of a roof as shown in Figure 4(c) and their coordinates are obtained from the original LP data shown in Figure 4(b). For example, the position shown as a dotted circle in Figure 4(b) corresponds to the tip of one of the roof in Figure 4(c). The respective 3D coordinates of GCPs are obtained from the original LP data. The local coordinates for each GCP is shown in Figure 4(d).

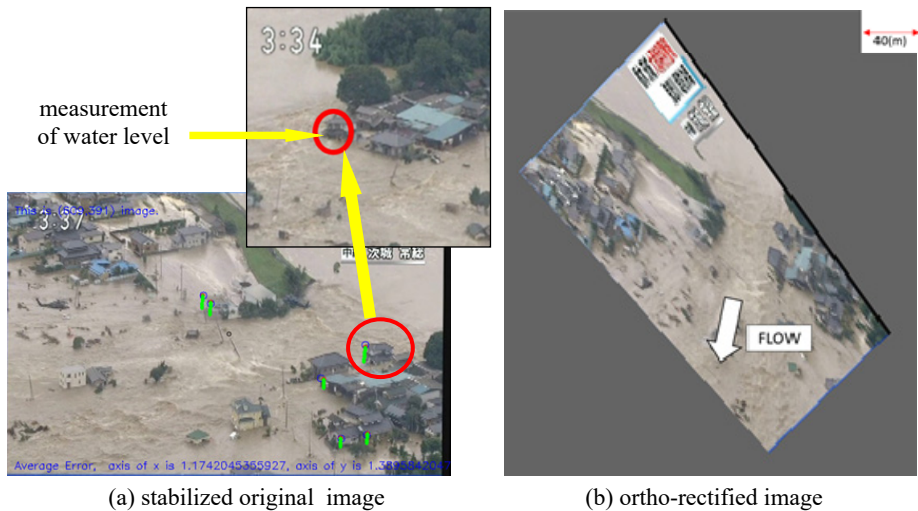
**Fig.5** Image transformation of stabilized oblique image.

determined in the 3<sup>rd</sup> step and the water level. In KU-STIV, a line segment drawn vertically from the GCP to the water level appears when the parameters for transformation is appropriate. Such vertical lines, green in colour, are shown in Figure 5(a). The water level was measured from an image viewed from another angle indicated in Figure 5. The ortho-rectified image is provided in Figure 5(b) demonstrating the overflow from the levee breach section.

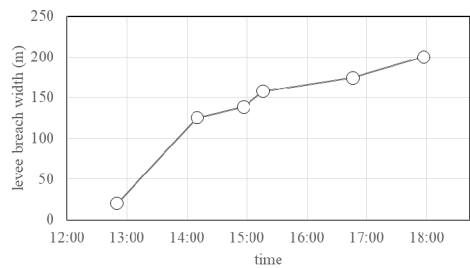
Fig. 6 Time variation of levee breach width.

According to the interview survey of local people, the levee breach started at 12:50 and the initial width is estimated to be about 20 meters. Other than the images indicated in Table 1, there are several scenes in which the width of the breakage can be observed clearly. The physical scale of the width were estimated by comparing with the detailed LP data introduced in Figure 4. Figure 6 shows the time variation of the levee breach width. It is obvious that the width increased quickly for one hour after the breakdown and after that it increased almost linearly with time until it reached the maximum width of about 200 meters, causing a huge amount of inundated water into the residential area.

By combining the time variation of the breach width shown in Figure 6, the outflowing mean velocity in Figure 8 and the estimated overflowing critical water depth, the evolution of accumulated inundated water volume is estimated as shown in Figure 9. The surface velocity coefficient that convert surface velocity to depth-averaged velocity was set at 0.85 in this case. According to the present calculation, the inundated water volume was estimated to be about  $1.10 \times 10^7 \text{m}^3$ , which roughly agrees with the officially reported data.

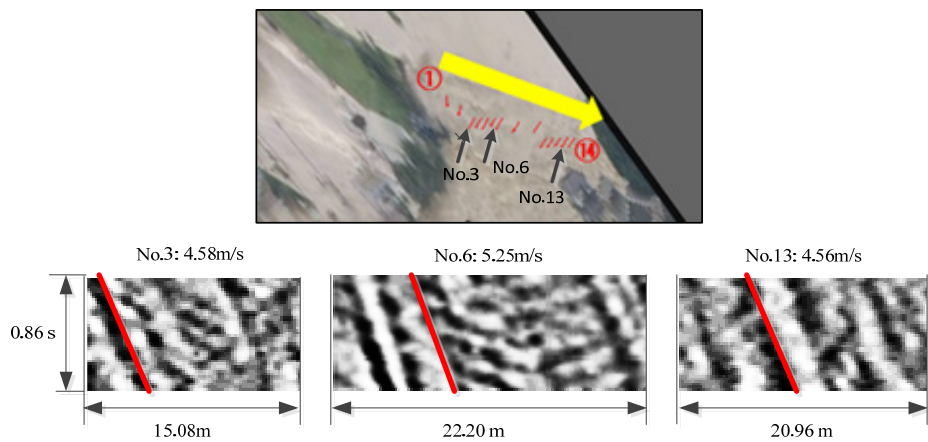
Fig. 7 STIV analysis for the scene 3 at 15 :37.

In order to estimate the overflowing discharge from the levee breach section, surface velocity distribution at the entering section was measured by the image-based technique STIV rather than LSPIV, because STIV is applicable for obtaining quantitative data even under deteriorated images such as the scenes provided in the present disaster. As an example, the measurement result by STIV at 15:37 is provided in Figure 7 together with some of the space time images (STIs). Although the texture appeared on an STI includes noisy patterns, an inclined pattern corresponding to the flow velocity is visible. In Figure 7, the texture on STI is enhanced by applying a histogram equalization filter. The average surface velocity is then calculated by taking the average of the total velocity data and it was

5.05m/s for the scene 3 at 15:37. The time variation of the outflowing mean velocity measured by analysing similar procedure for the other scenes is provided in Figure 8. The mean velocity takes a peak value of about 5m/s after 15:00 and decreases gradually to less than 3m/s before 17:00.

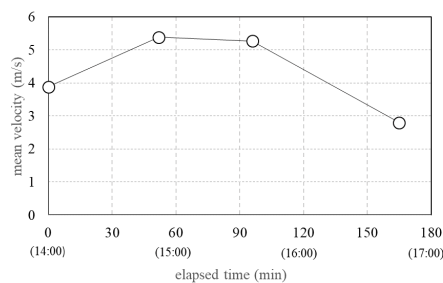
Fig. 8 Time variation of mean velocity outflowing from the levee breach section.

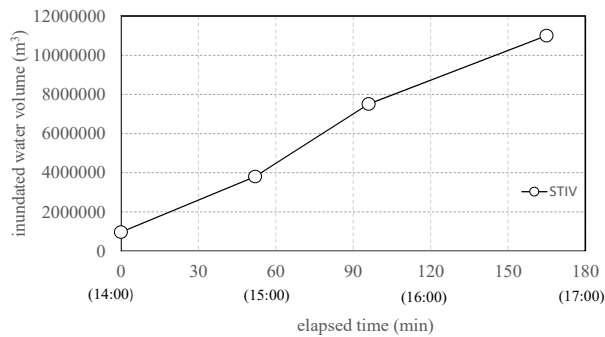
Fig. 9 Accumulated inundating water volume.

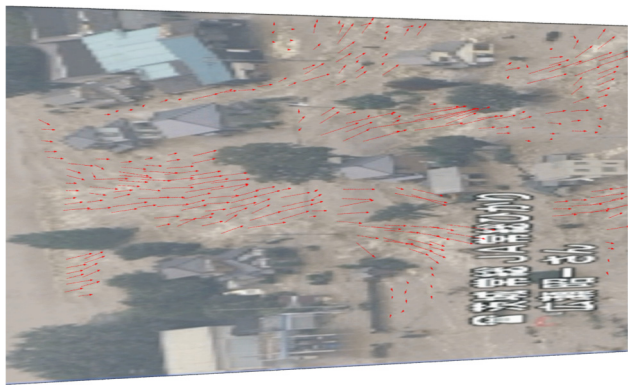
Fig. 10 Surface velocity distribution obtained by LSPIV for the scene 3.

In order to obtain the spreading flow features from the breach section, the large-scale particle image velocimetry (LSPIV) technique was applied to the ortho-rectified images. In the present analysis, a LSPIV software was developed so that the template for the pattern matching in LSPIV can be placed at an arbitrary point. This is because a template that contains a part of a house would yield erroneous values. Therefore, the templates were carefully set so that they include only water flowing area. Figure 10 provides an example of surface velocity distribution for the scene 3 obtained 13:47. The template size was set at 40 by 40 pixels with a physical dimension of 2.4 meters and 26 frame images were used to obtain the short time average data of 0.87 seconds. The result shows that the overflowing

water was accelerated downstream of the breach section and the flow spreads widely in between the residential area. The vector field presented in Figure 10 can be used as a measurement data when an inundation simulation is executed in this area.
