# Seismic performance of small earth dams with sloping core zones and geosynthetic clay liners using full-scale shaking table tests

Sawada, Yutaka ; Nakazawa, Hiroshi ; Oda, Tetsuya ; Kobayashi, Seita ; Shibuya, Satoru ; Kawabata, Toshinori

Soils and Foundations, 58(3):519-533

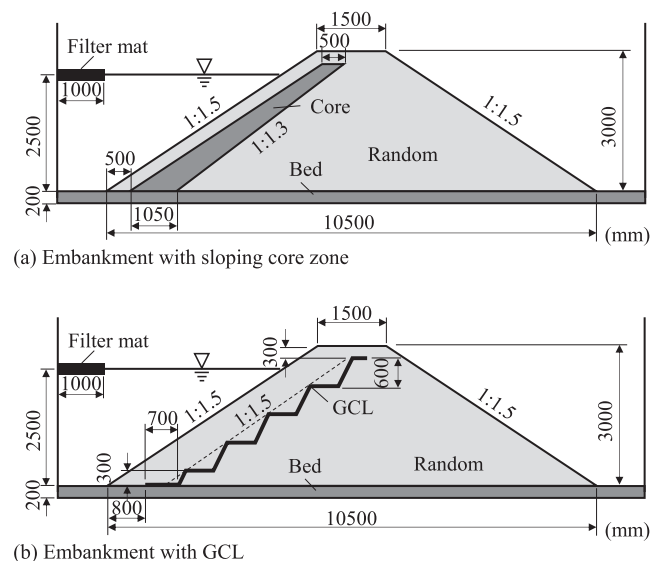
Fig. 1. Model configurations (modified from Sawada et al., 2016).

To examine the seismic behavior of small earth dams that have been repaired with sloping core zones or GCLs, the authors conducted full-scale shaking table tests on two embankments as high as 3 m, as shown in Fig. 1 (Sawada et al., 2016). One embankment had a sloping core zone and the other had a GCL. When the embankments were subjected to shaking corresponding to Level-2 seismic motion, as defined in the Japanese guidelines for the seismic design of agricultural facilities (Ministry of Agriculture, Forestry and Fisheries, 2015b), large longitudinal cracks were seen to develop at the crest of the embankment containing a GCL, although no water leakage was observed in either case. Observations of embankment cross-sections by Oda et al. (2016) have revealed that the presence of a GCL can cause the development of cracks. In addition, data on the recorded accelerations around a GCL have shown that the seismic characteristics at the upstream side separated by the GCL differed from those at the downstream side. Nakazawa et al. (2017) applied three-dimensional terrestrial laser measurements to reveal the location and characteristics of cracks at the crest of an embankment with a GCL and clarified its effectiveness. However, the recorded accelerations and response pore water pressure throughout the entire embankment were not discussed in their studies and many details of the seismic behavior have not yet been clarified.

Fig. 1 shows the model configurations for the two types of embankment models. The models were constructed in the above-described steel containers and were tested simultaneously. One model was an embankment with a sloping core zone (hereinafter referred to as “ESCZ”) and the other was an embankment with a GCL (hereinafter referred to as “EGCL”). The bed width and thickness were 12.59 and 0.2

In the present study, cohesive soil with gravel, excavated from a borrow-pit in Ono City, Hyogo Prefecture, was used as the core material at the upstream slope of the embankment, as shown in Fig. 1. According to the Unified Soil Classification System of Japan, the soil is classified as GFS. The material properties, the grain size cumulative curves, and the compaction curves are shown in Table 1, Figs. 2 and 3, respectively. Permeability tests were performed using two kinds of specimens with maximum particle diameters of 2 and 19 mm. The permeability coefficient of the 19-mm-diameter specimen was found to be 10 times higher than that of the 2-mm-diameter specimen. Since the grain size distribution was different for each case, the fine contents were also different. Moreover, the skeleton structures of the soil after compaction were also likely to

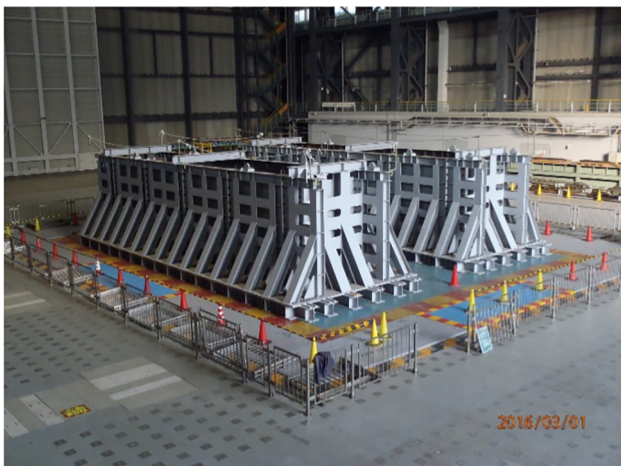
Photo 1. Shaking table and soil containers (Sawada et al., 2016).

In this study, steel containers (length = 12.59 m, height = 3.55 m, width = 2.50 m, and weight = 105 t) were designed and used. As shown in Photo 1, two containers were placed side-by-side on the shaking table. H-section steel beams were placed on top of the soil containers to reinforce the containers and to provide a location for the installation of the instruments. In addition, a filter mat was installed on the water surface to dissipate the wave energy, and the upstream part of the container was covered with a vinyl sheet to prevent the outflow of water.

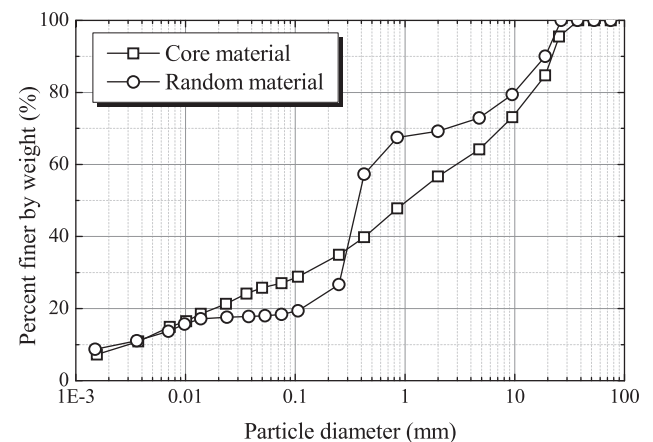
Fig. 2. Grain size cumulative curves.

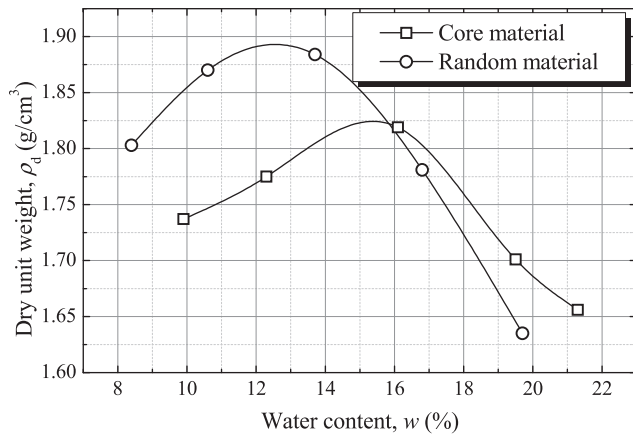
Fig. 3. Compaction curves.

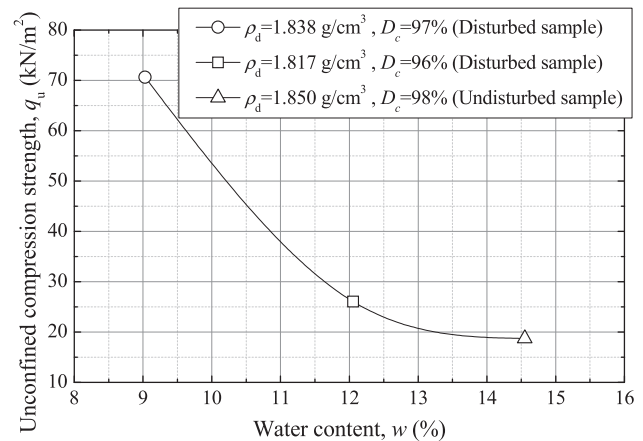
Fig. 4. Relation between water content and unconfined compressive strength.

Except for in the sloping core zone, random fill was used as the embankment material. The random fill consisted of the cohesive soil used for the core and silica sand excavated from a borrow-pit in Kyotango City, Kyoto Prefecture. The silica sand was mixed with the cohesive soil to increase the permeability of the random fill because there was not enough time for seepage after filling the water due to time constraints. It is reasonable to use sandy soils as the random fill for small earth dams. As mentioned earlier, sandy embankments have sustained more damage in past earthquakes than cohesive embankments. Moreover, when repairing embankments using GCLs, sandy soils can be used as embankment fill on the upstream side of the GCLs. Based on the permeability and slope stability during the construction [for details, refer to Sawada et al. (2016)], the mix ratio was approximately 1:1 by volume. According to the Unified Soil Classification System of Japan, the soil is classified as SFG. The properties of the random fill, the grain size cumulative curves, the compaction curves, and the relation between the water content and the unconfined compressive strength are shown in Table 2 and Figs. 2–4, respectively. Fig. 4 shows that the unconfined compressive strength decreases with an increasing water content, which can be attributed to the decline in suction.

stiffness with the increasing water content; and (2) there was a decrease in suction for the saturated soils, as shown in Fig. 4.

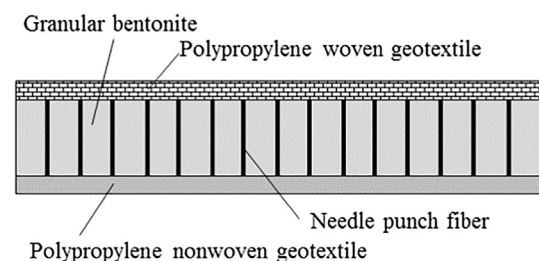
Fig. 5. Schematic of the GCL.

The GCL used in the present study was composed of granular bentonite sandwiched between a woven polypropylene geotextile and a nonwoven polypropylene geotextile, which were needle-punched together, as seen in Fig. 5 (Volclay Mat ST, Volclay Japan Co., Ltd.). The frictional properties between the core soil and the GCL have already been examined by Sasaki et al. (2015) using direct shear tests. They found the cohesion and friction angle between the woven and the non-woven GCL components to be 15 kN/m² and 28°, respectively. The cohesion and friction angle between the core soil and the woven GCL component were 0 kN/m² and 34°, respectively. Under low confining pressures, as in the present study, the interface between the woven GCL component and the core soil might be the weak point of the embankment. However, it should be noted that the frictional properties in this study will be different from those in past studies because the random fill here comes in direct contact with the GCL instead of the core soil.

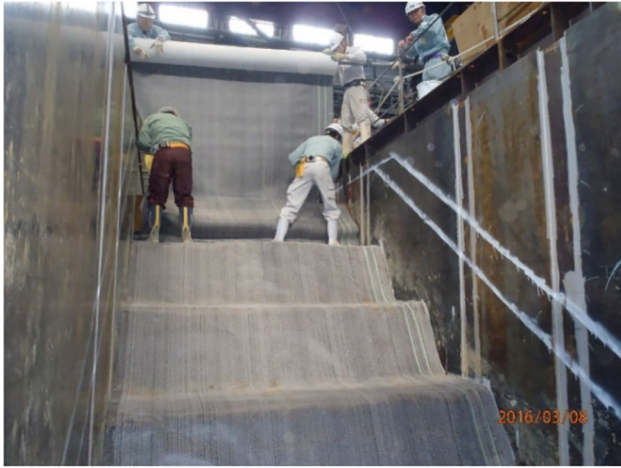
Photo 2. Installation of the GCL (Sawada et al., 2016).

For the embankment with a GCL, a bench cut with an inter-ramp slope of 1:1.5 was made at the upstream side, and the GCL was set on the bench, as shown in Photo 2. The bottom of the GCL along the bed had a width of 0.7 m, and granular bentonite was spread between the GCL and the bed to prevent leakage. On the upstream side of the GCL, the random fill was spread and compacted eight times using the plate compactor.

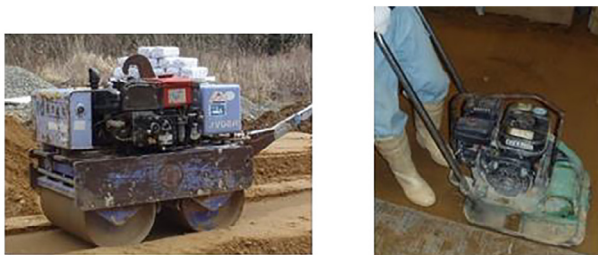
Vibrating roller

Plate compactor

on the basis of the Proctor test described in JIS-A 1210, as prescribed by the current guidelines (Ministry of Agriculture, Forestry and Fisheries, 2015a), the compaction numbers obtained using a vibrating roller (800 kg) and a plate compactor were 6 and 8, respectively.

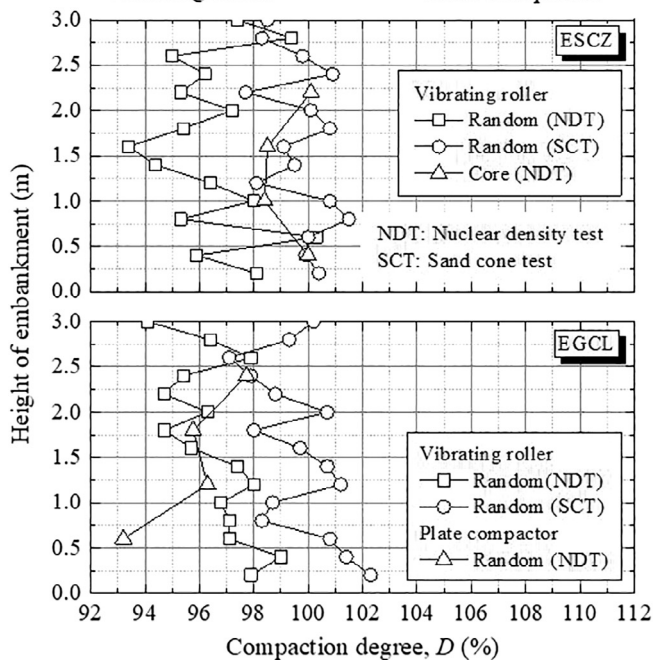
Fig. 6. Compaction degrees of embankments (modified from Sawada et al., 2016).

The soil density and the water content were measured using the nuclear method and the sand cone method, as shown in Figs. 6 and 7, respectively. For the nuclear method, testing was performed at three locations for the lift thickness of each embankment layer, whereas the sand cone testing was performed at one location for each layer. For the two embankments, the degrees of compaction were at least 93% and more than 95% on average.

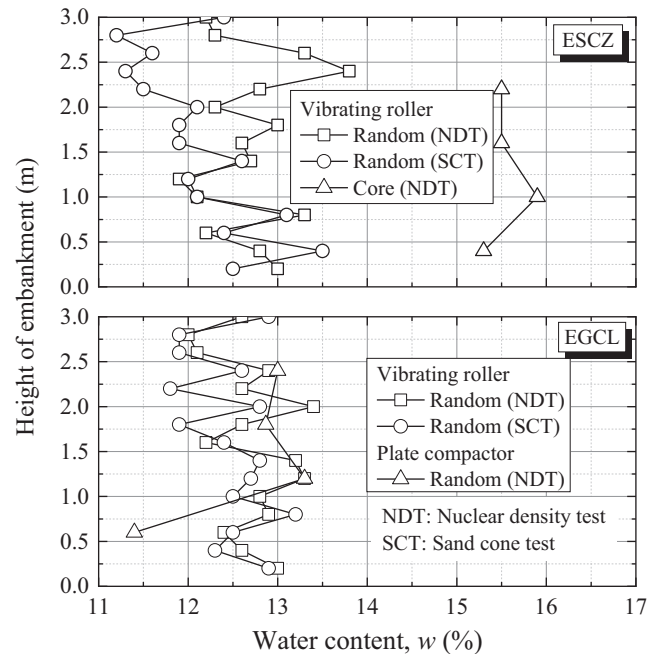
Fig. 7. Water content of embankments.

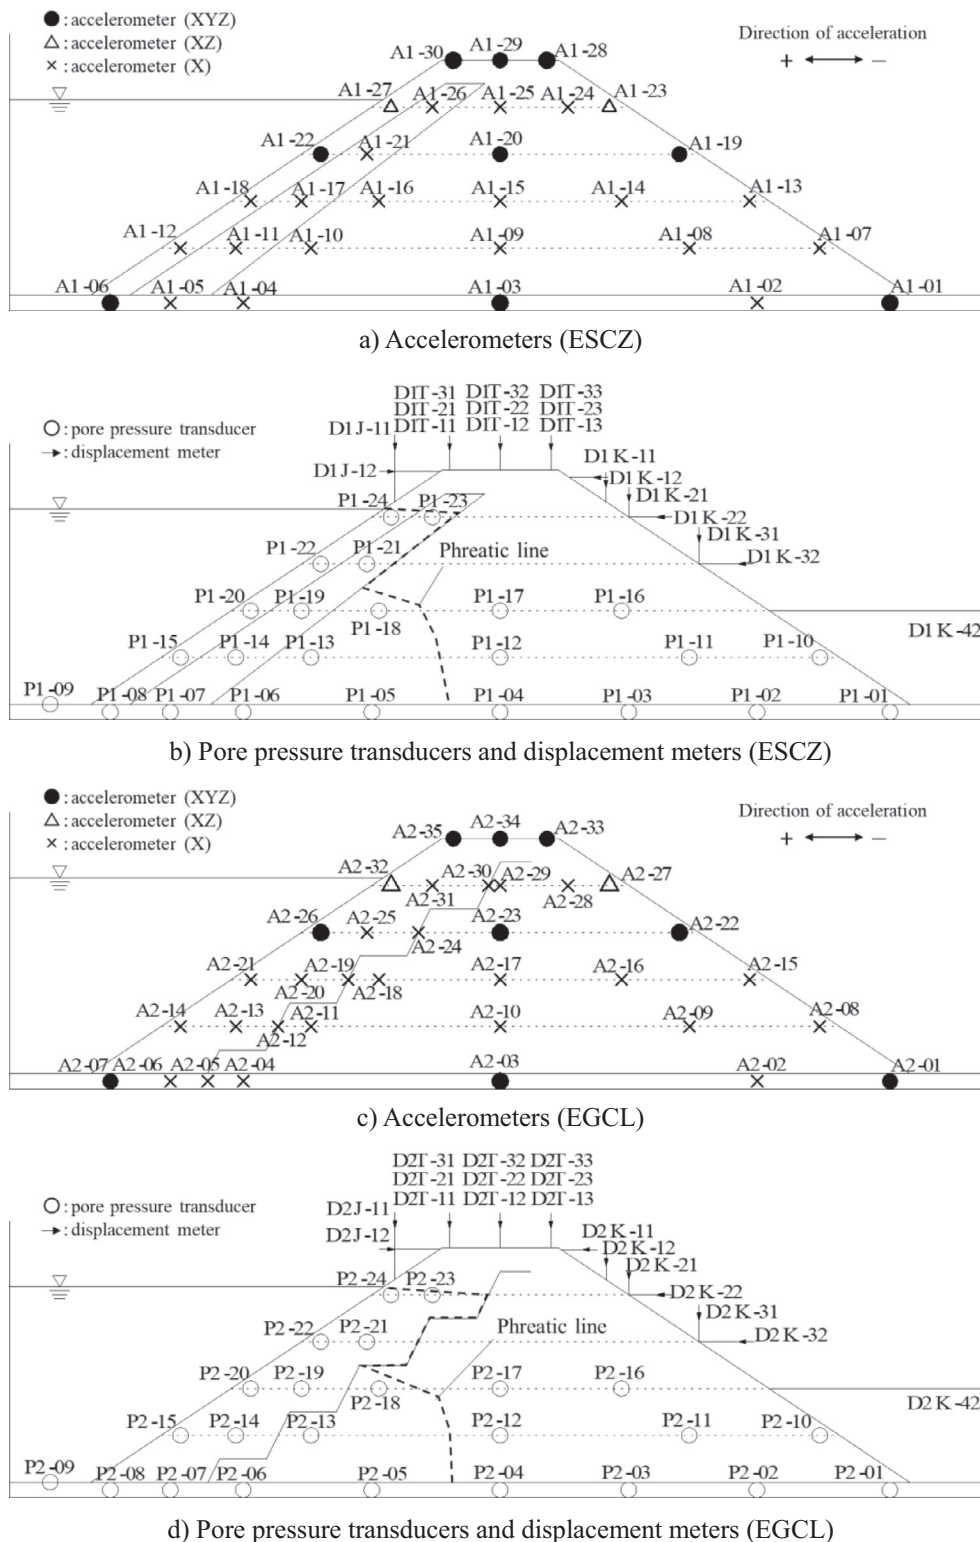
Fig. 8. Sensor locations (modified from Sawada et al., 2016).

Fig. 8 shows the locations of the sensors. The accelerometers (ASW-5AM36, Kyowa Electronic Instruments Co., Ltd.) and pore water pressure transducers (BPR-A-200KPS, Kyowa Electronic Instruments Co., Ltd.) were embedded at the prescribed locations at intervals of 0.6 m and are referred to as “A” and “P,” respectively. To measure the displacements of the crest and the slope, laser

displacement sensors (LK-500 and IL-2000, KEYENCE Corporation) were installed after the construction of the embankments. Since the soil behavior near the sloping core zone and near the GCL was expected to be different from

that at other locations, the transducers were closely spaced. In order not to reinforce the embankments with sensor cables, 5-mm-diameter cables were used and meandered. Pore water pressure transducers P1-09 and P2-09 were set

on the bed to measure the water level of the reservoir. Pore water pressure transducers P1-01 to P1-08 and P2-01 to P2-08 were installed  $-0.1$  m from the surface of the bed and backfilled with random fill instead of core material to correctly measure the water head pressure. It should be noted that P2-07 was installed under the GCL and that P2-08 was located on the upstream side.

GCL (P1-06 and P2-06) were much lower than those in front of them (P1-08 and P2-08), which can be attributed to the impervious effects of the protections. Based on all the pore water pressure values, the phreatic lines were determined (Fig. 8). These results clearly show that the soil had been saturated on the upstream side and unsaturated on the downstream side.

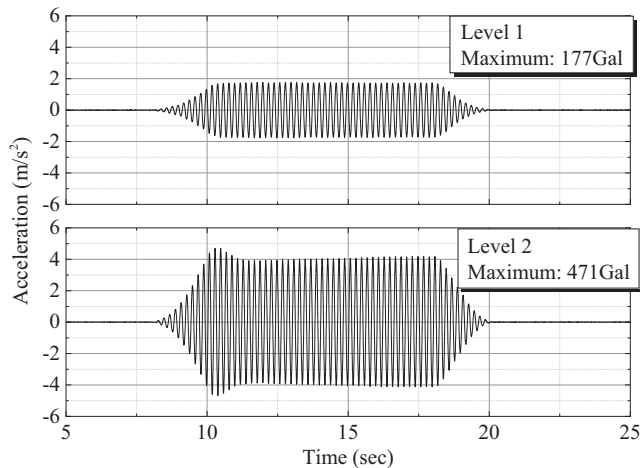
Fig. 9. Base acceleration time histories (Sawada et al., 2016).

Simple sine waves in the transverse direction of the embankments were used as the input motion because the purpose of this study was to obtain benchmark data for comparison with the results of numerical analyses, not to simulate earthquake damage in a specific dam. A wave frequency of 5 Hz was chosen in order to avoid the sloshing frequency of water in the reservoir, which was predicted by Housner's equation (Housner, 1963). The wave period was 12 s and had tapered parts (4 s). Two shaking events were designed to reproduce Level-1 and Level-2 seismic motion, as described by the Japanese guidelines (Ministry of Agriculture, Forestry and Fisheries, 2015b); they are hereinafter referred to as Level-1 and Level-2 shaking, respectively. They were subsequently applied to the same model. The base acceleration time histories measured in the two tests are shown in Fig. 9. The peak accelerations of the motions for Level-1 and Level-2 shaking were 177 and 471 Gal, respectively.

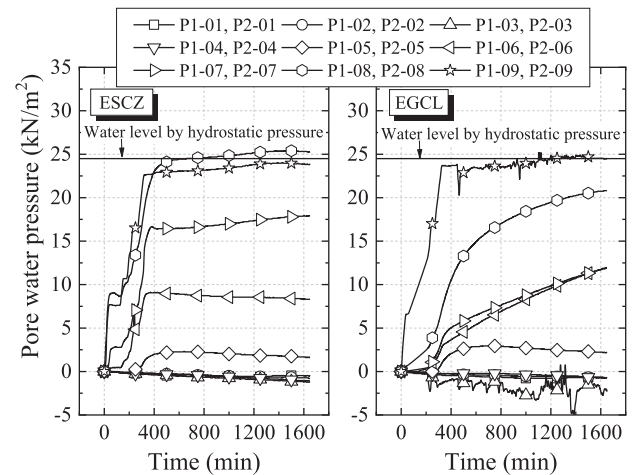
Fig. 10. Pore water pressure in the beds over time (Sawada et al., 2016).

Fig. 10 shows the pore water pressure in the beds over time while water was being poured into the reservoir. P1-09 and P2-09 indicate the hydrostatic pressure, which was equivalent to the water level. The pore water pressure at the base behind the sloping core zone and that near the

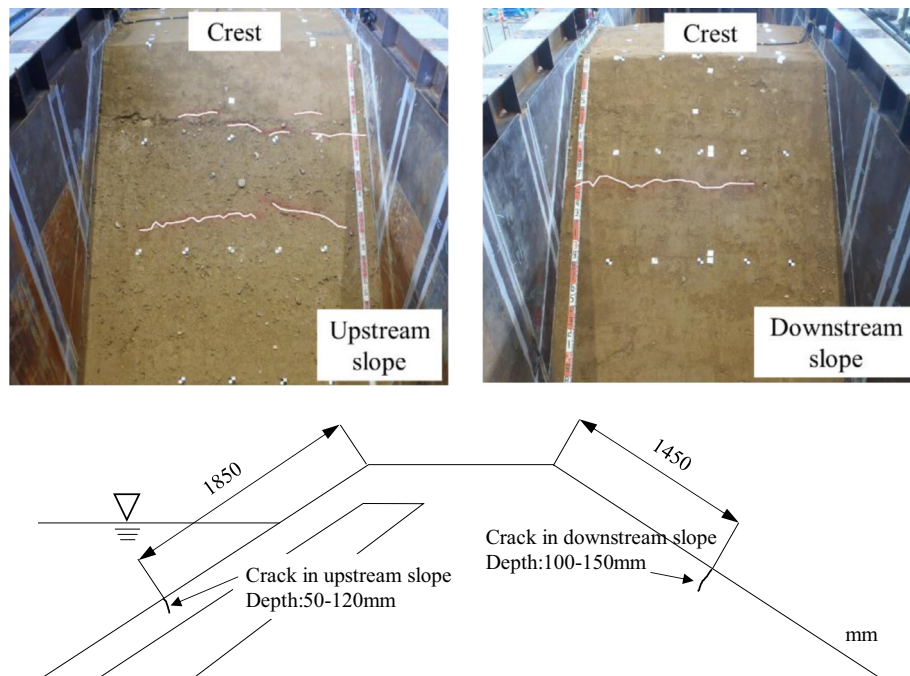
Fig. 11. Cracks in the ESCZ model (modified from Sawada et al., 2016).

After Level-1 shaking, no apparent damage (e.g., cracks or leakage) was observed in either embankment. Conversely, after Level-2 shaking, small cracks with widths of 1 mm and depths of 100 mm were observed in the upstream and downstream slopes of the ESCZ model (Fig. 11), whereas large longitudinal cracks developed at the crest of the embankment in the EGCL model (Fig. 12). Oda et al. (2016) reported mixing water with lime and pouring it into the cracks to investigate their depth. The results revealed that the cracks had developed to the corner of the highest step of the GCL and that the lime had remained along the highest slope of the GCL, as shown in Fig. 12. In addition, according to the article, although the lime was not observed in deeper places, because the cracks were narrow, the acceleration near the GCL indicated that the seismic characteristics were different on the upstream and downstream sides of the GCL. However, no water leakage was observed in either embankment in this study. According to the current guidelines (Ministry of Agriculture, Forestry and Fisheries, 2015a), if a crack occurs in a dam body, the embankment must be repaired. However, the guidelines state that seismic evaluations against Level-2 seismic motion are not done for small earth dams unless the capacity exceeds  $100,000 \text{ m}^3$  or the height exceeds 10 m. Based on the degree of damage caused to the embankments by subjecting them to Level-1 and Level-2 shaking, it can be judged that small earth dams with a height of 3 m have earthquake resistance, which is described in the current

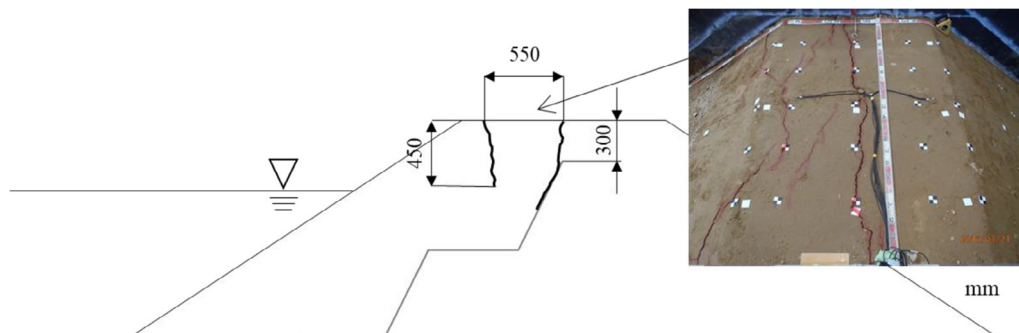
Fig. 12. Cracks in the EGCL model (modified from Oda et al., 2016).

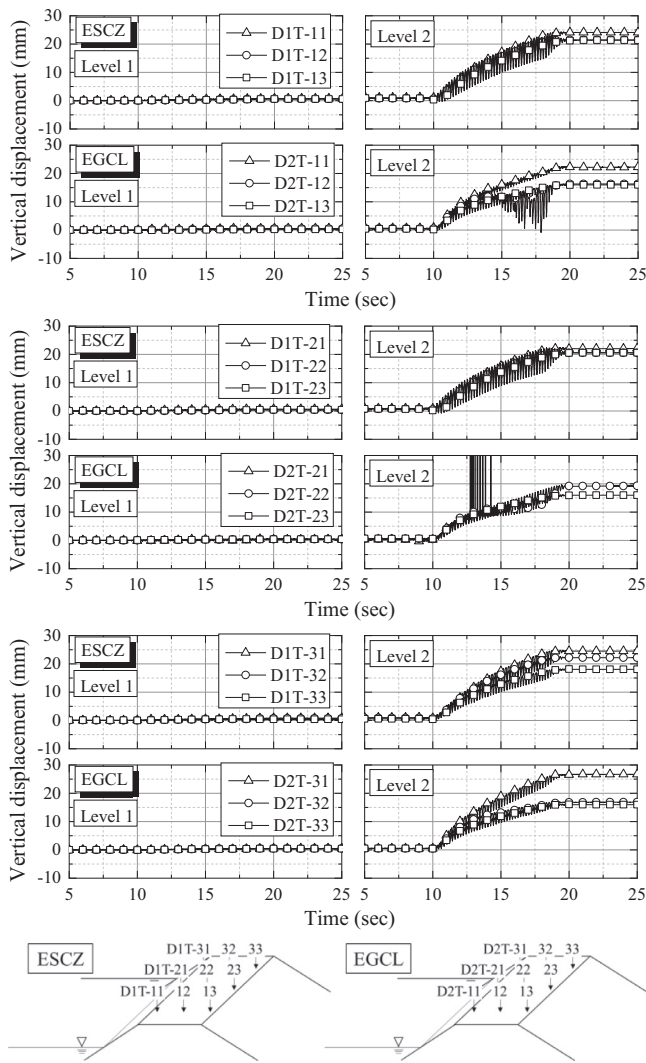
Fig. 13. Time histories of vertical displacement at embankment crests.

shaking. It should be noted that the target plates of sensors D2T-21 and D2J-12 were greatly displaced, and that the distance between the sensors and the targets exceeded the upper limit. Figs. 13 and 14 show that the vertical displacements at the crest and the horizontal displacements at the upper parts of the downstream slopes become positive, whereas the horizontal displacements at the upper parts of the upstream slopes and at the lower parts of the downstream slopes become negative. These results correspond to those of the survey data obtained before and after the tests using electro-optical distance measurements (Fig. 15). It should be noted that the displacements shown in Fig. 15 are enlarged by 10 times. In both embankments, settlement occurred at the crest, and lateral deformation occurred from the middle to the bottom of the embankment.

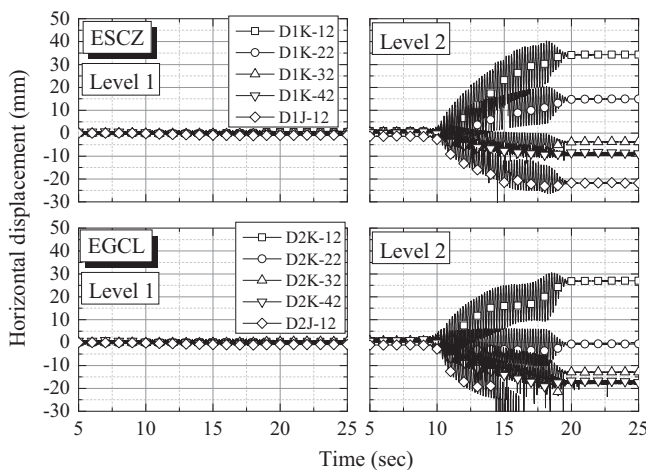
Fig. 14. Time histories of horizontal displacement at embankment slopes.

As shown in Figs. 14 and 15, the amount of settlement was almost of the same degree in both models. Namely, embankments with a GCL are not likely to be inferior to those with a sloping core zone.

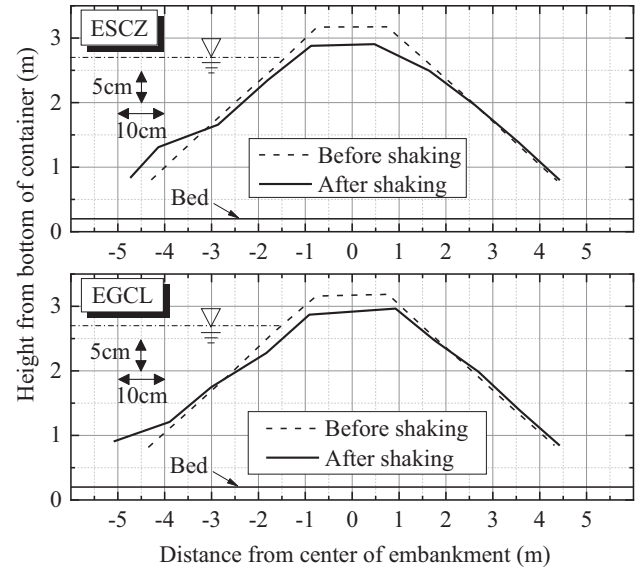
Fig. 15. Cross-sections of embankments before and after shaking (modified from Nakazawa et al., 2017).

side. According to Higo et al. (2015), this occurs because the shear elastic stiffness decreases with an increasing water content, leading to a smaller impedance ratio. These results agree with the deformation of the embankment, as shown in Fig. 15.

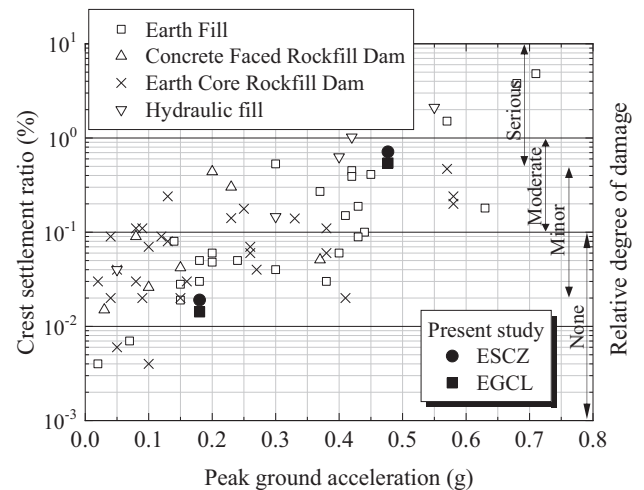
Fig. 16. Relations between peak ground accelerations and crest settlement ratios (modified from Swaisgood, 2003).

earthquake. The article stated that the crest settlement ratio is closely related to the peak ground acceleration and damage severity. Fig. 16 shows the data from Swaisgood (2003) alongside the settlement ratios obtained in this study. Fig. 16 shows that the settlement ratios observed after the Level-1 shaking can be classified as no damage, whereas those observed after the Level-2 shaking are classified as moderate to serious damage. As mentioned above, several large longitudinal cracks were observed at the crest of the EGCL model after the Level-2 shaking. Therefore, it is likely that the deformation behavior observed in our models is reasonable and similar to that occurring in the field during an earthquake.

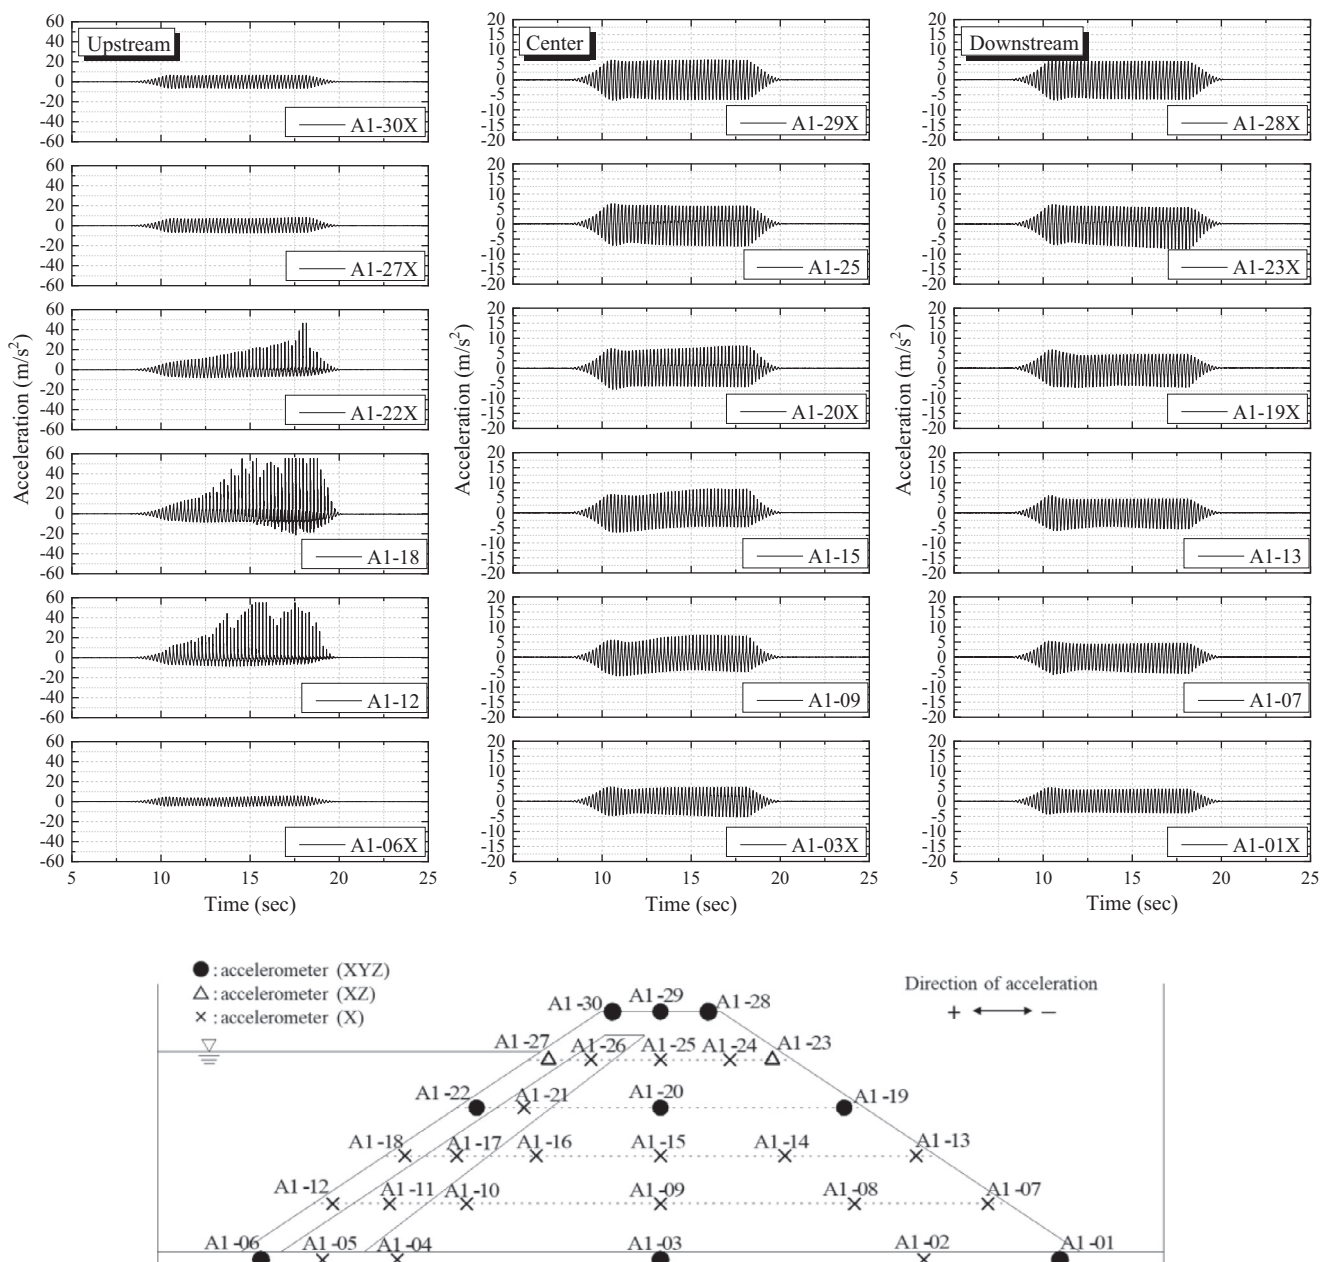
Fig. 17. Measured accelerations (ESCZ).

Figs. 17 and 18 show the measured accelerations for the two embankments during the Level-2 shaking. It should be noted that the scales of the vertical axes for the upstream sides were  $\pm 60 \text{ m/s}^2$ , whereas those for the center and downstream sides were  $\pm 20 \text{ m/s}^2$ .

At the centers of the embankments, the measured accelerations increased as the location on the embankment became higher. In other words, the input wave was more amplified toward the upper part of the embankment, which is a general dynamic characteristic of elastic solids. The amplification factor between the bed and the crest was

approximately 1.4 in the ESCZ model. In contrast, in the EGCL model, the amplification factors were 2.1 and 3.3 before and after the development of cracks at the crest, respectively. It appears that the increase in amplification factor was caused by the cracks in the crest. The soil mass on the upstream side was separated from the dam body and moved more freely after the appearance of cracks than before it (i.e., the resistance decreased).

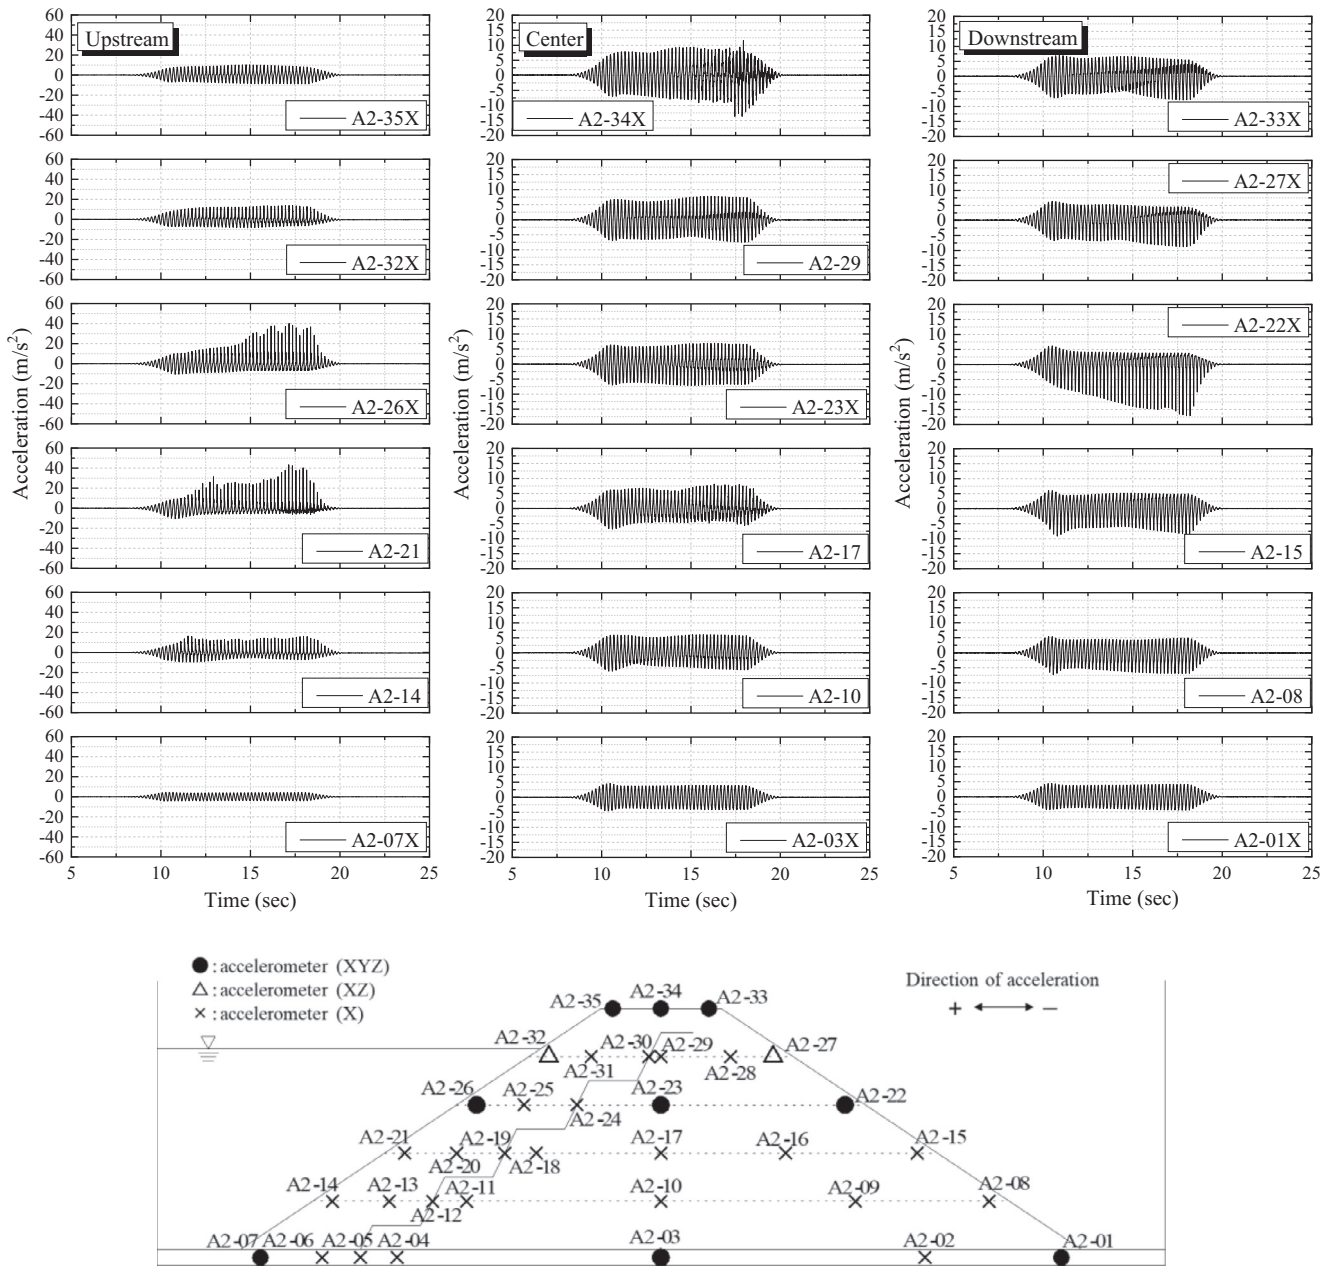
Fig. 18. Measured accelerations (EGCL).

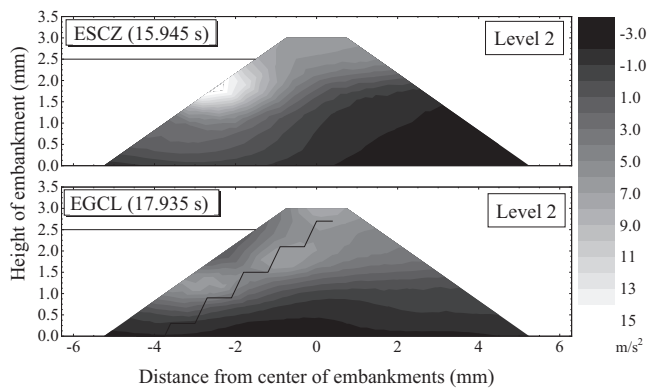
Fig. 19. Distributions of measured accelerations (maximum acceleration at the crest).

Fig. 19 shows the contours of the measured accelerations when the accelerations at the crests were maximized in the upstream direction (15.945 s in the ESCZ model and 17.935 s in the EGCL model). Fig. 20 shows enlarged views of the measured accelerations on the upstream and downstream sides at the height of 1200 mm above the bed. A large difference in phase was observed between the measured accelerations. In other words, when the upstream slope was displaced toward one side, the downstream slope was displaced toward the other side, most

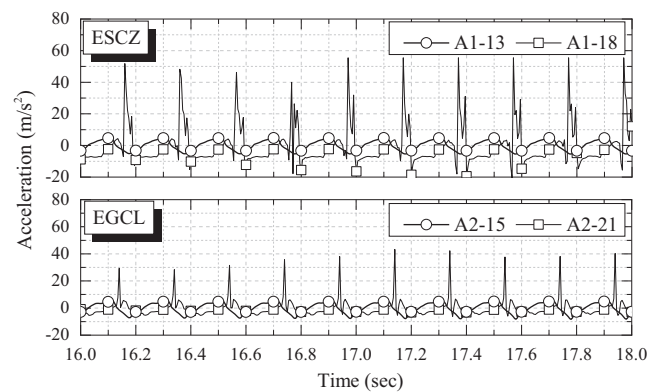
Fig. 20. Measured accelerations from 16 to 18 s.

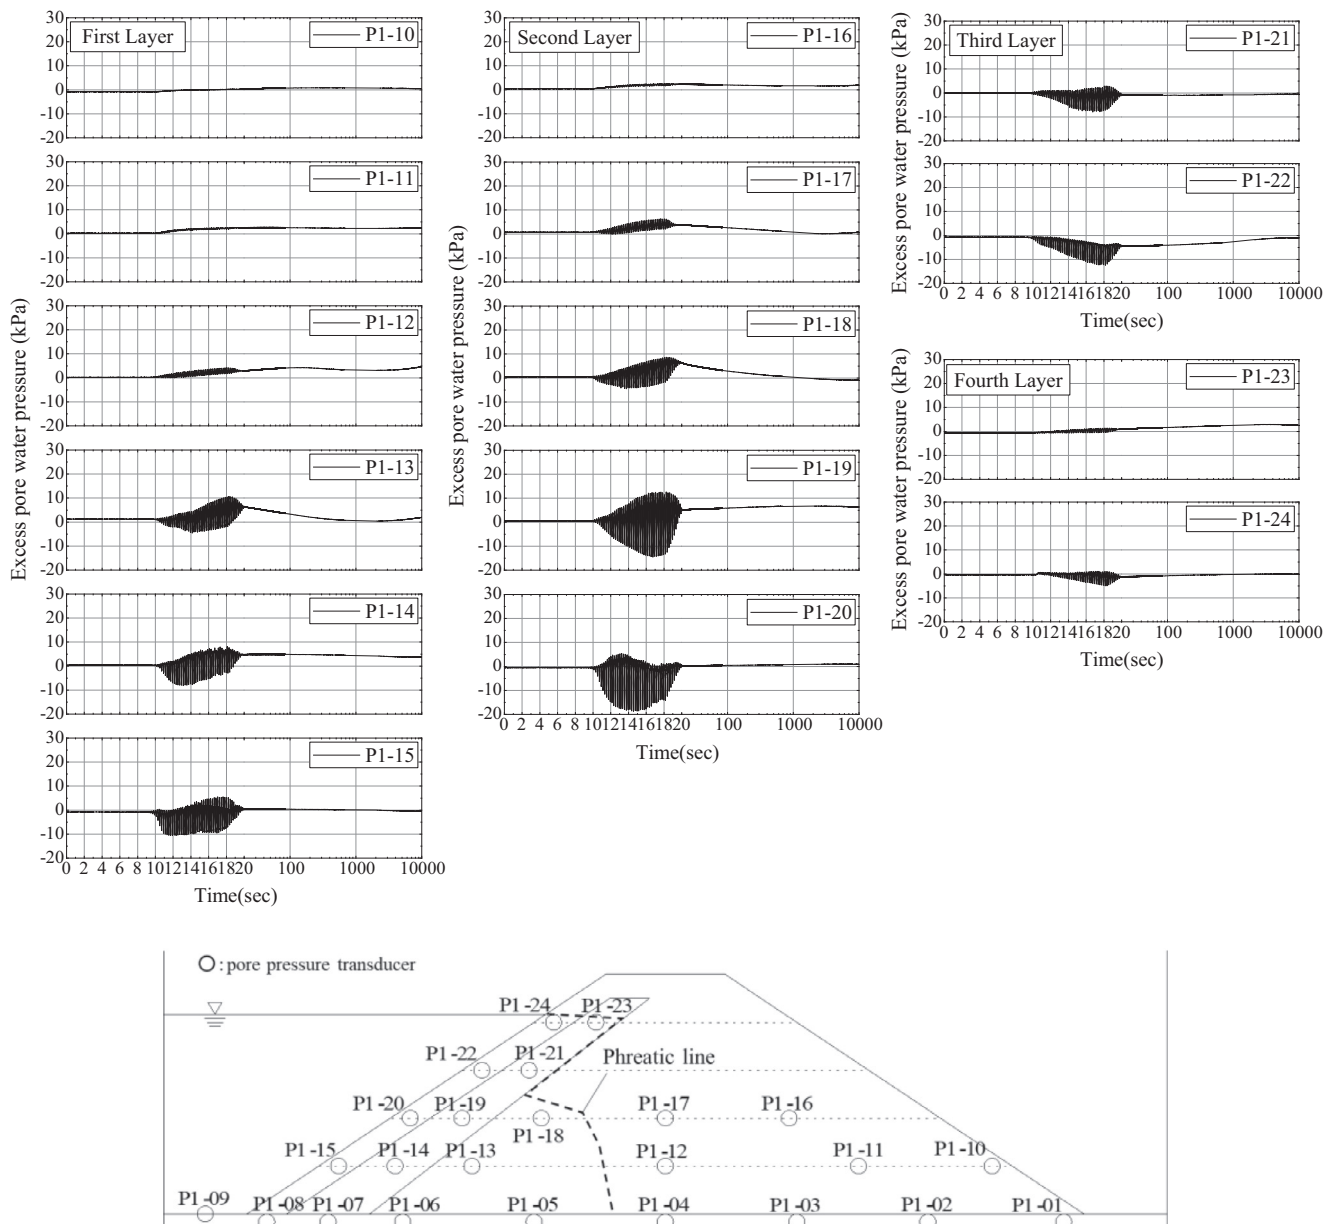
Fig. 21. Time histories of pore water pressure (ESCZ).

Figs. 21 and 22 illustrate the excess pore water pressure (EPWP) over time during Level-2 shaking in both embankment models. In order to discuss the dissipation process of pore water pressure, the  $x$ -axes in Figs. 21 and 22 are presented as logarithmic scales after 20 s of shaking.

Regarding the EPWP on the upstream side of the impermeable materials (i.e., the sloping core zone or the GCL), the EPWP hardly accumulated, except for at P1-22 and P2-19. The negative amplitude of the EPWP was much larger than the positive one. The negative pore water pressure is related to the undrained shear behavior of compacted soils; namely, the undrained condition was retained because of the short shaking period (12 s) and no volume change occurred in the soils. This behavior probably led to an increase in effective stress in the saturated soils as well as the restraint of slope failure on the upstream side. Therefore, it is suggested that compaction control by 95% of the maximum dry density, proposed by the guidelines (Ministry of Agriculture, Forestry and Fisheries, 2015a), is significantly effective for improving

the earthquake resistance of embankments. However, in the ESCZ model, negative EPWP accumulated in the upper part of the upstream side (P1-22) during shaking and increased gradually after shaking. This probably resulted in volume expansion with water absorption. In other words, the soil became loose and susceptible to liquefaction by subsequent earthquakes. For the EGCL model, the EPWP gradually increased after the decrease in the upper part of the upstream side (P2-21 and P2-22), most likely because of the above-described gap between the GCL and the upstream side. It can be assumed that the pore water around P2-21 and P2-22 flowed into the gap, and that the water was absorbed from the reservoir after shaking.

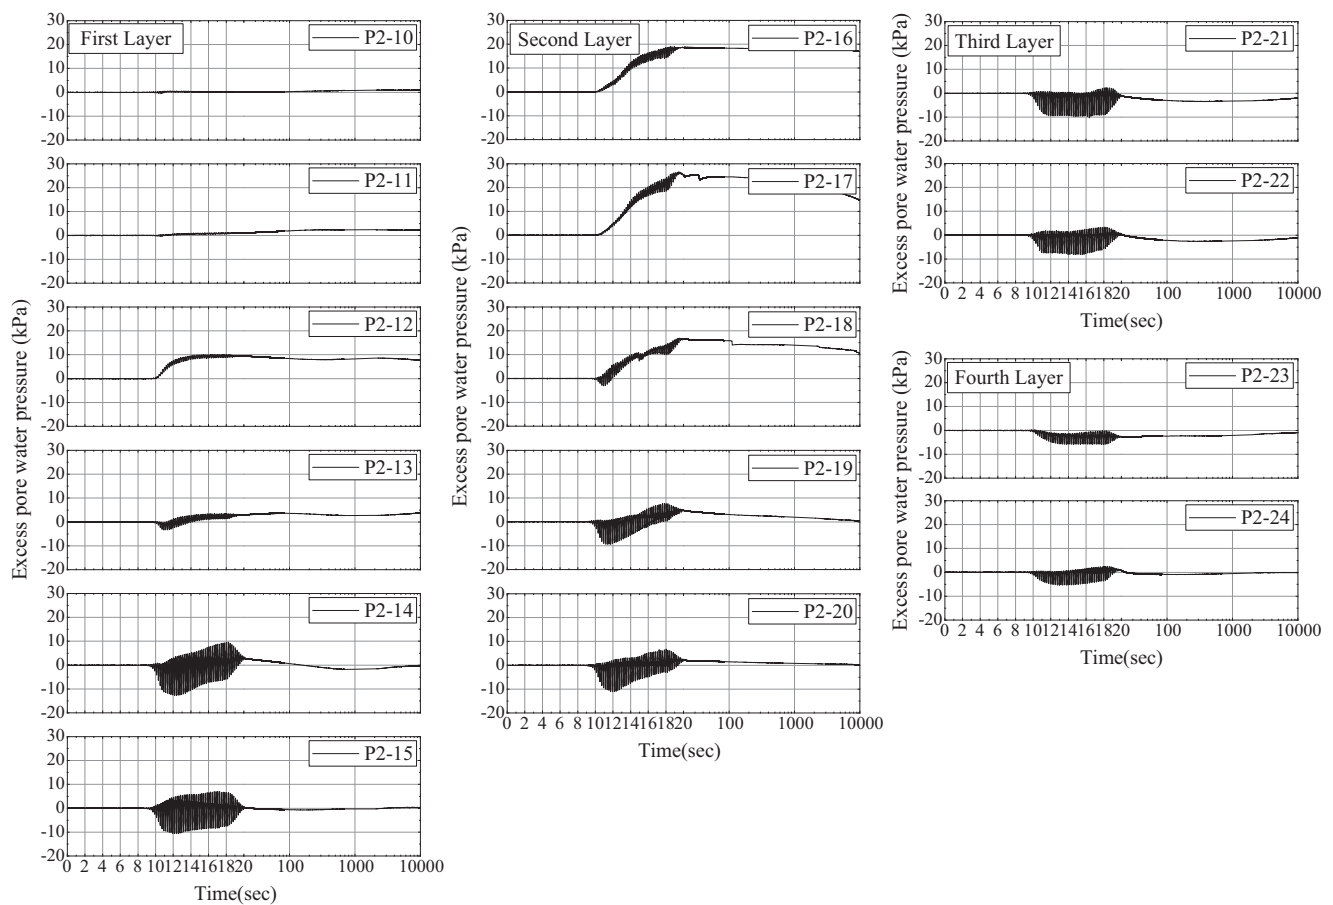
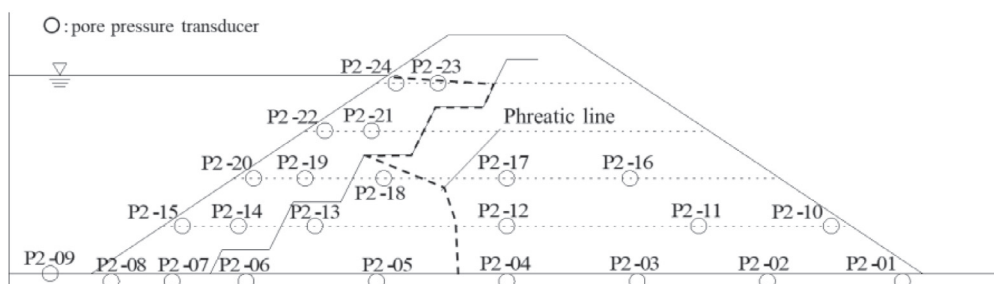
Fig. 22. Time histories of pore water pressure (EGCL).
