# Seismic vulnerability assessment of residential buildings using logistic regression and geographic information system (GIS) in Pleret Sub District (Yogyakarta, Indonesia)

Geoenvironmental Disasters, 4:11-11

**Keyword:** Earthquake, Damage pattern, Building vulnerability, Probabilistic model

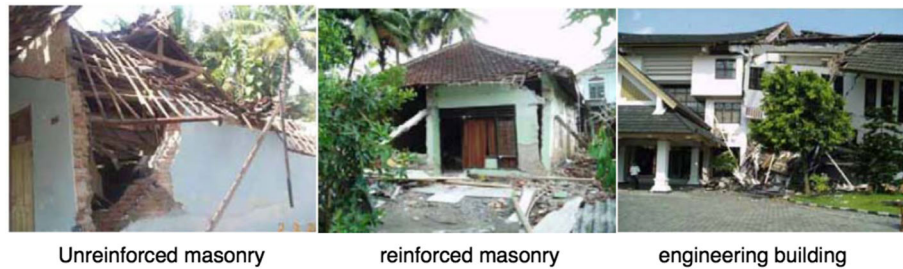
**Fig. 4** Buildings damaged types (Daryono, 2011)

The description of damaged buildings above may reveal that the buildings had been constructed with lack of anticipation on seismic events as well as quality of construction (Elnashai et al., 2006). Generally, buildings consist of non-structural and structural elements. Non-structural elements refer to the components of the building that are not considered to support its self-weight as well as the external forces of the building. On the other hand, the structural elements refer to the components of the building that are carefully designed to hold and distribute the forces acting on the building and transfer every single force to the ground continuously without any significant deformation. Each part of the structural elements of the building collaborates with each other to form a structural system that guarantees the utility of a building.

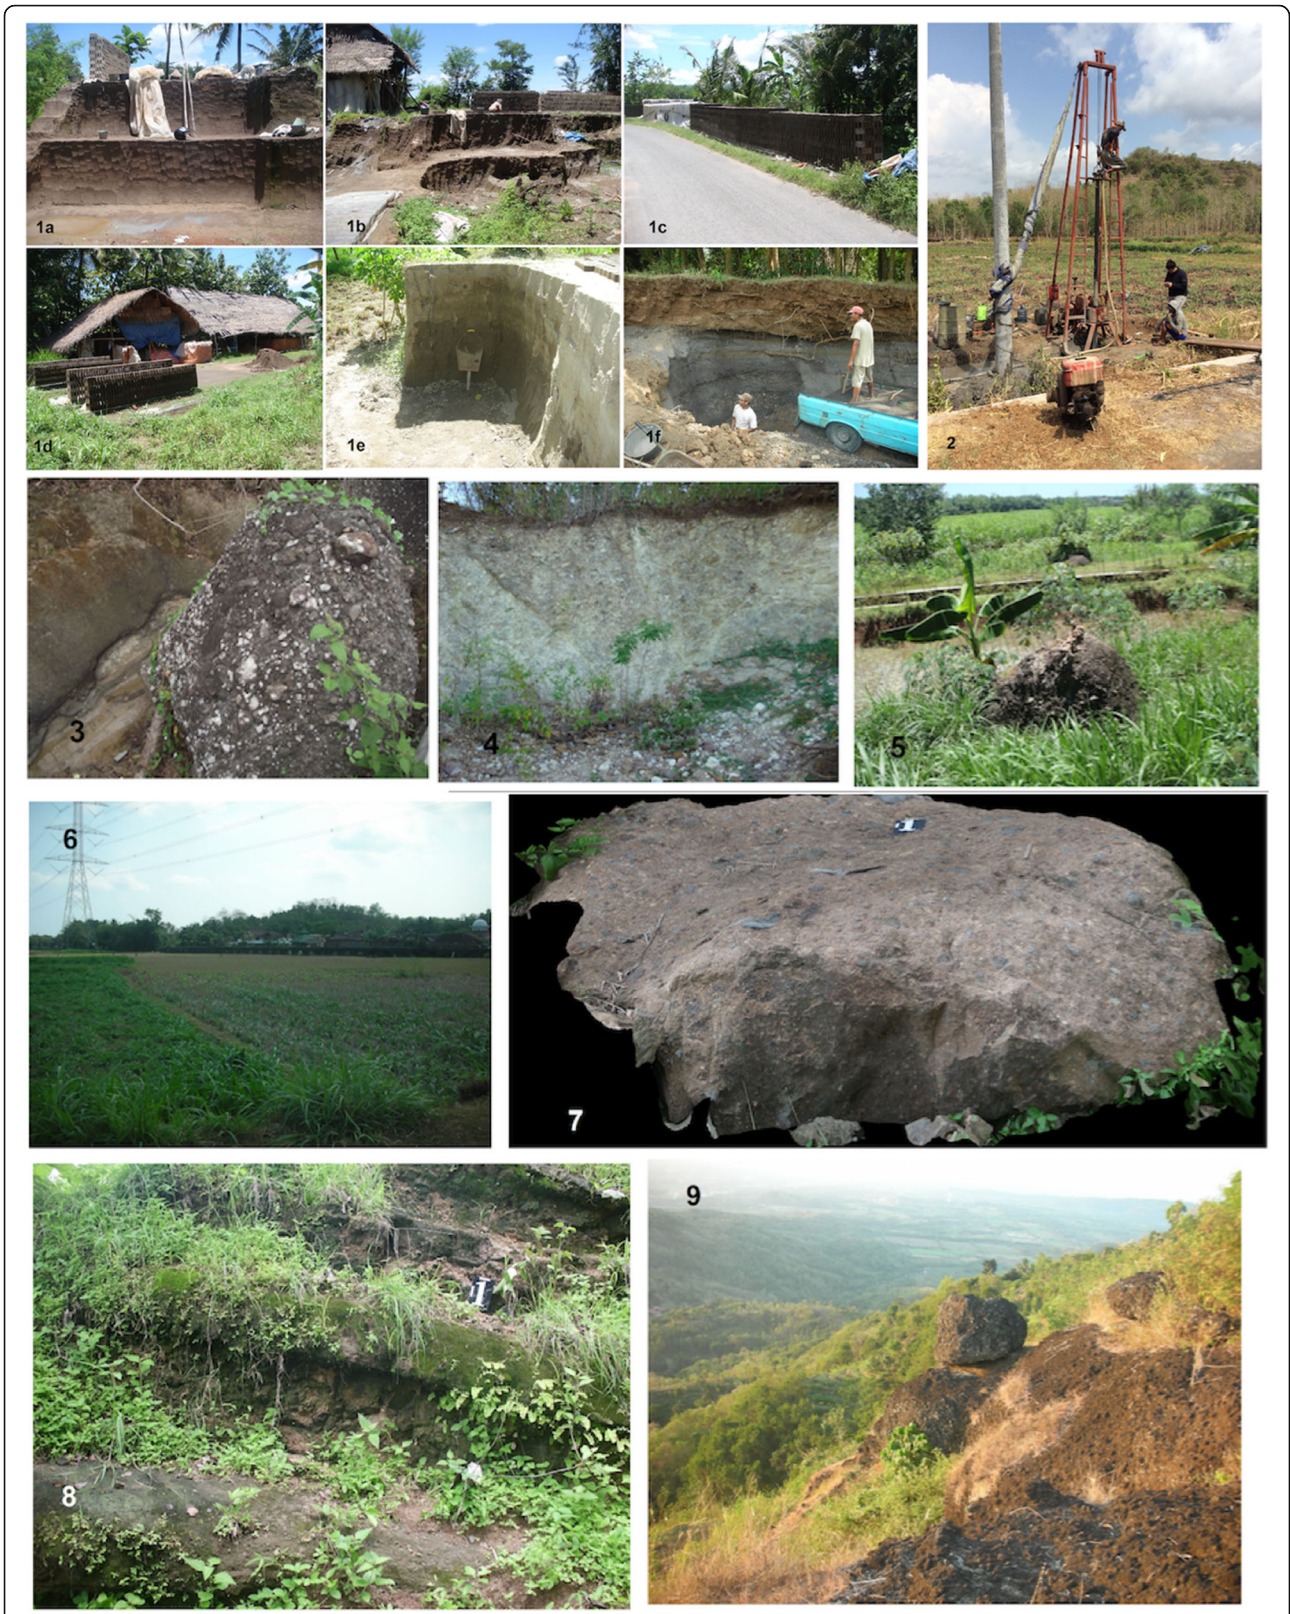
**Fig. 10** The documentation of field verification

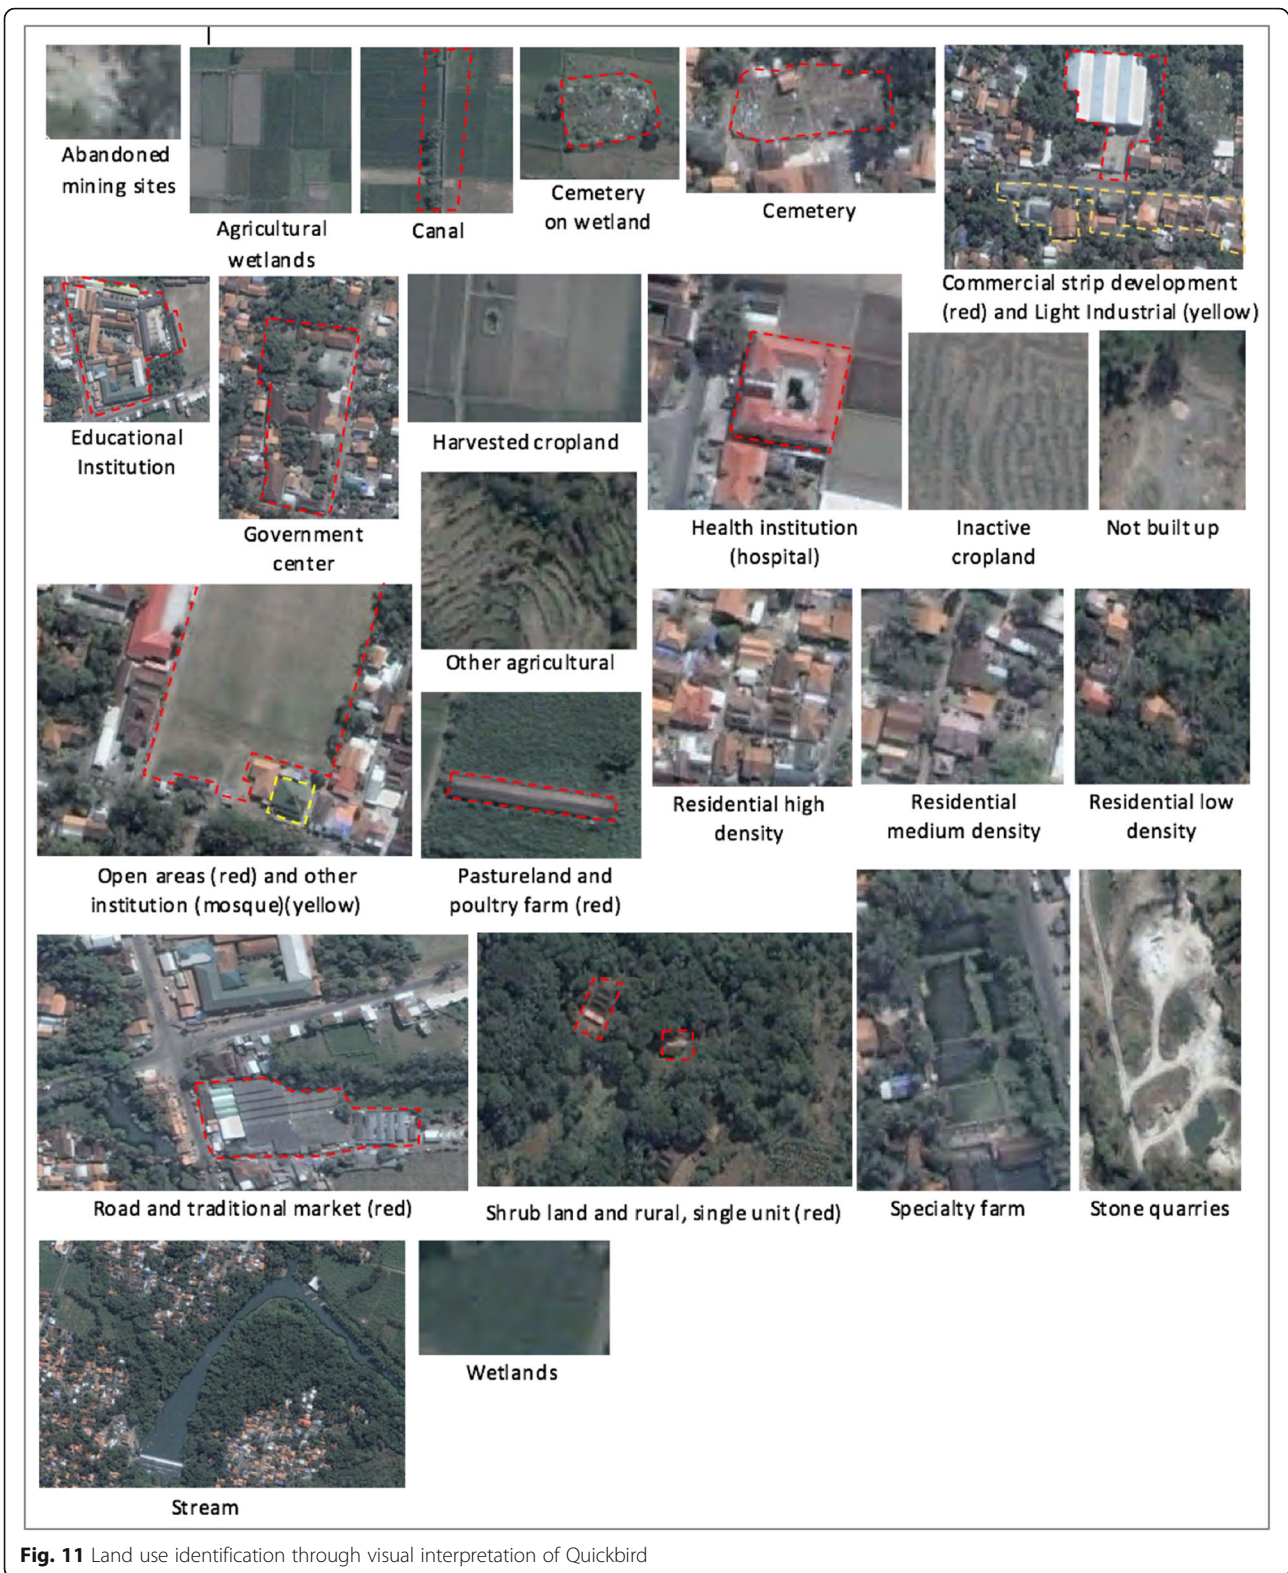
**Fig. 11** Land use identification through visual interpretation of Quickbird

Based on the Land use- Land cover classification system, NJDEP modified Anderson System 2002, there are 29 land use units in the research areas. Those land use units cover 10 units of level 1 i.e., residential, commercial, industrial, transportation, other built up area, agricultural area, confined feeding operation, forestland, stream & canal, and wetland. The land use classification show that the research area is dominated by the shrub land which cover approximately of 42.36% of the total area. The wetland agricultural area or paddy field only cover 25.34% of the total area, while the residential area (high, medium, and low density) cover approximately 3.79%, 5.70% and 3.01%, respectively. Most of them are distributed in the west and middle part of research area which are the Qmi and Qa. Detail information is shown in Fig. 11, and Table 8, while the land use map is shown in Fig. 12.
