SEISMIC VULNERABILITY OF A WATER-SUPPLY PIPELINE BASED ON THE DAMAGE ANALYSIS OF TWO EARTHQUAKES DURING THE GREAT EAST JAPAN EARTHQUAKE

Yasuko KUWATA¹, Keisuke SATO², and Soji KATO³

ABSTRACT: The city of Iwaki, located in Fukushima Prefecture, Japan, faced water outage twice because of the Tohoku earthquake that occurred on March 11, 2011, as well as the earthquake that followed on April 11, 2011. It is rare that two large earthquakes, each with different mechanisms, occur within a short period of one month. This study focuses on the pipeline damage in Iwaki due to these earthquakes and tries to clarify the seismic vulnerability of pipe attributes on the basis of the earthquake damage analysis on the water-supply pipeline. As the result of the analysis on the seismic vulnerability index of the pipe material, pipe diameter, and its geomorphological classification, the seismic vulnerabilities to pipe diameter and material were very similar between the two earthquakes. The seismic vulnerability to pipe diameter was also similar to that in earthquakes in the past, whereas polyvinyl chloride pipes (VPs) were evaluated to be stronger. The geomorphological classification factor does not

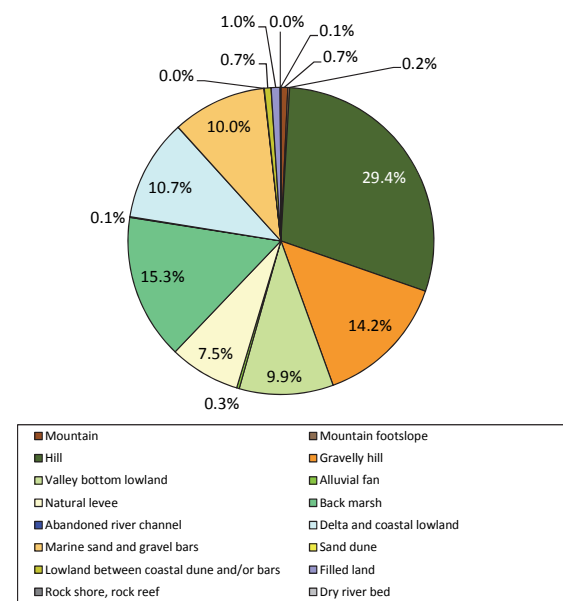
Fig. 3 Ratio of pipeline lengths in terms of the engineering geomorphological classification

In order to clarify the geological condition at the location of pipeline damage, the 250 m-by-250 m mesh that is one-fourth size of standard regional was used. Each grid square is given an engineering geomorphological classification that was proposed by Wakamatsu et al.¹⁶⁾ Fig. 2 shows the city map as classified by the engineering geomorphological classification, and Fig. 3 shows the ratio of pipeline lengths according to the engineering geomorphological classification. The pipeline is installed in a range of different areas classified as hills, gravelly terraces, back marshes, and coastal lowlands, although the majority of the city of Iwaki is in the mountains or hills.

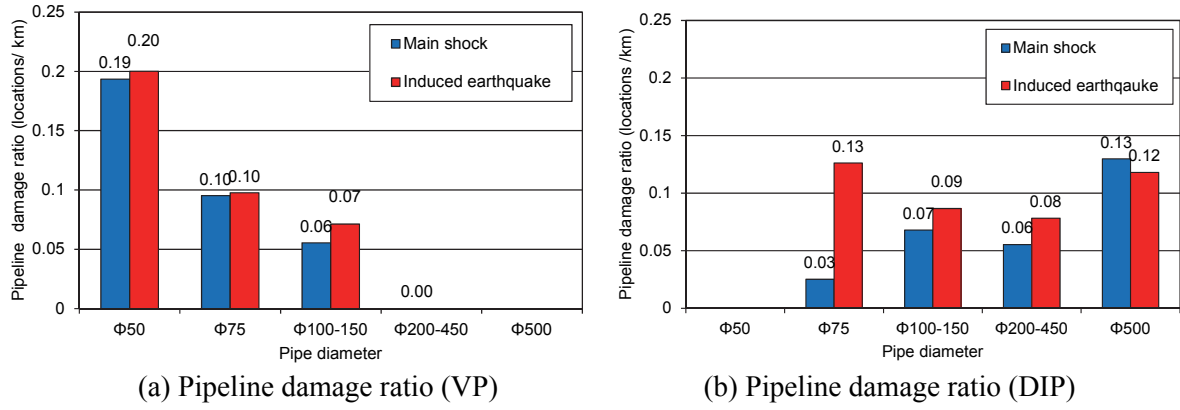
Fig. 4 Pipeline damage ratios of the MS and IE in terms of the diameter of VP and DIP

Comparing the pipeline damage ratios in terms of pipe material, the ratios for steel pipes (SPs) and asbestos cement pipes (ACPs) were remarkably high. The correction coefficient of pipeline damage estimation by JWWA²⁾ was also high for ACPs. However, this is because the installed lengths of both types of pipelines were short, only 6 km of ACPs and 21 km of SPs, compared to the other pipe material, and therefore the pipeline damage ratio may be overvalued. The damage ratio of VP became smaller than that of CIP although the correction coefficients of the damage estimation for both pipe materials were determined to be the same. It is thought that a contributing factor may be the fact that many VPs were installed on hills and the ground motion at the VP sites was therefore relatively small. In terms of pipe diameter, the pipeline damage ratio increases as the diameter gets smaller, excluding the category of ϕ 500 or more.

and more than ϕ 500 of DIPs may be overestimated or underestimated, as the installation lengths are shorter than the others. In addition, when comparing the pipeline damage ratio of VPs and DIPs at ϕ 100–150, those of DIPs were somewhat high regardless of which earthquake caused the damage.

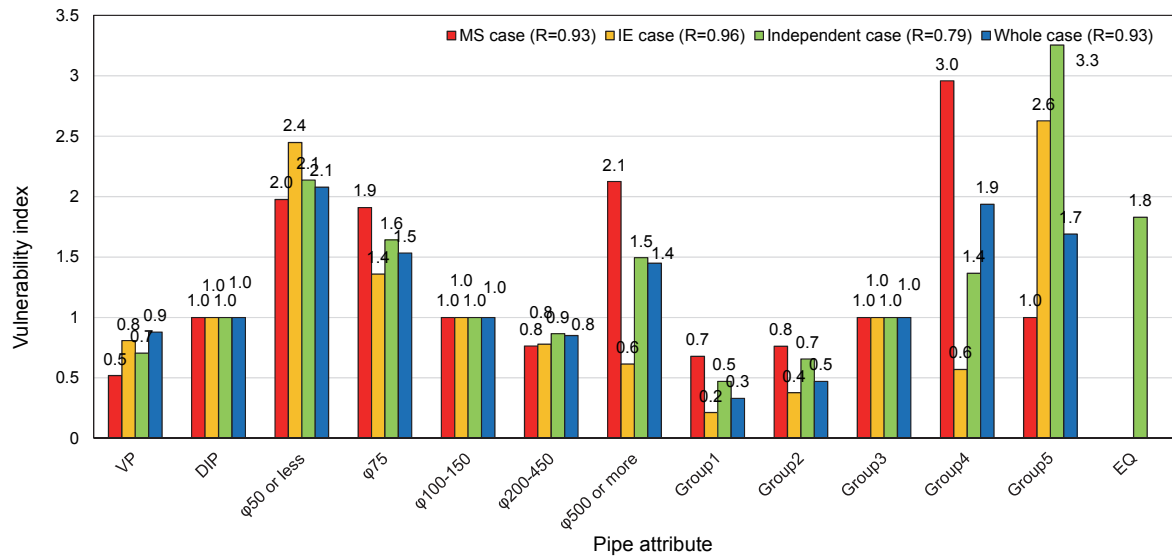
Fig. 5 Vulnerability index of pipe attributes from each regression analysis case. *Note 1.* The index shows the MS case, IE case, independent case, and whole case from the left bar. *Note 2.* The number of () in the legend means the correlation coefficient of the regression analysis. *Note 3.* The value of EQ means the index of the IE when the earthquakes are dealt separately.

As for each correlation coefficient, the MS case was 0.93, the IE case was 0.96, the independent case was 0.79, and the whole case was 0.93. As a whole, high correlations were obtained. Fig. 5 shows the vulnerability index of each pipeline attribute according to the analytical cases. Comparing the indexes between the cases, the index of pipe material and diameter can be seen to vary within the range of 0.5 points, except in the case of a diameter of ϕ 500 or more. The pipeline with a diameter of ϕ 500 or more is only a DIP, and the damage locations were 11 after the MS and 9 after the IE. The number of damage locations does not seem to be very different between the two earthquakes, but it is considered to be due to a difference in geomorphology. Overall, it was confirmed that the index of DIPs is a little bit smaller than that of VPs, and it becomes smaller as the diameter gets larger, excluding the case of ϕ 500 or more. These tendencies are similar to the pipeline damage ratio of DIPs as mentioned in Fig. 4. In a word, the obtained indexes of pipe material are adjusted to the result of past earthquakes, whereas the indexes of diameter are evaluated for VPs that have not been damaged as easily compared to previous research reports.

While the indexes of pipe material and diameter indicate similar values between the cases, the index of the geomorphology group shows a large difference. In particular, the indexes of Group 4 and Group 5 show an opposite tendency to the MS and IE cases. These groups are marine sand and gravel bars, sand dunes, and filled lands. Since the pipeline length in filled lands is only about 1% of the total, it is thought that the index was either overvalued or undervalued. Moreover, there is a good reason to
