Seismology and Ground Motion Features of 1995 South Hyogo Great Earthquake.....	220
Liquefaction and Damages to Harbour Facilities.....	228
Mountain Slope Failures Caused by the Great Hanshin Earthquake.....	233
Damages to Bridges on Highways and Railroads Caused by the Great Hanshin Earthquake of January 17, 1995.....	237
Damage to Large-Scale Underground Lifelines during the 1995 South Hyogo Prefecture Earthquake.....	272
Lifelines Performance and Damage during Jan. 17, 1995 South Hyogo Great Earthquake.....	283
Outline of the Geographical Information System (GIS) and Internet Information.....	296

## **Liquefaction and Damages to Harbour Facilities**

# Mountain Slope Failures Caused by the Great Hanshin Earthquake

# DAMAGE TO BRIDGES ON HIGHWAYS AND RAILROADS CAUSED BY THE GREAT HANSHIN EARTHQUAKE OF JANUARY 17, 1995

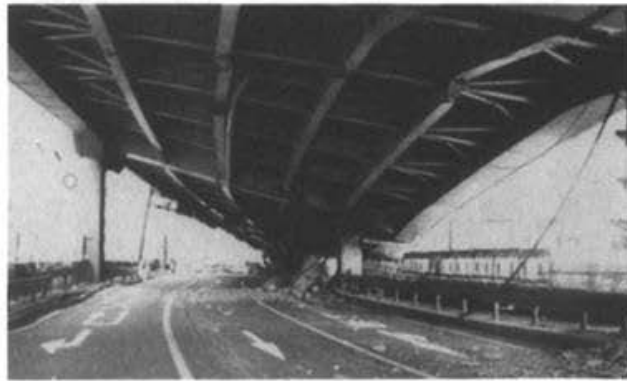
Photo 2.1.10 HANSHIN EXPRESSWAY  
(Meriken Park north side )

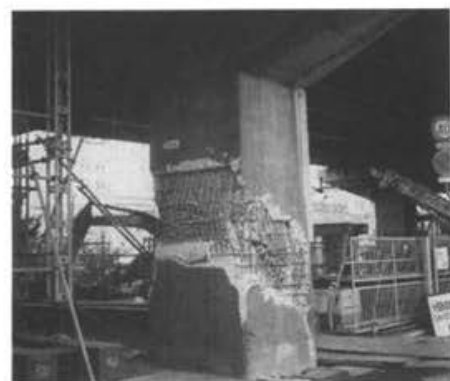
Photo 2.2.1 MEISHIN HIGHWAY  
(Nishinomiya City - Tsumon-ida-cho)

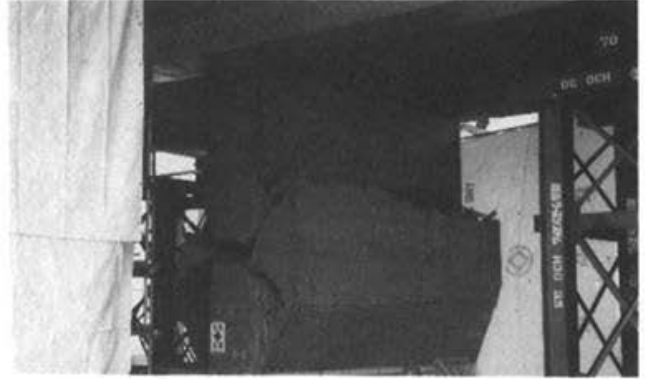
Photo 2.2.4 MEISHIN HIGHWAY  
(Amagasaki City - Suido-cho )

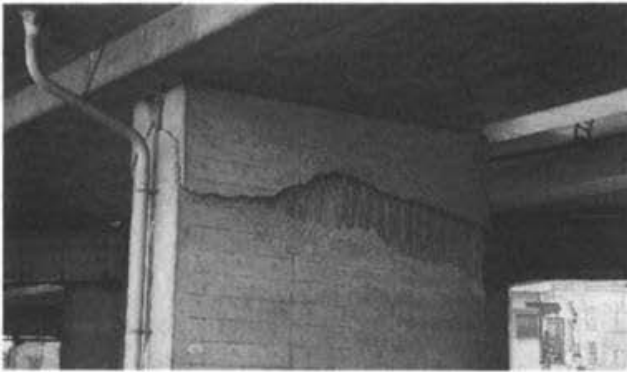
Photo 2.2.5 MEISHIN HIGHWAY  
(Amagasaki City - Suido-cho)

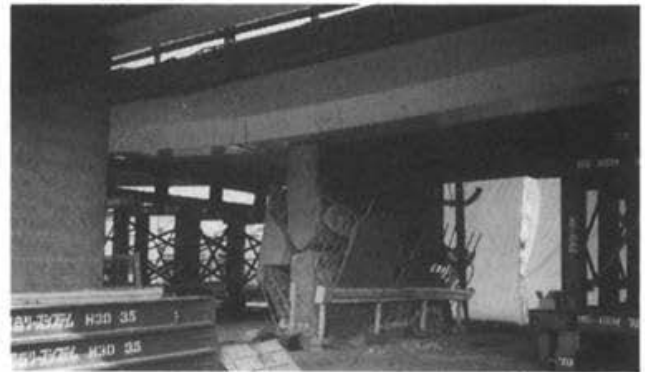
Photo 2.2.6 MEISHIN HIGHWAY  
(Amagasaki City - Tachibana-cho)

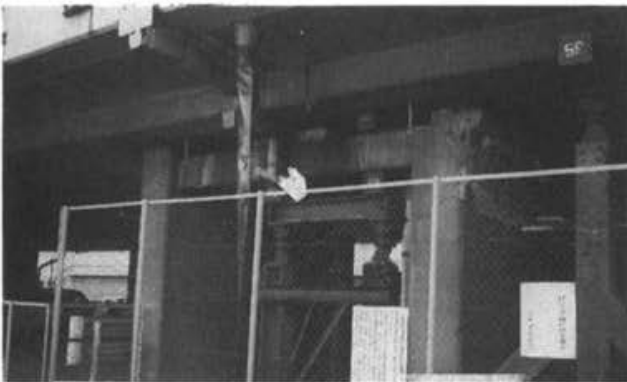
Photo 2.2.7 MEISHIN HIGHWAY  
(Amagasaki City - Jakuoji-cho)

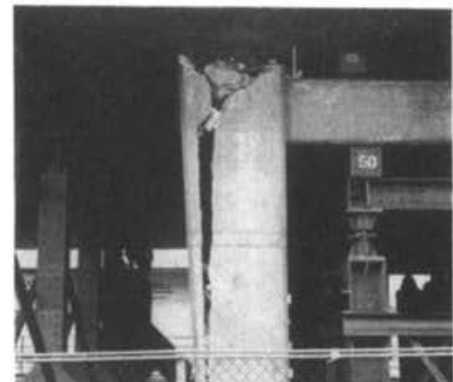
Photo 2.2.8 MEISHIN HIGHWAY  
(Amagasaki City - Jakuoji-cho)

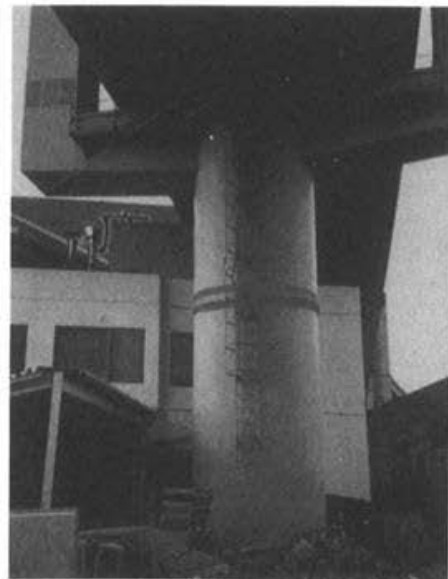
- Piers N. Hamate 7-9**
- Bridge type : Super-structure : Two-lanes, Simple steel plate girder  
Sub-structure : Single RC piers of rectangular cross section and also bents composed by multiple columns
  - Damage situation : Foundation : RC basement.  
Relative displacement of the girder at some of its bearing supports
  - Picture 2.4.2

Photo 2.4.1 ROUTE 2 - HAMATE BY-PASS  
(Chuo-Ward - Hamabe-dori)

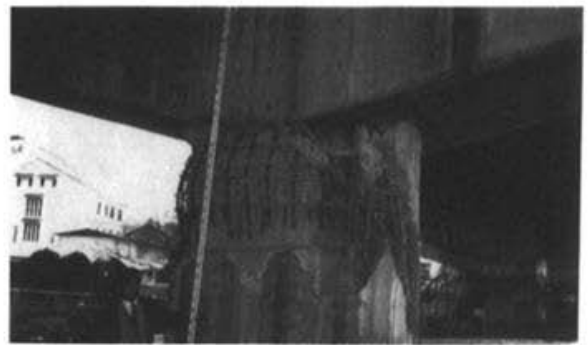
Photo 2.6.1 ITAMI TOYONAKA ROUTE  
(Itami City - Amatsu)

- Picture 2.6.1

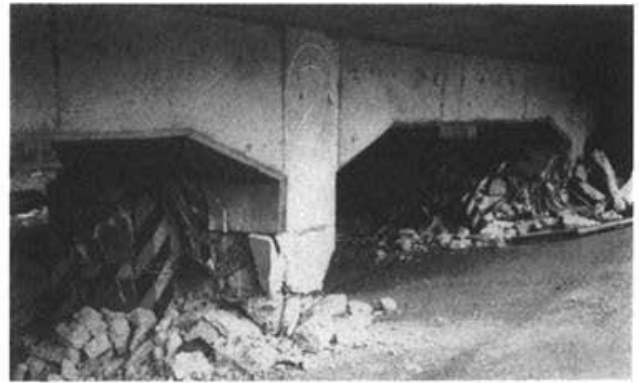
Photo 3.3.3 JR TOKAIDO LINE  
(Rokko-michi station)

- Bridge type : Super-structure : RC continuous rigid frame.  
Sub-structure : RC continuous framed structure.  
Foundation : RC footing.
- Damage situation : Severe damage at the middle part of the columns on both up and down lines.
- Picture 3.3.3

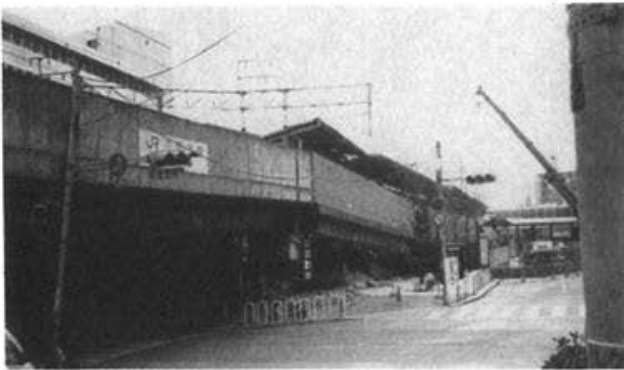
Photo 3.3.4 JR TOKAIDO LINE  
(Higashinada-Ward - Mikage-cho, Gunke)

- Bridge type : Super-structure : RC simple girder.  
Sub-structure : RC continuous framed structure.  
Foundation : RC footing.
- Damage situation : Girder fall by the collapse atop of columns on both up and down lines.
- Picture 3.3.4

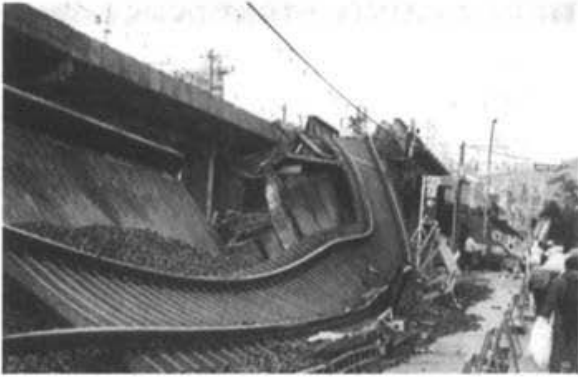
Photo 3.5.3 HANKYU LINE  
(Nishinomiya City - Tonoyama-cho)

- Damage situation : Fall down of an apartment house on railroad track.
- Picture 3.5.3

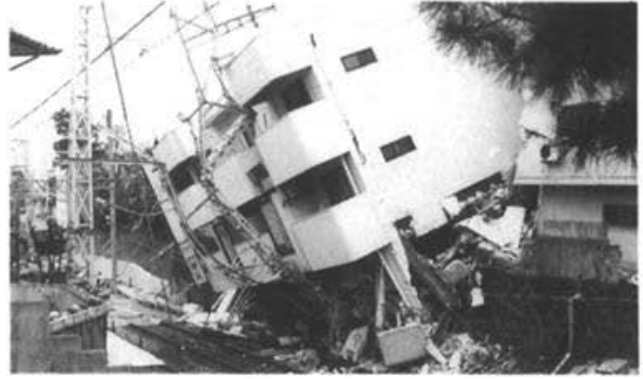
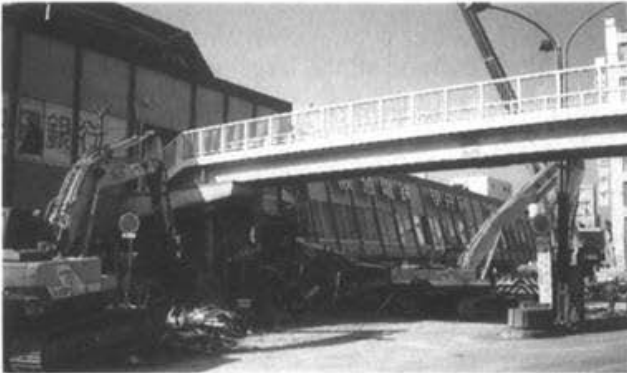
- Pictures 3.5.4 and 3.5.5

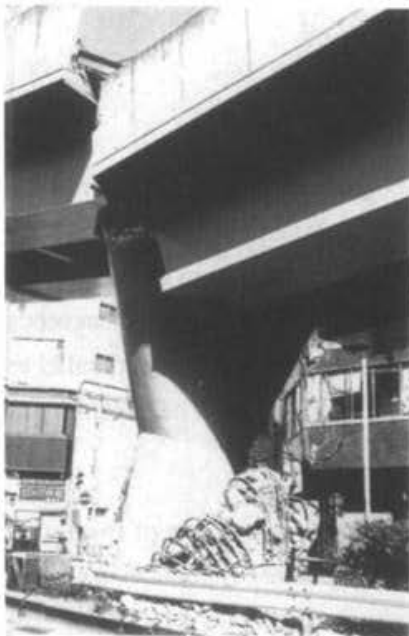
Photo 3.6.1  
PORT LINER  
(Chuo-Ward - Miyuki-dori 6-chome)

- Bridge type : Super-structure : Steel box girder.  
Sub-structure : RC circular piers.  
Foundation : RC basement.
- Damage situation : Slip down of girder caused by the collapse of a pier.
- Picture 3.6.1

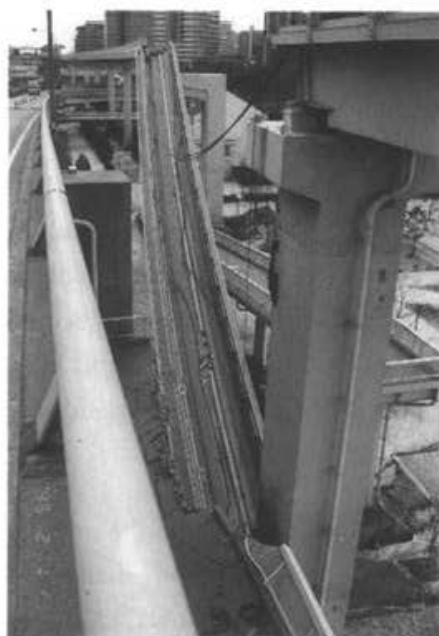
Photo 3.7.1 ROKKO LINER  
(Rokko Ohashi)

- Bridge type : Super-structure : Steel box girder.  
Sub-structure : Steel single columns.
- Damage situation : Fall of girder to one side.
- Pictures 3.7.1 and 3.7.2
